# Mortar Accident Mali

*The Hague, December 2017*

On 6 July 2016, members of a mortar squad from the Airmobile Brigade were conducting an exercise firing 60 mm mortar rounds. During the exercise one of the rounds exploded in the mortar. As a result, the two members of the mortar squad operating the mortar lost their lives and a third one was seriously wounded. The exercise took place near the UN camp in Kidal, Mali, where the Netherlands is participating in the UN Multidimensional Integrated Stabilization Mission in Mali (MINUSMA).

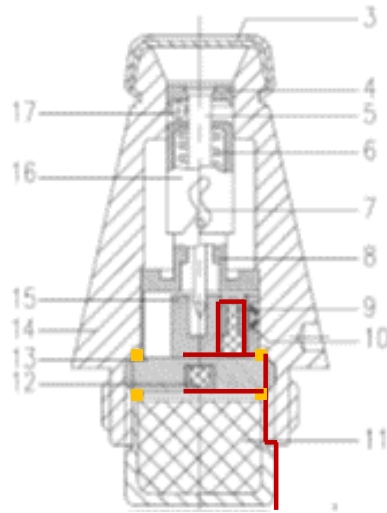
Figure 9 shows two other potential routes for the exudate; one to locations below the metal barrier and one to locations above the metal barrier. It is considered unlikely that the exudate penetrated the screw thread of the booster and the sealing ring below the metal barrier (lower red line in Figure 9) and that combustion of the exudate, due to the shock of the launch, initiated the lead charge (which subsequently caused detonation of the booster and main charge). This is unlikely because the lead charge requires a shock for initiation. This is also true when RDX crystals from the booster have migrated with the exudate (see paragraph 3.1.2).

It is even more unlikely that the exudate migrated via the screw thread of the booster and the sealing ring, the screw thread of the metal barrier and the (second) sealing ring and subsequently settled between the metal barrier and detonator and around the detonator. In this scenario a 'bridge' of energetic compounds would be formed between the primer and the lead charge (top red line in Figure 9).

In this case the bridge of exudate will combust without initiation of the lead charge. The transfer of the shock by the exudate from the primer to the lead charge (with subsequent initiation of the booster and main charge) is considered unlikely. This is also true in case RDX crystals from the booster have migrated with the exudate (see paragraph 3.1.2).

Figure 9 Potential but unlikely routes for exudate to locations below and above the metal barrier.

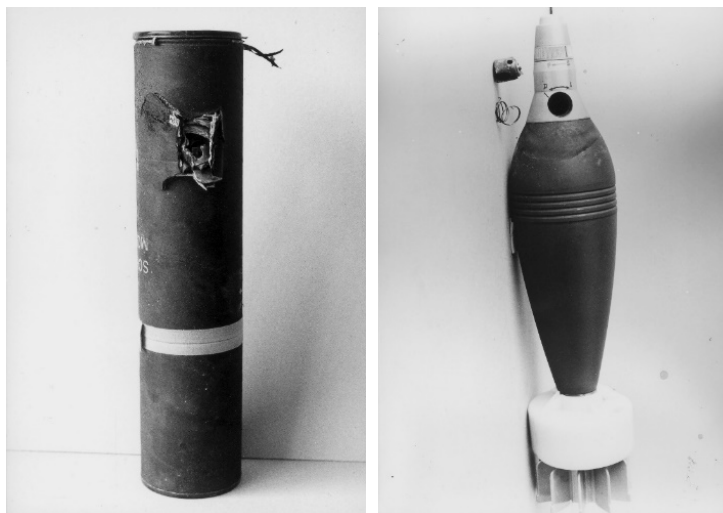
- Lead azide (center part of the detonator) is not hygroscopic, is insoluble in water, has a deflagration temperature of 320 to 360°C and a high thermal stability [Meyer, 2007].  
In the past lead azide was associated with the formation of the extremely sensitive copper azide. [Shaneyfelt, 1984] states that lead azide does not corrode most metals in dry condition. However, if moisture is present lead azide can react with copper, mercury, tin and zinc and form extremely sensitive and hazardous azides. An example is provided in [Kroon, van Ham, Bouma, 2015]: Copper azide is an extremely sensitive compound that may react to mild impact or shock. In 1974, TNO analysed the accidental reactions involving the 81 mm mortar of the Royal Dutch Navy [Josseling de Jong, 1976]. During maintenance of this ammunition, which had returned to Den Helder from a mission in the Antilles<sup>12</sup>, it was observed for a number of rounds that the rotor that ensures arming after firing (part of the safety and arming mechanism) was projected through the cardboard packaging; see Figure 12. The investigation revealed that the detonators of the fuzes had corroded, resulting in the formation of copper azide. It was concluded that the brass components near the detonator (percussion cap) had reacted with the lead azide inside the aluminium detonator. As a result of internal friction, probably caused by transport vibration, the copper azide reacted and initiated the primer charge and the delay charge. The main charge was not activated because the fuze was in safe (unarmed) position.

Figure 12 Perforated cardboard packaging and projected rotor of the arming and safety mechanism of the 81 mm mortar round [Josseling de Jong, 1976].

The ammunition was on board of a ship of the Royal Dutch Navy located at the Antilles for 18 months. The prevailing high temperature and humidity caused the reaction of the lead azide with water vapour in the atmosphere. The reaction is seen on the top view of the detonator in the brass casing in Figure 13. Traces of the primer (antimony sulphide and potassium chlorate) are visible as grey and white crystals, possibly mixed with aluminium compounds from the detonator. Traces of the red (sealant) lacquer are also observed. The green crystals indicate copper compounds such as copper azide and the non-explosive copper hydroxide ( $\text{Cu}(\text{OH})_2$ ) and copper oxide ( $\text{CuO}$ ).

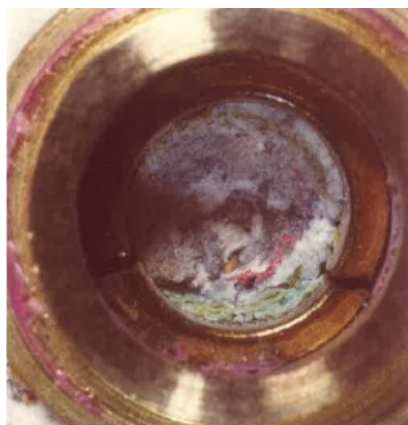
Figure 13 Top view of the aluminium detonator in a brass casing of fuze type V-19 [Josseling de Jong, 1976].

In this condition the ammunition can no longer be used because reliable functioning has become impossible and handling of the ammunition poses a great risk. However, this is a temporary effect; copper azide will continue to react with water (vapour) until copper oxides are eventually formed, at which point all explosive properties are lost.

Moisture can also result in hydrolysis of the lead azide creating hydrogen azide.<sup>14</sup> The hydrogen azide can react with the copper in the Melchior cup holder and in the brass slider and form copper azide. In the first stage of this process extremely sensitive compounds can be formed, which at a later stage convert to less sensitive compounds, which, in addition to copper and azide, can also contain hydroxyl groups, water molecules and possibly carbonate groups [Lamnevik, 1967]. The green tarnish around the detonator in Figure 13 is an indication of these copper compounds.

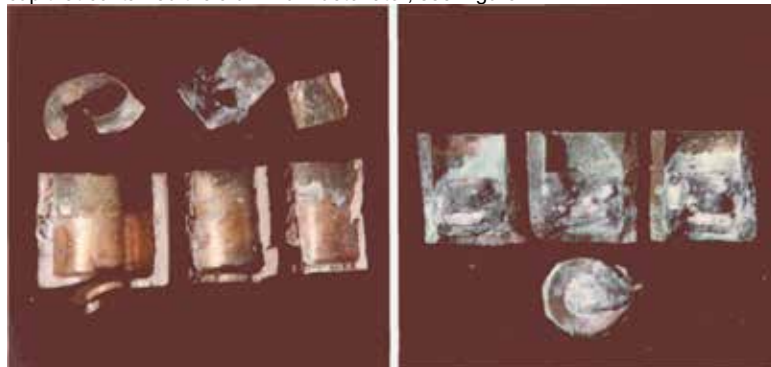
[Josseling de Jong, 1976] demonstrated that corrosion also occurred in the brass cup that contained the aluminium detonator; see Figure 14.

Figure 14 Brass cups (left) and aluminium detonators (right) from the V-19 fuzes originating from the Dutch Antilles [Josseling de Jong, 1976].

Figure 14 displays the brass cup (left) and aluminium detonators (right). The yellow colour on the brass cups clearly shows where the detonator resided in the cup. Above it, a green tarnish is observed. The contents of the detonators are for the greater part still present. Also here, a green tarnish is observed.

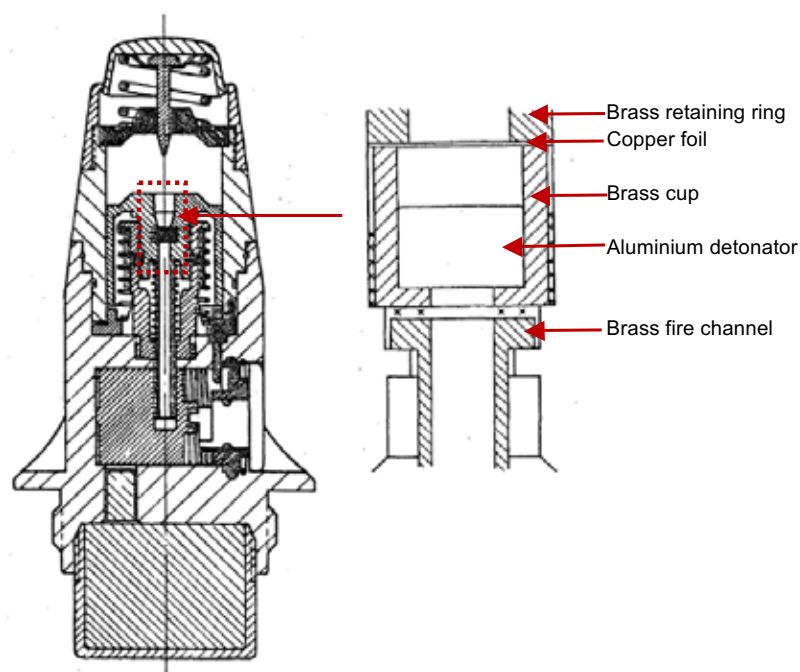
The green tarnish was found all over the brass components, also in the space between the brass housing and the brass cup and also on the top side of the brass fire channel, as shown in Figure 15. The green tarnish above the detonator was examined for azide and carbonate. Both were found<sup>15</sup>. This azide could possibly have originated directly from the lead azide in the detonator. The green crystals between the brass housing and the brass cup also gave a positive reaction for azide; copper was also found. This azide cannot have originated directly from the lead azide in the detonator. Figure 15 demonstrates that copper azide can form at some distance from the detonator as a result of degradation. [Josseling de Jong, 1976] concludes that one can generally state that the presence of copper in the direct vicinity of lead azide must be considered unacceptable, also when in the form of brass and with an airspace in between.

Figure 15 V-19 fuze in safe position (left) and position of the detonator (right) with azide containing green tarnish indicated with x, which cannot have originated directly from the lead azide in the detonator [Josseling de Jong, 1976].

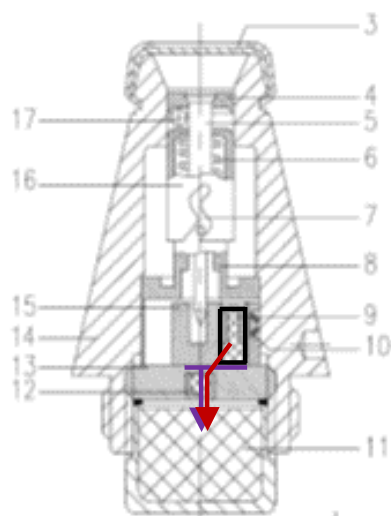
If copper azide actually formed in the M6-N fuze there are two possible ways to set off the explosive train (detonator - lead charge - booster - main charge). See Figure 16; due to the shock of the launch of the mortar round the copper azide detonated, which resulted in the initiation of the detonator (black):

- with transmission of the shock through the metal barrier (indicated with red arrow) to the lead charge, where the metal barrier failed to function according to the safety and arming design principle. This intrinsic safety was not verified by Arsenal by means of an *explosive train interruption test*<sup>16</sup> [Company visit to Arsenal, 2017]
- with the transmission of the shock along a 'bridge' between the detonator and the lead charge (indicated with purple arrow) over the metal barrier, with the bridge (in contrast to exudate) consisting of compounds with explosive properties, such as copper azide possibly supplemented with a residue of sublimated tetrazene.

Figure 16 The copper azide detonates when launching the mortar round, resulting in detonation of the primer (red) or detonation of the primer and the 'bridge' of copper azide between the primer and the lead charge (purple).

In Figure 16 both routes for potential shock transmission relate to the sensitivity of the lead charge (and booster), which may increase for temperatures above 50 to 60 °C (or higher). Figure 17, reproduced from [Zhang & Weeks, 2010], provides an indication for this; the impact sensitivity of PETN is approximately twice as high at a temperature of 65°C than it is at room temperature.

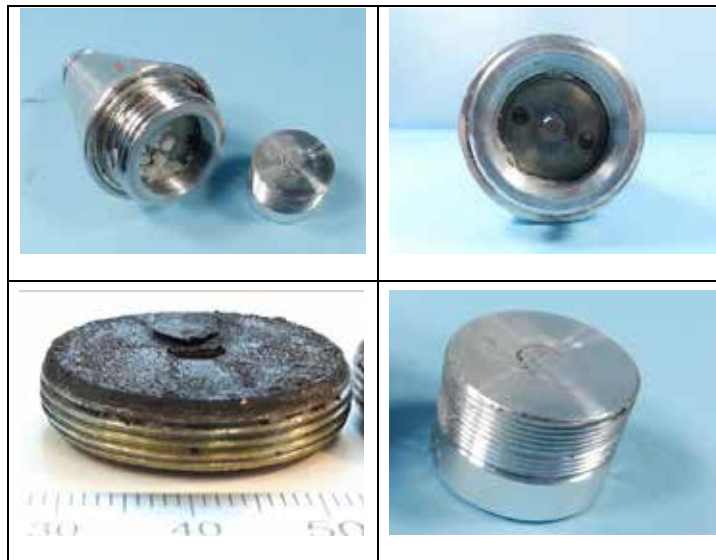
After the experiment the impact fuze is still clamped in the test configuration. No damage is visible to the exterior of the impact fuze. The aluminium cap is stuck in the screw thread, and has to be removed with force.

Once the cap is removed the bottom of the barrier becomes visible. The latter displays traces of expansion gases. Only a thin, circular piece of metal is present at the position of the lead charge. It appears that this is the base of the lead charge cup. The explosive lead charge has disappeared. The metal of the barrier above the lead charge has been blown away. This means that a transfer of reaction from the duplex detonator to the lead charge has occurred. The aluminium cap displays a slight indentation, caused by the reaction of the lead charge. Figure 10 shows some pictures of the impact fuze after the experiment.

Figure 10 Some pictures of experiment 1, from top left, clockwise: impact fuze after the experiment and removal of the aluminium cap; bottom surface of the barrier with fragment of the lead charge cup; dent in the aluminium cap; top surface of the barrier with indentation at the location of the duplex detonator.

After the experiment the impact fuze was further disassembled. The top surface of the barrier displays a clear indentation at the location of the out of line positioned duplex detonator.

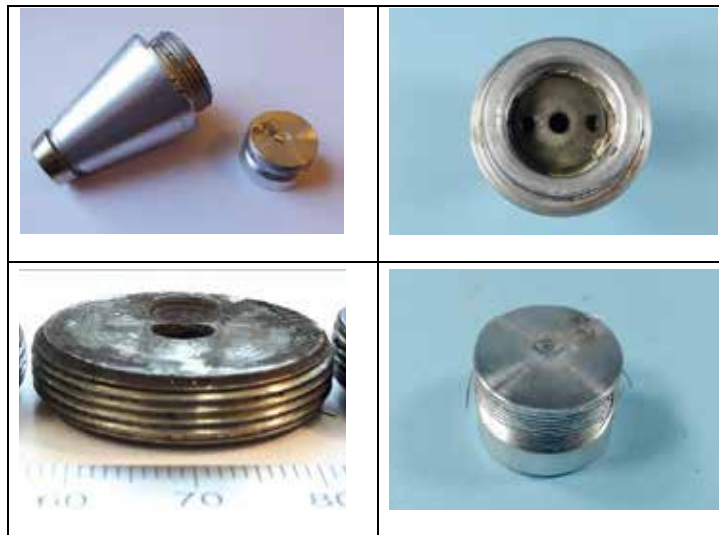
In experiment 2 also a transfer of reaction from the duplex detonator to the lead charge is observed. The effect of this is clearly visible directly after the experiment. The fuze body was expelled from the laboratory clamp into the bunker as a result of the initiation. The force released during initiation and the transfer of reaction to the lead charge resulted in the aluminium cap being thrown from the fuze body damaging the screw thread. The cap was recovered from a different part of the bunker. The bottom surface of the barrier is directly visible and again displays traces of expansion gases. The central cavity in the barrier is empty and the metal above the lead charge has been blown away. The top surface of the barrier displays a clear indentation at the position of the duplex detonator. Again, the aluminium cap displays a slight indentation, caused by the reaction of the lead charge. Figure 11 shows some pictures of the impact fuze after the experiment.

Figure 11 Some pictures of experiment 2, from top left, clockwise: impact fuze after the experiment; bottom surface of the barrier; dent the aluminium cap; barrier with the indentation at the position of the duplex detonator.

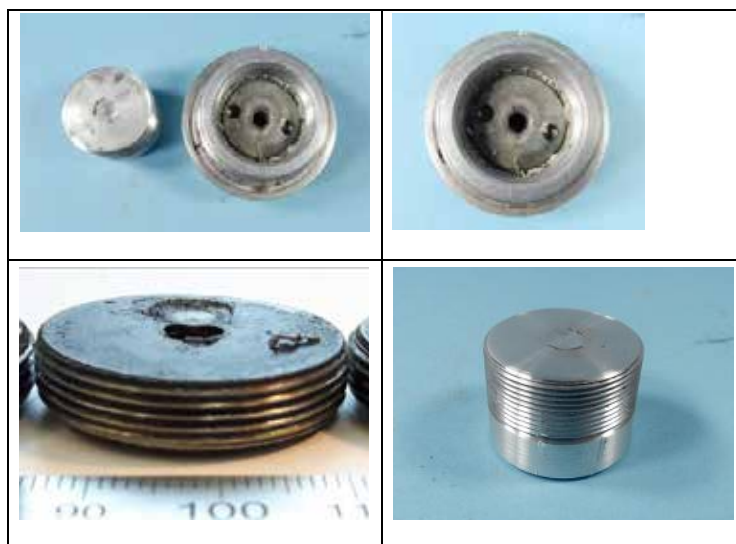
After removal of the cap and the barrier the indentation in the top surface of the barrier at the location of the duplex detonator becomes visible and transfer of reaction from the duplex detonator to the lead charge has occurred.

The metal above the lead charge was blown away. Figure 12 shows some pictures of the impact fuze after the experiment.

Figure 12 Some pictures of experiment 3, from top left, clockwise: impact fuze after the experiment; bottom surface of the barrier; dent in the aluminium cap; barrier with an indentation at the position of the duplex detonator.

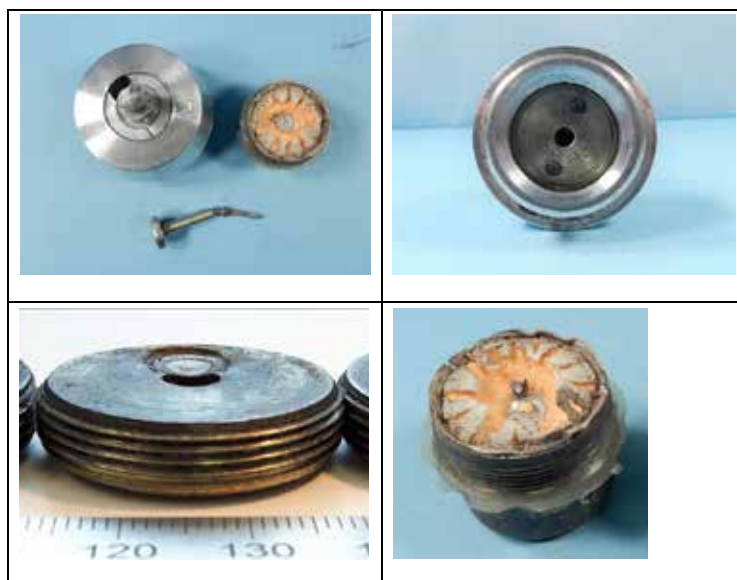
The other impact fuze components display similar results as in experiments 1 and 2. The metal of the barrier above the lead charge has also been blown away by the transfer of the reaction from the duplex detonator to the lead charge. Figure 13 shows several pictures of the impact fuze after the experiment.

Figure 13 Several pictures of experiment 4, from top left, clockwise: impact fuze after the experiment; bottom surface of the barrier with debris of the lead charge cup; indentation of base of the lead charge cup in the booster charge; impacted barrier with an indentation at the location of the duplex detonator.

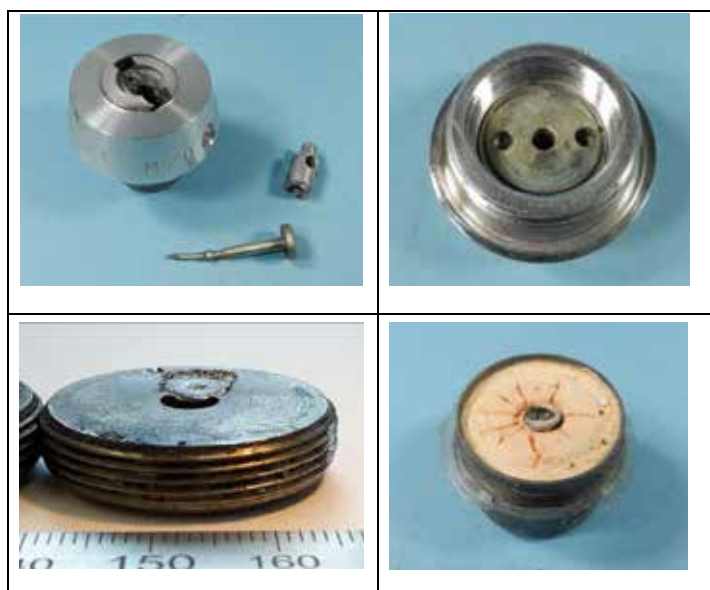
The result of experiment 5 is similar to the result of experiment 4. No detonation of the booster charge is observed. The booster charge cup is still intact and connected to the fuze body. When removed, the top side of the booster displays a damage pattern resulting from the reaction of the lead charge. The cardboard has completely disappeared. The base of the lead charge cup has impacted on the RDX charge of the booster, although the indentation is considerably smaller than in experiment 4. The base of the lead cup is left behind in the RDX, see Figure 14, bottom right.

There is a clear indentation in the top surface of the barrier at the location of the duplex detonator, but its shape is different from that observed in the other experiments. Transfer of the reaction from the duplex detonator to the lead charge was observed once more.

Figure 14 Several pictures of experiment 5, from top left, clockwise: impact fuze after the experiment; bottom surface of the barrier with debris of the lead charge cup; indentation of base of the lead charge cup in the booster charge; impacted barrier with an indentation at the location of the duplex detonator.

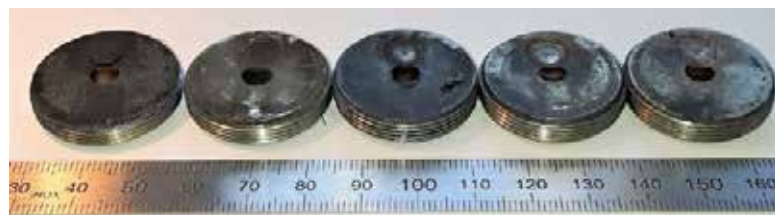
The five impact fuzes were disassembled after finalizing the experiments. The five barriers have been placed side by side in Figure 15. They very clearly display an indentation caused by the reaction of the duplex detonator. Although a slight variation in the shape and depth of the indentation is observed, it can be stated that the initiation method (detcord versus mechanical) did not result in any clear difference in indentation.

Figure 15 also clearly shows that the metal above the central cavity has been blown away in each of the five barriers. In some cases the duplex detonator has also caused deformation to (the edge of) the central cavity.

Figure 15 Barriers from the five experiments (left to right: experiments 1 through 5).

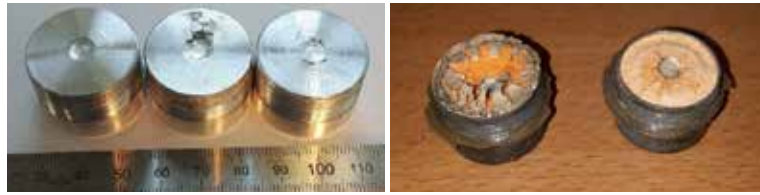
Experiments were performed with three inert and two original boosters, see Figure 17. The indentation in the aluminium cap below the lead charge indicates a high explosive effect of this charge. There is visible variation in indentation, with the largest indentation occurring in experiment 2. The indentation in the original booster charges is also clearly different, with the largest indentation occurring in experiment 4.

Figure 17 Effect of the lead charge on boosters from experiments 1 through 5 (left to right). Three aluminium caps as inert boosters in the picture on the left and two original boosters charges in the picture on the right.

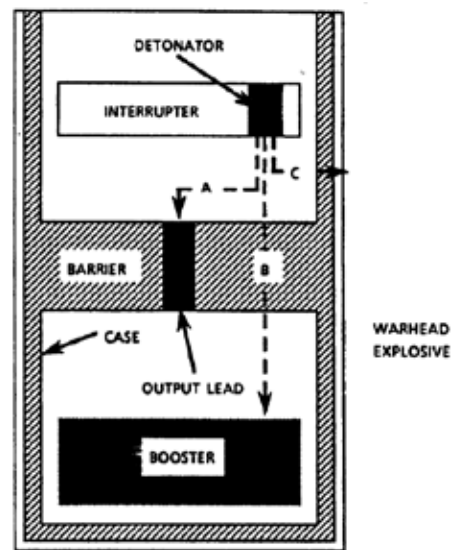
This means that the most likely route of the initiation of the lead charge appears to be: transfer of the shock wave from the duplex detonator through the barrier to the lead charge (route A in Figure 18). The (shortest) distance between the duplex detonator and the lead charge and / or the thickness of the metal above the lead charge are insufficient to prevent a reaction of the lead charge. There was no transfer of the shock wave of the duplex detonator through the barrier directly to the booster charge (route B in Figure 18). The thickness of the barrier appears adequate to prevent this from happening.

Figure 18 Three possible routes for shock wave transfer from the out-of-line detonator. Route A is from the detonator to the lead charge, route B is via the barrier to the booster charge and route C is directly from the detonator to the main charge (and only applies to a fuzing system built into the main charge [6].

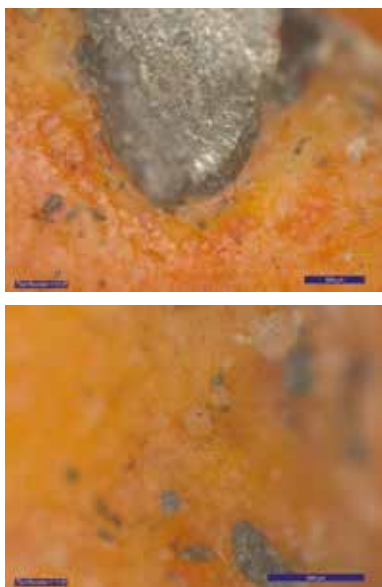
Optical microscopy was used to examine the surface of the booster charge, see Figure 19. The top picture shows localised discolouration<sup>5</sup> at the edges of the crater in the booster charge and near the impact of a relatively large metallic fragment. Spherical particles have also been identified, with a typical diameter of 150 to 250  $\mu\text{m}$  (Figure 19, bottom) and with minuscule metal particles in the surface. These are indications that the booster charge encountered a (localised) thermal load.

Figure 19 Experiment 4; colour differences in the surface of the booster near a metallic fragment (top), and spherical, relatively transparent particles with small metallic fragments in the surface (bottom).

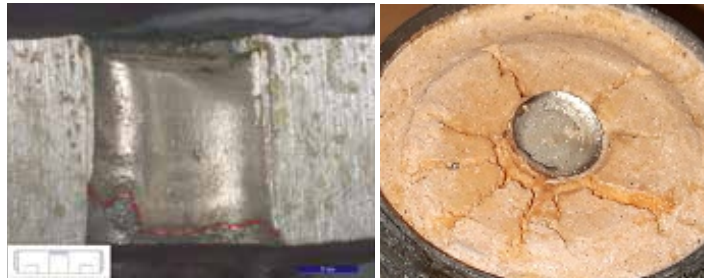
The base of the lead charge cup was left behind in the booster charge. Reference is made once more to [4]. The wall of the lead charge cup was still present in the central cavity of the barrier from the accident. The bottom edge of this remnant of the lead charge cup shows that the base of the cup has been blown downward, see Figure 20, left. The similarity with the base of the cup in the booster is clear, see Figure 20, right.

Figure 20 Left: central cavity of the barrier from the accident with remnant of the lead charge cup [4]. Right: the base of the lead charge cup in the booster after experiment 5.

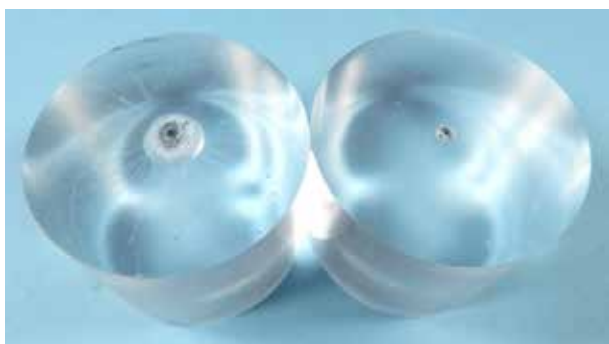
Figure 23 shows the effect on a PMMA cylinder from a detcord with a booster (left) and without a booster (right). The effect with a booster is clearly more prominent.

Figure 23 Damage to PMMA cylinders caused by the detonation using the detcord with (left) and without (right) a booster.

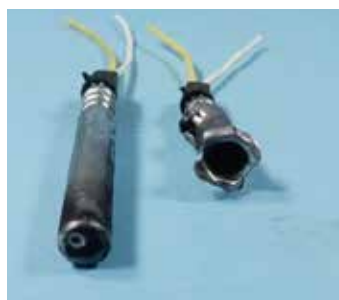
This difference in the effect was also tested by positioning the detcord with and without a booster against the base of a C2 detonator, with the underlying idea that the C2 detonator could simulate the duplex detonator that needs to be initiated. The base charge of the duplex detonator will be 'comparable' to the base charge of the C2 detonator; both require sufficient shock-sensitivity for initiation and adequate output to initiate a subsequent charge in the explosive train. The result is shown in Figure 24. The detonator without a booster is only able to damage the metal casing of the C2 detonator. The charge of the C2 detonator does not detonate, in contrast to the experiment in which the detcord with the booster cup was used.

Figure 24 Effect of the detcord without a booster (left) and with a booster (right), positioned against the base of a C2 detonator.

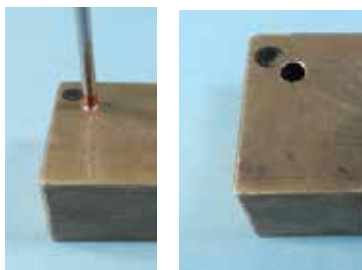
For comparison the effect of the detcord with a booster was also determined using the brass block only. A hole with the diameter of the booster (2.9 mm) and a depth of 9 mm was drilled into the brass block, see Figure 25, left. No deformation of the brass was found after the experiment. (NB: The black mark top left of the hole was caused by the detcord that came to rest on the surface of the block due to the effect of the booster in the hole next to it, leaving behind some combustion products.)

Figure 25 Effect of the detcord with a booster sunk into a brass block; configuration before the test (left) and the result after the test (right).

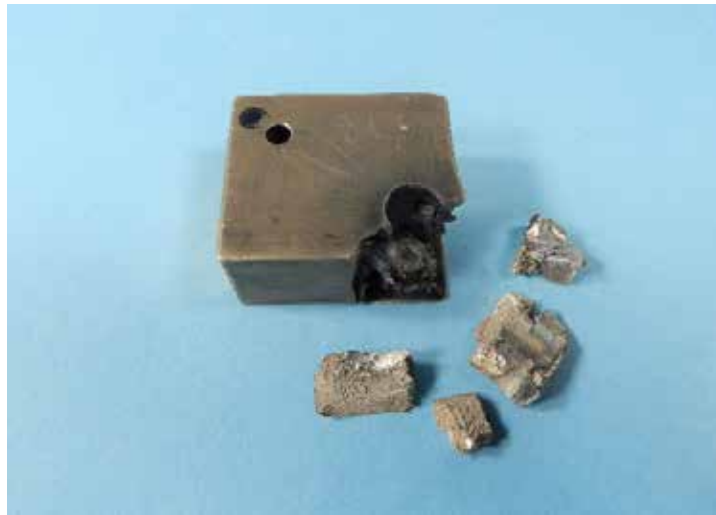
The duplex detonator initiated following the detonation of the detcord. The effect of the detonator on the brass block is significant, see Figure 27. While the booster of the detcord did not display any deformation of the hole in which it was inserted in the brass block, the duplex detonator deforms and cracks the brass block. The detonator's longitudinal effect is also easily identified.

Figure 27 Damage to the brass block following detonation of the duplex detonator.

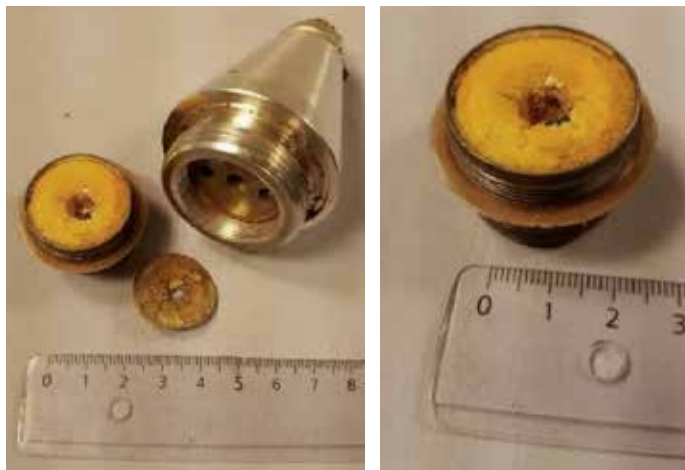
After the experiment the booster charge is removed from the fuze. It is observed that transfer of reaction from the duplex detonator to the lead charge has occurred. The lead charge has punched a crater in the RDX/wax of the booster and remnants of the lead charge cup are left behind in the RDX/wax, see Figure 3.

Figure 3 Booster charge that was disassembled after the test.

The crater in the RDX/wax is deeper than in previous experiments [1]. This can be explained by the higher temperature, which softens the wax in the booster charge.

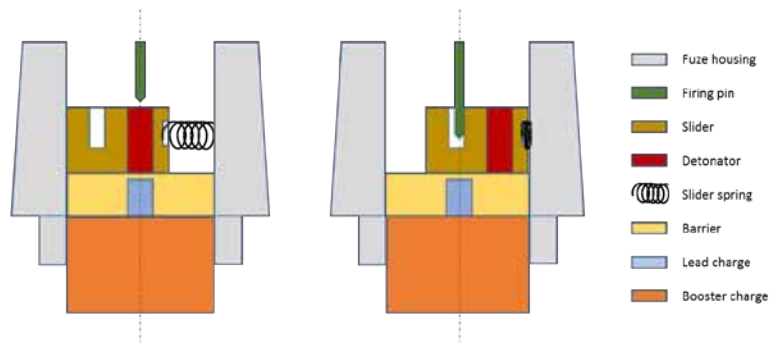
See Figure 7; upon functioning of the detonator the slider is broken into two parts; the part on the left of the detonator is accelerated to the left and the part on the right of the detonator is accelerated to the right. Since in armed position the slider and slider spring are positioned at some distance from the fuze body inner wall, the imprint on the fuze body inner wall is less prominent than when the detonator functions in the slider in safe position, when the slider and slider spring already make contact with the inner wall of the fuze body. This is a strong indication that the accident mortar round detonated with the fuze in safe position.

Figure 7 Cross-section of (part of) the fuze in armed position (left) and in safe position (right).

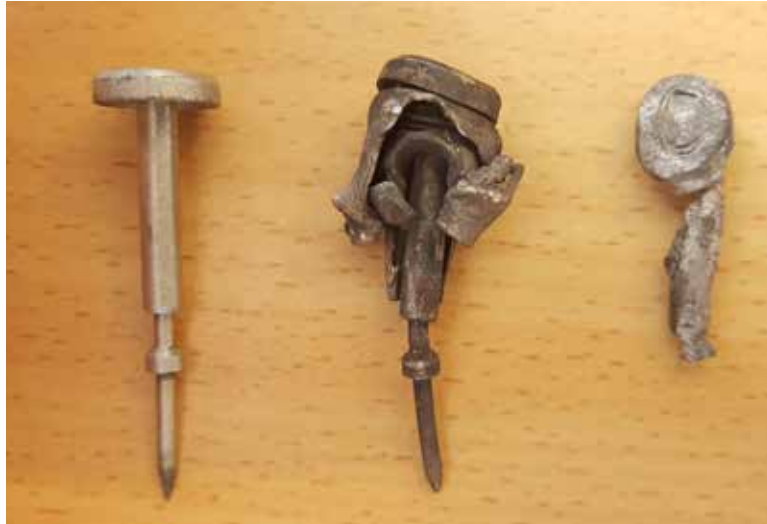
When the detonator functions in the slider in safe position (right in Figure 7) the part of the slider with the recess for the firing pin is accelerated to the left. As a result, the firing pin will deform substantially or break. Figure 8 shows three firing pins; an unused firing pin (left), the firing pin from the test in armed position (centre) and the firing pin from the accident mortar round (right). The latter has sheared off just below the lower thickened section. This is a strong indication that the accident round detonated in safe position.

Figure 8 Unused firing pin (left), firing pin from the test in armed position (centre) and from the accident mortar round (right).

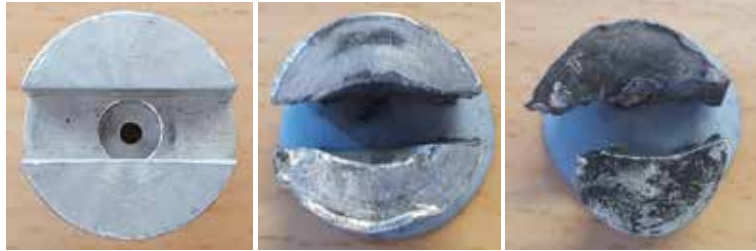
The bottom of the firing pin housing is circular with a rectangular recess in the centre in which the slider moves, see Figure 9 (left). When the detonator functions due to the impact of the firing pin the housing is deformed. In armed position this deformation is imposed on the centre of the housing. The deformation is virtually symmetrical in the radial direction, see Figure 9 (centre).

The energetic materials in the detonator transfer a flame in the top section of the detonator to a detonation in the bottom section of the detonator. This is why the deformation is largest at the bottom of the housing. The remnants of the housing from the accident also show a deformation, see Figure 9 (right). It deviates from the symmetrical and centred deformation that is obtained in the test in armed position. This is an indication that the accident mortar round detonated in safe position.

Figure 9 Bottom view of an unused firing pin housing (left), from the test in armed position (centre) and from the accident mortar round (right).

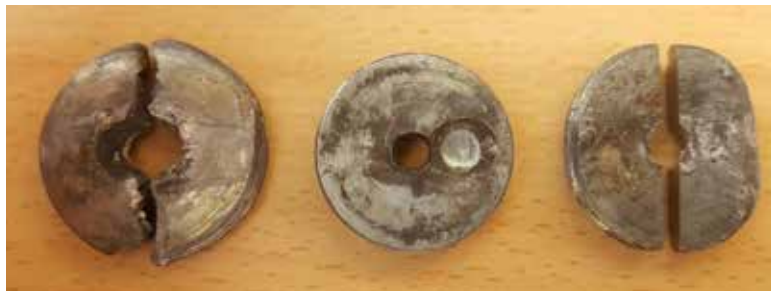
The effect of a functioning detonator on the explosive train interrupter (barrier) varies with the position of the detonator at the time of detonation. In armed position the detonator is above the centre of the barrier and in line with the lead charge (see Figure 7 left). The shock originating from the detonator propagates through the barrier and initiates the lead charge, thus creating a large central hole in the barrier, see Figure 10 (left). In safe position the detonator is positioned eccentric on the barrier (see Figure 7 right). When the detonator functions it leaves an imprint in the top surface of the barrier. As a result of the transfer from the detonator through the barrier the lead charge reacts and the metal of the barrier directly above the lead charge is blown away. This also results in a central hole, although smaller than with the detonator in armed position. The imprint and relatively small central hole are observed in an explosive train interruption test in safe position (Figure 10 centre) where the lead charge reacted without initiating the booster. A similar imprint and small hole are also observed in the barrier of the accident mortar round (Figure 10 right).

The *presence* of an imprint *off* centre and the *absence* of a large central hole *in* the centre of the barrier, demonstrate that the fuze from the accident mortar round was in safe position at the moment of the accident.

Figure 10 Top surfaces of the barrier from the test in armed position (left), from the test in safe position (centre) and from the accident (right). The barrier from the test in armed position is broken as a result of the detonation, the barrier from the accident was recovered in one piece, but cut in half for further examination.

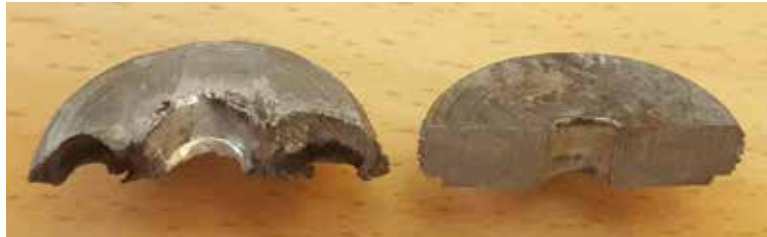
Additional evidence is provided by the variation in the deformation of the central hole across the thickness of the barrier. In armed position the detonator is in line with the lead charge. When both detonate the explosive force exerted on the barrier is greatest since both charges are in close proximity. Therefore, the radial deformation is larger near the top surface of the barrier than near the bottom surface, where the deformation is caused solely by the lead charge, see Figure 11 (left). This variation of radial deformation across the thickness of the barrier is not observed in the central hole of the barrier from the accident mortar round, see Figure 11 (right); this hole is clearly cylindrical, which indicates a reaction of only the lead charge. This finding also demonstrates that the fuze from the accident mortar round was in safe position at the time it was fired.

Figure 11 Top surface of the barrier from the test in armed position (left), and from the accident (right). The barrier from the test in armed position is broken as a result of the detonation, the barrier from the incident was recovered in one piece, but cut in half for further examination.

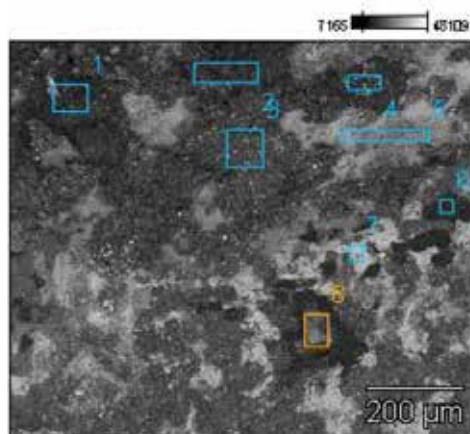
Figure 13 SEM photo with measurement areas for chemical element analysis at the edge of the firing pin recess of slider number 15.

Table 1 shows that the elements lead and nitrogen occur on the edge of the firing pin recess of slider number 15. These elements were also found on the surface of slider number 15 and on the surfaces of slider numbers 11, 14 and 20, see Table 2 [3].

The combination of lead and nitrogen is not expected to be found at the hole for the duplex detonator in the slider, on the external surface of the slider, or at the recess for securing the firing pin. Therefore it is likely that these primary explosives have migrated from the duplex detonator to the surface of the slider.

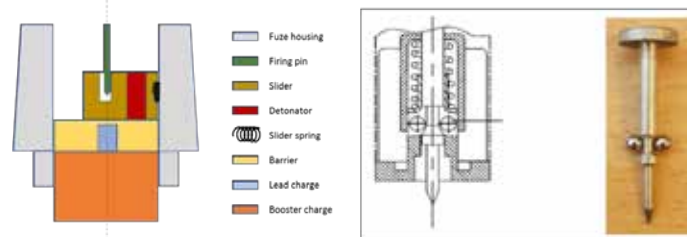
During careful examination of the safety and arming mechanism, a small tolerance is found on the firing pin enabling it to move 1 or 2 millimetres between the retaining balls underneath the setback cap. See Figure 14 left; in safe position the tip of the firing pin is secured by a recess in the slider. The force from the slider spring forces the right wall of the recess against the tip of the firing pin. The firing pin is secured vertically by two retaining balls that are locked between the setback cap and the recess in the firing pin, see Figure 14 centre [6]. As shown in the image on the right in Figure 14 there is a small gap of one or two millimetres between the retaining balls and the recess in the firing pin. As a result of the pressure from the spring under the setback cap (Figure 14 centre) the firing pin is forced upwards and the retaining balls downwards; the firing pin accordingly is situated in the upper position and the two retaining balls in the lower position.

Figure 14 Cross-section of part of the M6-N fuze in safe position (left), cross-section of the part with the setback cap, spring, retaining balls and firing pin (centre) and firing pin with the retaining balls in the recess of the firing pin (right).

At the moment the mortar round is accelerated during launch, both the setback cap and the firing pin move downwards. The latter will move 1 to 2 millimetres downwards until the two retaining balls reach the top edge of the recess (as in Figure 14 on the right). During this movement the tip of the firing pin slides against the right side wall of the firing pin recess in the slider. If the extremely sensitive copper azide is present near the edge of the firing pin recess or on the wall of the firing pin recess, friction may result in its detonation. In contrast to a prematurely functioning detonator, a detonation in the firing pin recess is straight above the lead charge and thus in line with the detonation train. This can result in a propagation of reaction through the barrier with initiation of the lead charge, with subsequent detonation of the booster and main charge.

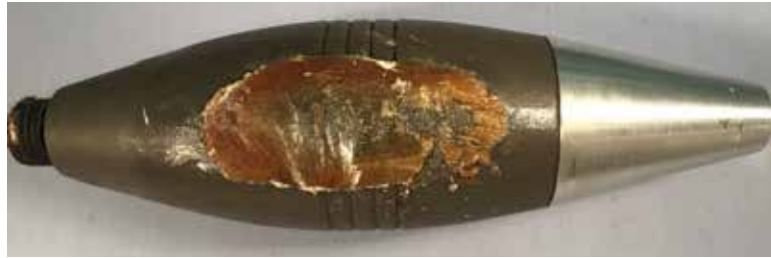
Figure 19 shows the HE80 mortar round. Exudate is visible in the form of re-crystallised TNT on, and several centimetres next to, the grooves on the exterior of the casing, with fine white crystals on both sides of the TNT. A thin line from the interface between the fuze and the shell body marks the path along which the molten TNT has flown (at the bottom side of the round during heating).

Figure 19 HE80 shell body with dummy fuze with TNT exudate.

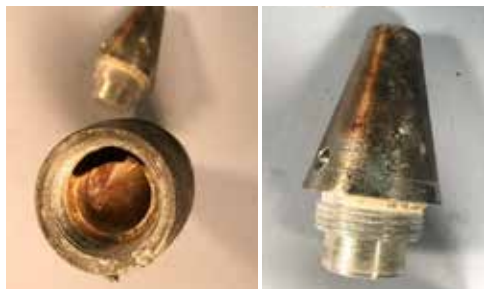
No deflagration or detonation of the TNT main charge has occurred during the burning of the thermite charge for approximately one minute. The dummy fuze is removed from the shell body after the test. See Figure 22 ; an estimated 20% of the TNT main charge has flown out via the fuze screw thread during the exudation test. The colour of the TNT at the top of the main charge has changed from yellow/orange (prior to the test) to brown (after the test). Re-crystallised TNT is found on the screw thread and the bottom surface of the aluminium dummy fuze.

Figure 22 20% of the TNT main charge has flown out via the screw thread on the fuze (left); re-crystallised TNT on the bottom surface and the screw thread of the aluminium dummy fuze (right).

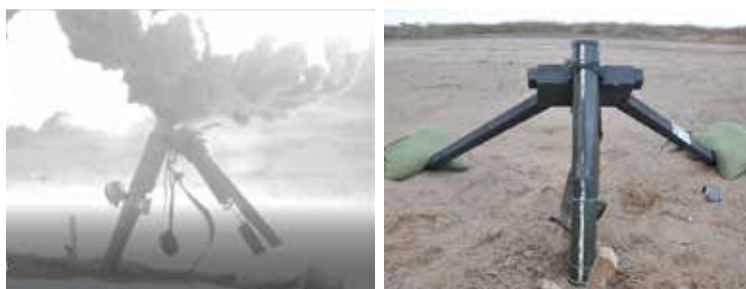
On recordings of the experiment with the casing with a 5 mm hole, a deflagration of the mortar round in the launch tube is observed, see Figure 25. The launch tube sustains severe damage; the sight unit is dislodged during launch as the tube bulges due to the high internal gas pressure. The mortar round does not fragment, probably because the accumulating gases in the shell body escape through the 5 mm hole and insufficient pressure builds up for a transition into a detonation. Fragmentation does not occur because the mortar round does not detonate.

These tests illustrate that, in the case of the 5 mm hole, the TNT has ignited prematurely, but no DDT of the main charge has occurred.

Figure 25 Deflagration during launch of the mortar round with the 5 mm hole in the casing [2].

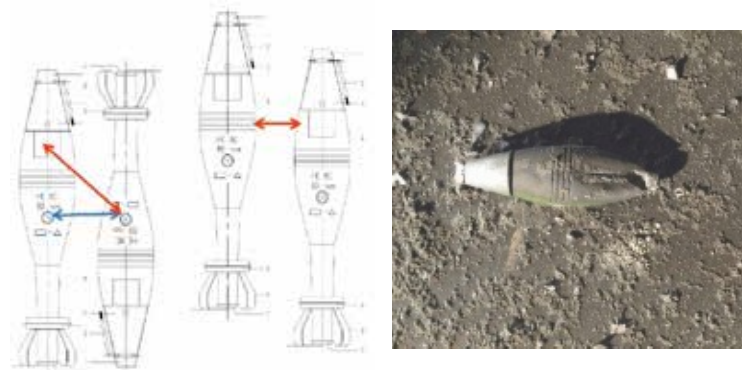
When conducting the study into the occurrence of sympathetic detonation for the HE80 mortar round, different positions and orientations of the rounds relative to each other have been tested; the main charge of one round (donor) is aligned with the booster and with the main charge of the adjacent round (acceptor) (see Figure 28). This study concluded for both test configurations that detonation of an HE80 mortar round did not result in a sympathetic detonation.

These results indicate that the HE80 TNT main charge is insensitive and cannot easily be set off. Even the effects of the shock and fragmentation originating from an adjacent and detonating HE80 round does not result in a reaction of the main charge. It is noted that Great Britain, the United States and Canada use the 60 mm mortar round with an HC of 1.2E. The designation 1.2 means that fragment projection occurs without mass detonation. The designation E means that there is a secondary detonating explosive present which does not have its own means of initiation. Since no sympathetic detonation occurs, this seems to be a more reasonable classification.

Figure 28 Experiments with the HE80 mortar round: main charges aligned and main charge aligned with the booster (left). An adjacent HE80 round is severely deformed but a sympathetic detonation does not occur (right) [11].
