DUTCH  
SAFETY BOARD

# Quarterly Aviation Report

January - March 2023

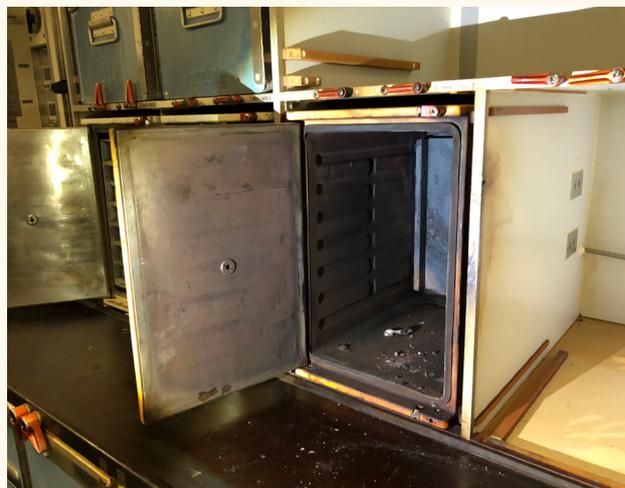
▲ The oven in the galley.

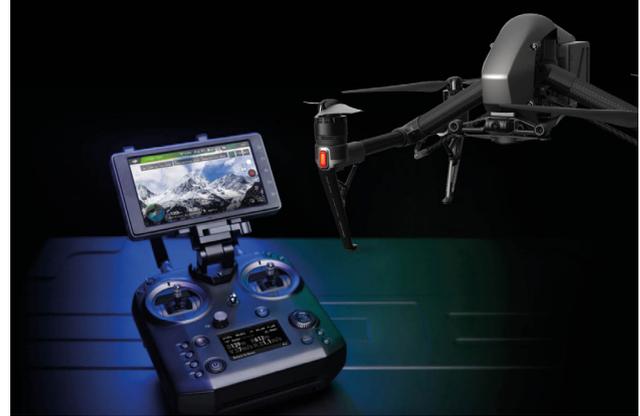
The operator did not have procedures for compass calibration in relation to payload changes and relied on indications from the DJI GO 4 app. By doing so, the operator complied with the UAS manufacturer's recommendation, which stresses to only calibrate the compass when indicated by the software. This investigation shows that the DJI GO 4 app is not able to detect an incorrectly calibrated compass in

The manufacturer of the loudspeaker payload did test for interference during development, but not extensively. There was no coordination between the UAS and payload manufacturers, which is an important prerequisite for the development of payloads that can be used safely

▲ DJI Inspire 2 UAS (Source: djicdn.com)

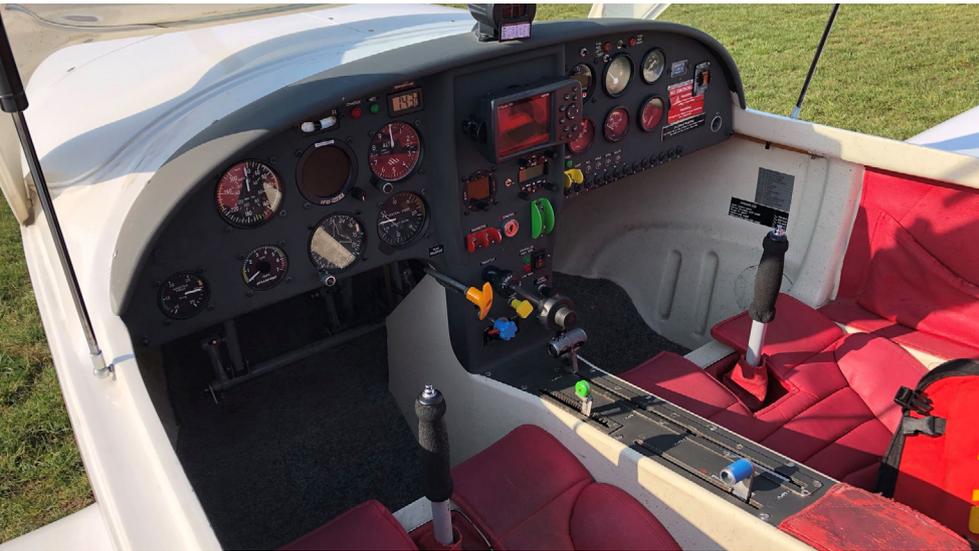
Additionally, the manufacturer issued a Recommended Service Bulletin in 2019 to install a canopy lock with safety latch and sensor to prevent unintentional opening of the canopy. This new canopy lock would indicate the insufficient plug-in of the main latch by means of a yellow check light in the cockpit. It would also hold the main latch – and therefore the canopy closed – after the plug-out from the canopy lock socket. The accident aircraft did not have this new and recommended lock and check light installed.

When the aircraft was purchased in 2009, the Pilot's Operating Handbook did not contain the changed information as required in the Mandatory Service Bulletin of 2008. The flying club, holder of the aircraft, was not aware of the Mandatory Service Bulletin. Holders themselves are responsible for checking the manufacturer's website regularly. The recommendation to install a new lock with safety latch and sensor was considered unnecessary by the flying club. Regular maintenance and inspection of the aircraft and its documentation did not bring to light that the required incorporation of the mandatory service bulletin in the pilot's operating handbook had not taken place. A previous canopy incident with this aircraft encountered by a member of the flying club did not lead to a raise in awareness due to unclear safety practices within the club and the lack of robust safety reporting. At that time the tasks and responsibilities, especially in the areas of maintenance, instruction and safety, within the flying club were not adequately assigned.

▲ Cockpit Aerospool Dynamic WT9.

To increase the safety of MLA flying, in particular with Dynamic WT9 aircraft, the Dutch Safety Board therefore makes the following recommendations:

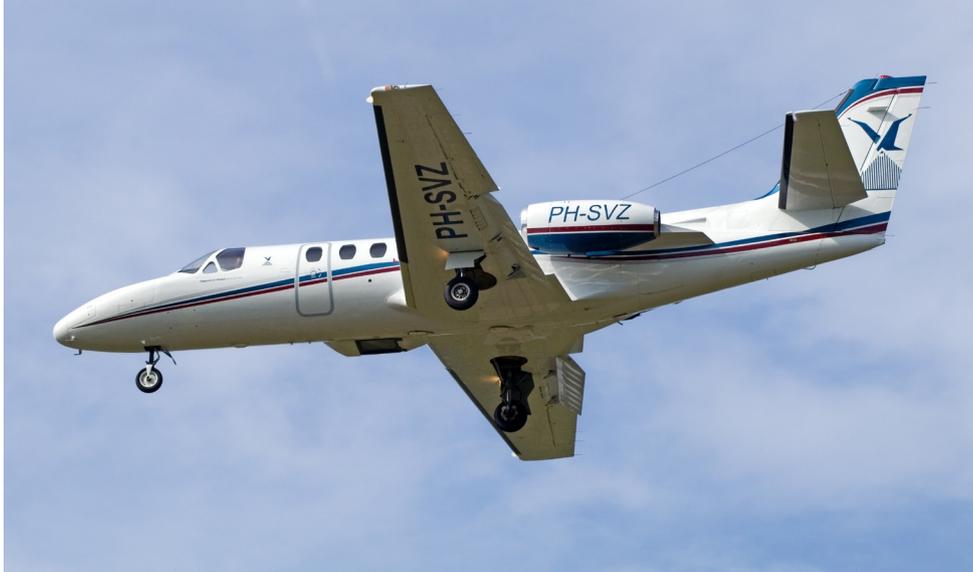
Following the event and engine failure, a visual inspection at EHGG of the left engine showed no evidence of FOD in the fan air inlet. When rotating the fan by hand, a slight abrasive sound was heard and, when hands off, the rotation slowed down quickly. The engine oil dipstick showed no oil level.

▲ Archive photo of PH-SVZ. (Source: C. Schmitt)

The Initial Findings Summary report revealed blade tips rubbing damage and the front inner bypass duct rear flange was fractured at numerous locations. Oil wetness and partially burnt oil contamination were found in the turbine section. Metallic particulate were found in the engine oil filter housing and remnants of bearing #3 in the accessory gearbox. The bearing #3 air seal was damaged and all roller elements and the cage of the #3 bearing were liberated from their respective positions and blocking the scavenge port. Both jets of the bearing oil nozzle were unobstructed and the oil pump was capable of manual rotation, but during the engine tear down it appeared that components were stuck together when trying to disassemble them.
