DUTCH  
SAFETY BOARD

# Quarterly Aviation Report

October - December 2019

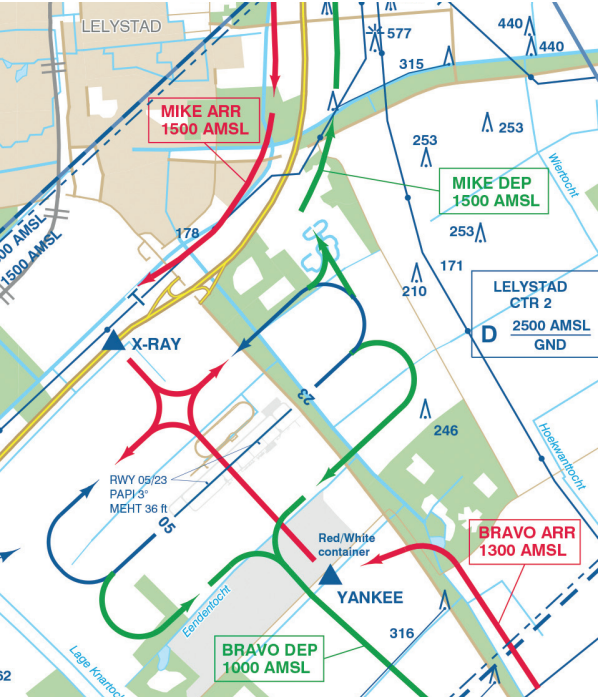
In November 2019, six occurrences<sup>3</sup> were reported to the Dutch Safety Board that occurred in the control zone (CTR) of Lelystad Airport. These involved situations in which aircraft approached each other.

Visual Approach Chart/VFR procedures. (Source: AIP Netherlands)
