**Collision and capsizing of tug Fairplay 22 on the
Nieuwe Waterweg near Hook of Holland**

**Collision and capsizing of tug Fairplay 22 on the
Nieuwe Waterweg near Hook of Holland**
11 November 2010

The Hague, March 2012 (project number M2010ZSV1111-01)

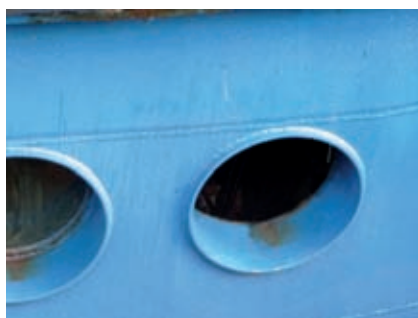
SMC A sidescuttle on Fairplay 22.
Safety Management Certificate

The trainee maritime officer was located in the shower area when the tug capsized. He managed to open a starboard sidescuttle, and escaped from Fairplay 22. He then swam to Fairplay III without further assistance. The captain, chief engineer and trainee captain found themselves trapped in the bridge of the capsized tug. They were able to breathe for a while thanks to an air bubble, but at a certain point there was no other option left but to abandon ship. The trainee captain managed to escape by opening one of the bridge doors and was subsequently rescued by the pilot vessel. The chief engineer and captain did not manage to escape from the tug.

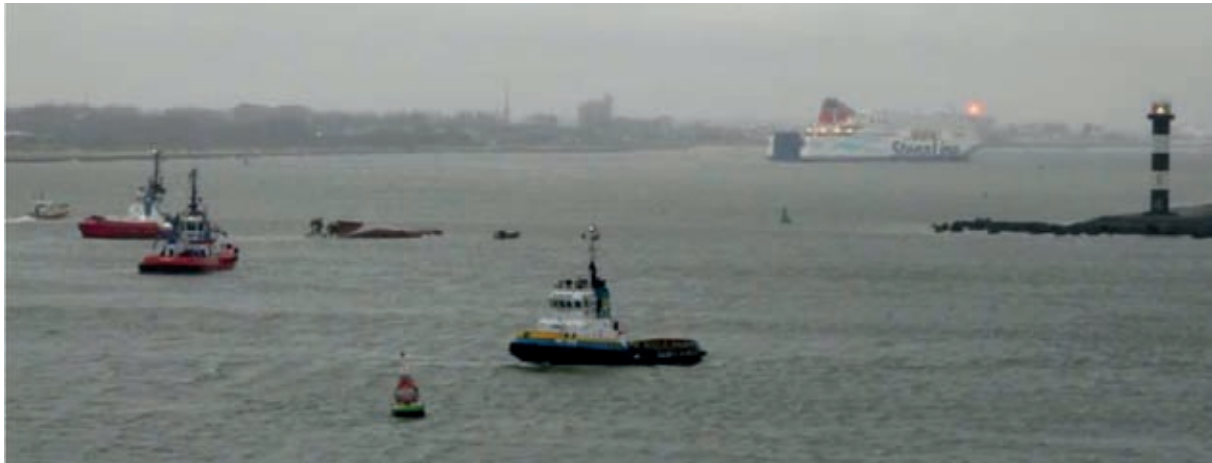
Figure 7: The accident site shortly after the occurrence, with the capsized Fairplay 22 on the left and Stena Britannica in the background [source: www.tugspotters.com].

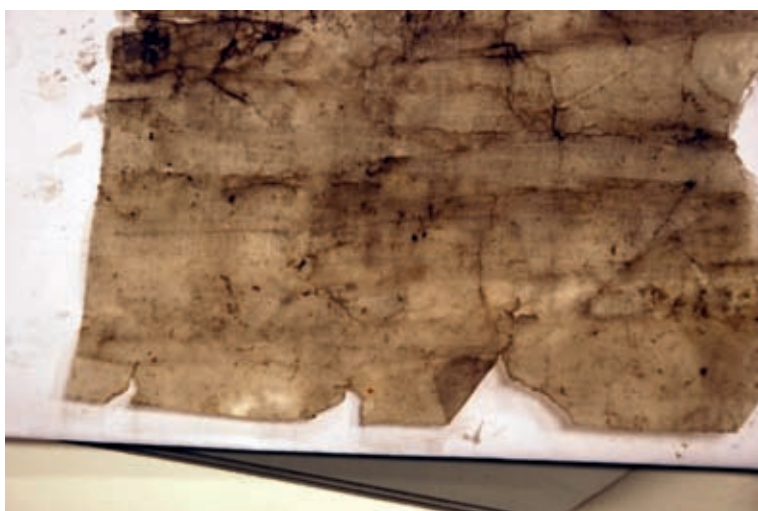
Engine room alarms were recorded on board Fairplay 22. A printout of the system registrations shows that various alarms were generated on the day of the accident. The printout found by investigators is shown in figure 12.

Figure 12: Printout of Fairplay 22 engine room alarm registrations.

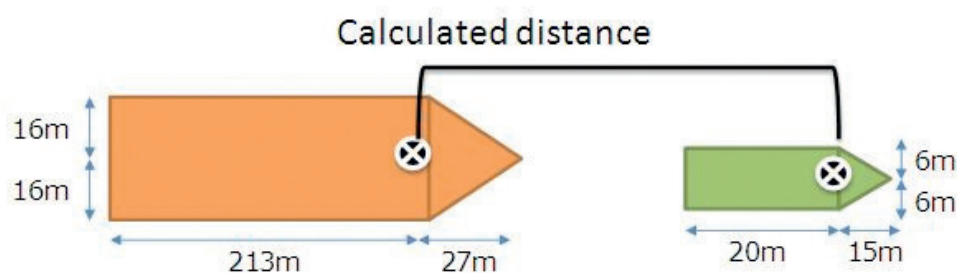
The distance between Fairplay 22 and Stena Britannica was calculated on the basis of the positions of the GPS aerials on both ships. The calculation method is shown in Figure 16. The calculated distance is absolute and is shown by the straight line between the two antennae. The angles at which the two ships were positioned relative to each other have not been taken into account. The actual distance could have been smaller as a result of the girth of the ships' hulls.

Figure 16: The distance between Fairplay 22 and Stena Britannica was calculated on the basis of the position of the GPS aerials on both ships.

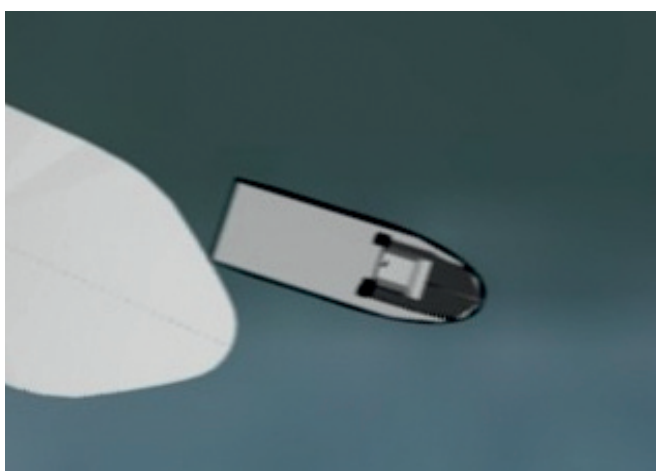
The first attempt to pass Stena Britannica's heaving line to Fairplay 22 began at around 15.47:20. Stena Britannica's ground speed was approximately 7.4 knots; its longitudinal water speed²⁹ was 8.4 knots and decreasing, its lateral water speed³⁰ was 0.7 knots to port side. Fairplay 22's ground speed was lower, approximately 7* knots, which meant that the distance between the two ships was decreasing. AIS data shows Fairplay 22 regularly changing course. This was interpreted as Fairplay 22 manoeuvring. Stena Britannica was making headway along a 114 degree course (see Appendix 5). The two ships were closest to each other at 15.47:36, at which time the distance between the two ships was 35* metres. Figure 17 shows the positions of both ships at that time.

Figure 17: Reconstruction of the position of Fairplay 22 and Stena Britannica during the first attempt.

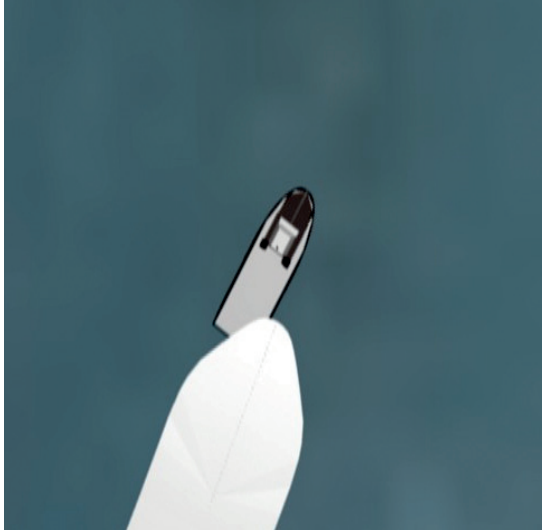
Figure 18: Reconstruction of the position of Fairplay 22 and Stena Britannica during the second attempt.

Due to current and wind Stena Britannica experienced a transverse movement to port. A lateral water speed of 1.2 knots was recorded on the VDR. Fairplay 22's speed increased to match Stena Britannica's speed. Fairplay 22 manoeuvred to Stena Britannica's port side. Figure 18 shows the positions of both ships during the second attempt.

At 15.49:08 the distance between the two ships was 35* metres. The distance was therefore the same as during the first attempt. Then, within two seconds, the distance decreased to 32* metres. The attempt to pass the heaving line to Fairplay 22 again failed.

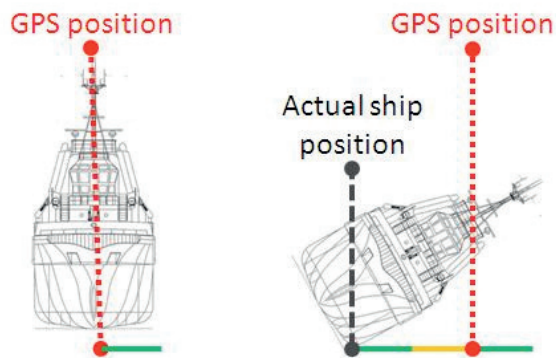
Figure 21: Difference between the GPS position and the actual position of the tug at the time Fairplay 22 was rolling.

The calculation of the distance during the last ten seconds (between 15.49:11 and 15.49:21), based on the available AIS information, shows that the distance between Stena Britannica and Fairplay 22 is increasing. This is inconsistent with the evidence from witness testimonies and the reconstruction, according to which the two ships remained in contact. The change in distance can be explained by Fairplay 22 rolling after the tug had contacted Stena Britannica's bulbous bow. The position of the GPS aerials changed because Fairplay 22 rolled. In reality the bulbous bow and Fairplay's hull remained in contact. This explanation corresponds to the rolling of Fairplay 22 as was seen by witnesses, the established pattern of the damage and the high ROT obtained from AIS data. Figure 21 shows the difference in GPS position and the actual position when Fairplay 22 rolled.

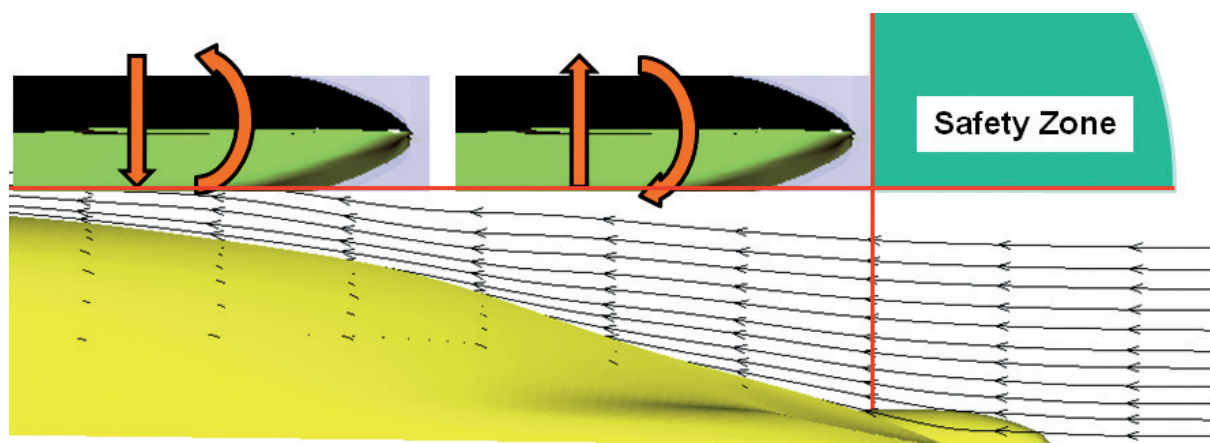
Figure 22: Safety zone, taking into account the streamlines surrounding the bow of Stena Britannica as well as the hydrodynamic force and the turning moment with a straight flow [source: MARIN].

The MARIN investigation revealed that the hydrodynamic interaction between two ships depends on the speed and the position of the two ships relative to each other. The hydrodynamic interaction consists of two components: a sideways force³³ and a turning moment³⁴. The extent and the direction of the sideways force and the turning moment change as Fairplay 22 moves closer to Stena Britannica's bow lengthwise. The hydrodynamic interaction also grows substantially when the ships sail at higher speeds and when there is a shorter distance between the two ships.

The investigation furthermore shows that the strength of the forces and turning moments are so great that, in a number of positions, they attract and turn Fairplay 22 such that the tug can no longer move away from Stena Britannica. At the speed at which the two ships were sailing at the time of the accident, Fairplay 22 could have manoeuvred safely if the ship had been located in the Safety zone, as Figure 22 illustrates. If the distance between Fairplay 22 and Stena Britannica decreases, the likelihood of the tug no longer being able to move away from Stena Britannica increases, thus resulting in a collision. For that reason tugs should preferably manoeuvre in the Safety zone. In practice it sometimes proves difficult to manoeuvre in the Safety zone because the distance between the tug and the seagoing vessel in that case becomes too large to be able to take hold of the heaving line. However, by reducing speed the Safety zone can be enlarged so that the heaving line can be passed within a short distance from a seagoing vessel.

The Safety zone should be taken into account when manoeuvring at Stena Britannica's bow. The hydrodynamic force and the turning moment in the area between the Safety zone and Stena Britannica increase to such an extent that the tug may no longer be able to move away to avoid a collision. Higher speed amplifies the hydrodynamic force and the turning moment. The drift angle of Stena Britannica also deteriorated the tug's situation.

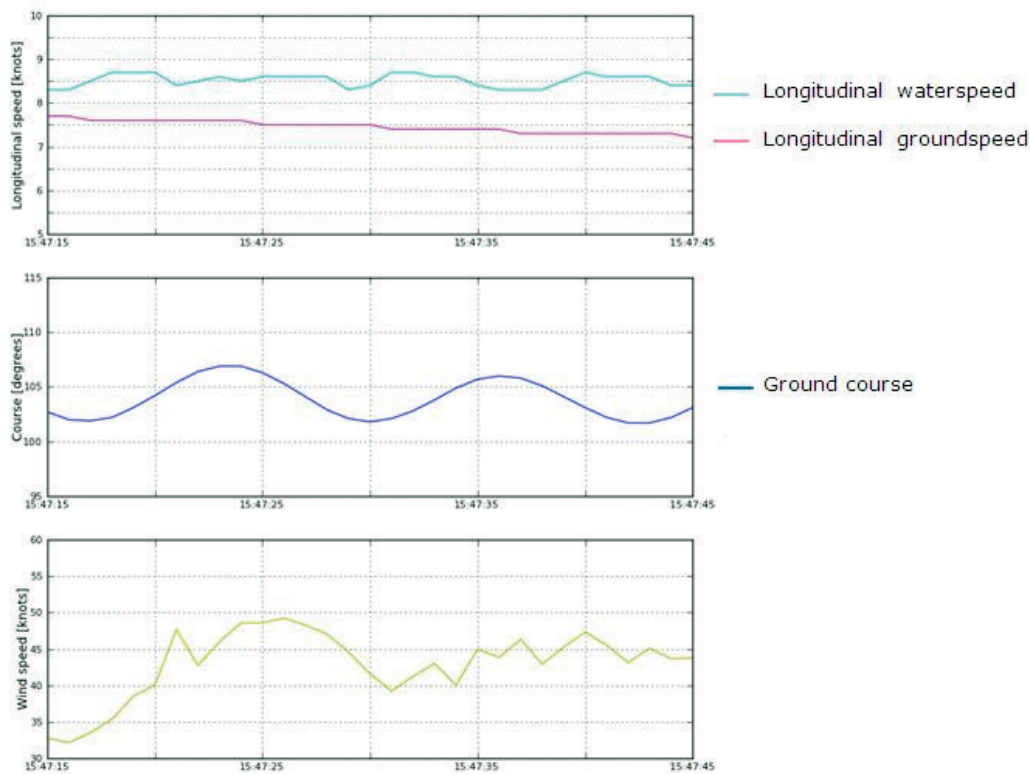
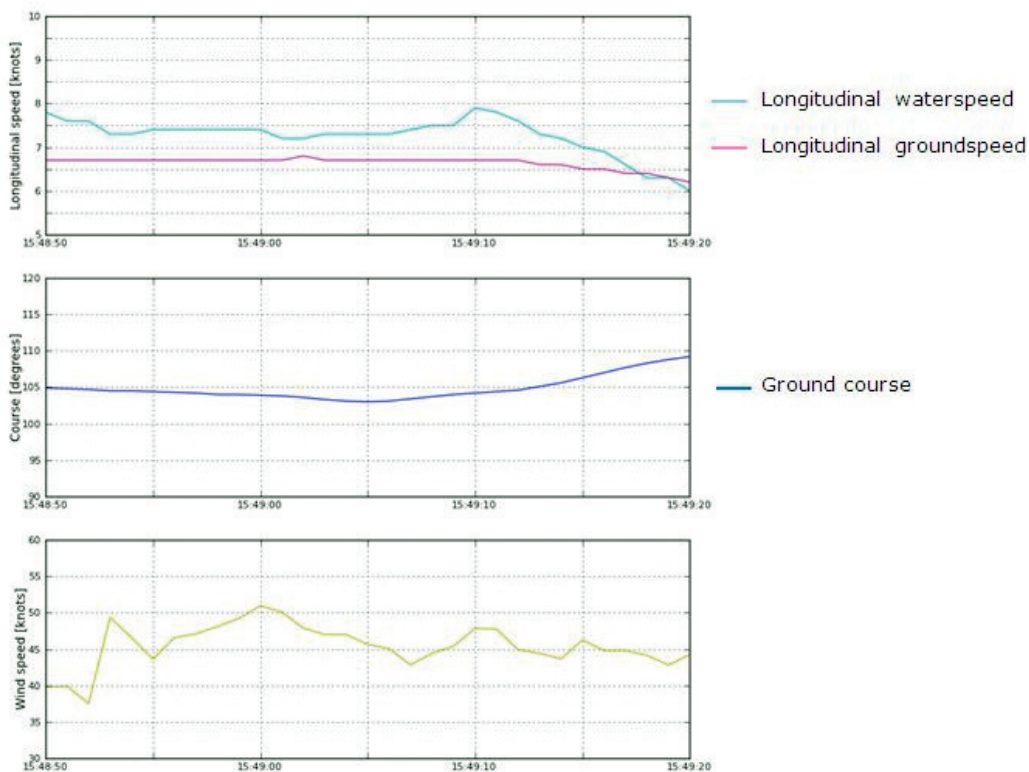
Figure 24 Overview of Stena Britannica's water speed, ground speed and ground course, and the wind force during the first and second attempts at passing the heaving line (the horizontal axis represents time and the vertical axis represents speeds and course).

Gusts of wind of up to 50 knots were measured during manoeuvring. Since gusts of wind have a short duration and occur suddenly, it is difficult to maintain a steady ground course when they occur. Figure 24 shows Stena Britannica's ground course together with the gusts of wind measured.

Figure 24 above shows that during the first attempt at 15.47:20 Stena Britannica's speed was not yet steady; the speed was still slowly reducing. The ground course fluctuated slightly, in part because of the effects of the wind and the lateral current.³⁶ During the second attempt between 15.49:00 and 15.49:07, Stena Britannica's speed was steady as was its ground course. Compared with the first attempt, however, the ship's lateral water speed was higher on average.

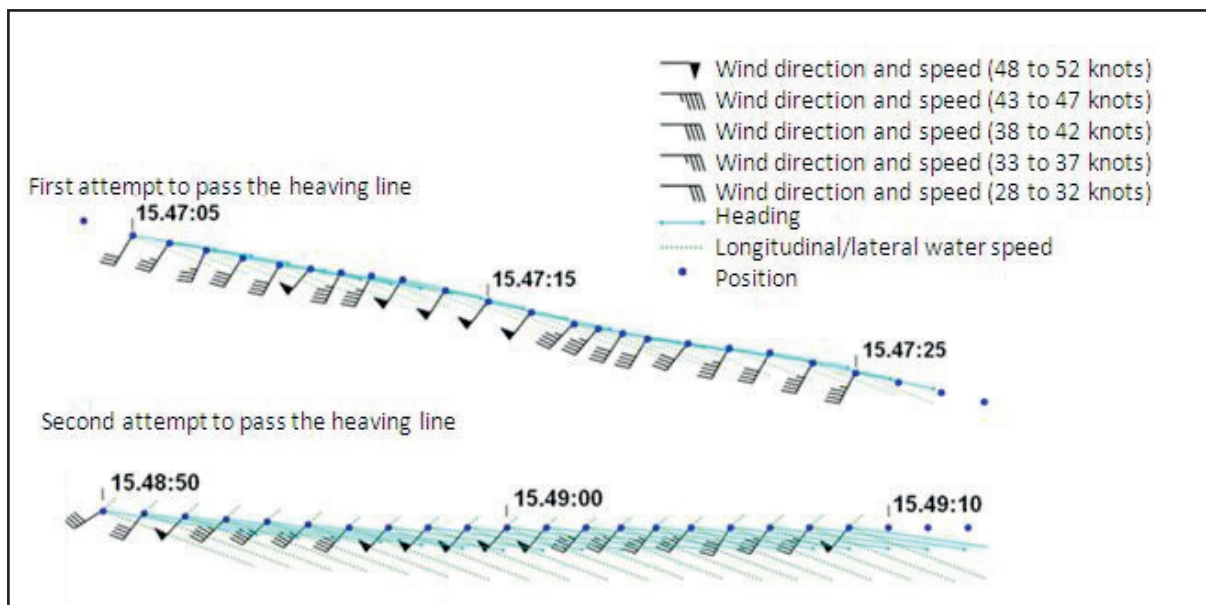
Figure 25: Overview of Stena Britannica's ground course and the speed and direction of the wind during the first and second attempts to pass the heaving line.

Figure 25 specifies the gusts of wind per second, and shows that the direction of the gusts of wind was fairly constant during both attempts. During the second attempt the force of the wind peaked on a number of occasions. It also shows that Stena Britannica's ground course only fluctuated slightly during the first attempt, despite the gusts of wind, and was steady during the second attempt.

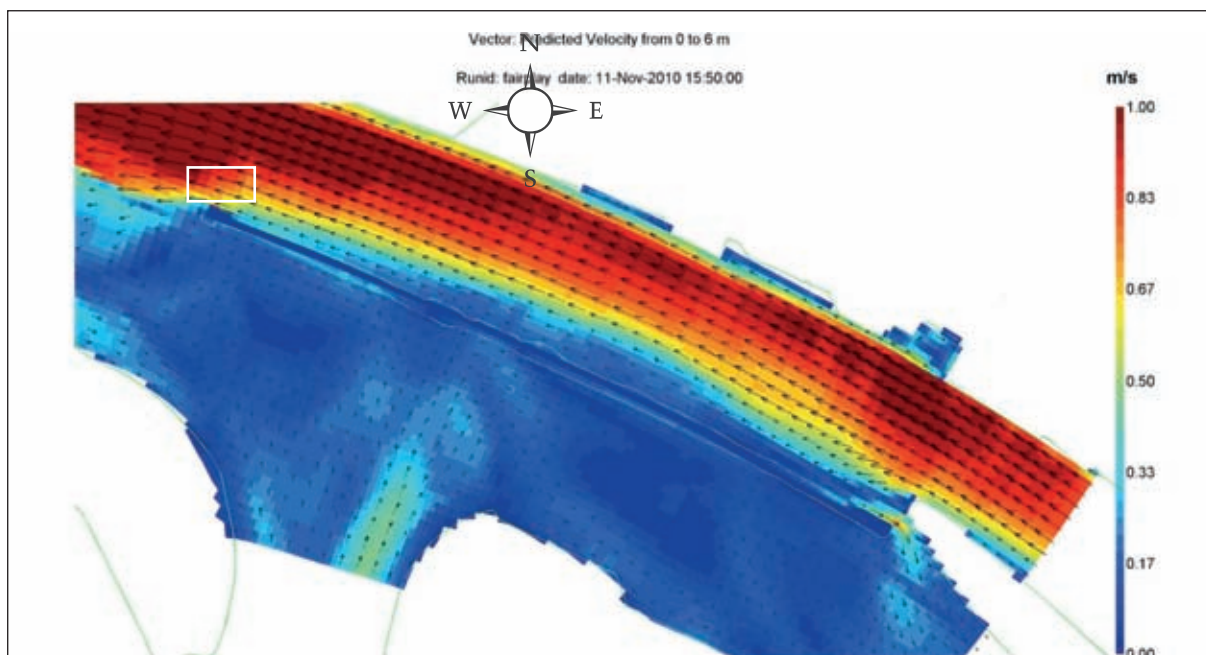
Figure 26: The current diagram at the accident location at the time the attempts to pass the heaving line (the white rectangle indicated the accident location) [source: Port of Rotterdam Authority (edited manually)]

The tide was rising with High Tide expected at 18.06. The wind prevailing for a prolonged period of time in part determines the behaviour of the current when the tide rises. For instance, a stormy, southerly wind will cause the water level to fall. A stormy westerly wind will cause the water level to rise or cause the water to fall slightly less. The behaviour of the current also depends on the depth of the water. The current and direction may differ at different water depths. Tidal calculations and the current diagram of the Port of Rotterdam Authority (calculated at a depth of 0 to 6 metres) and data recorded by Stena Britannica's VDR show that an ebb current was present on the Nieuwe Waterweg that may possibly have been caused by the stormy wind. The current diagram is illustrated in Figure 26.

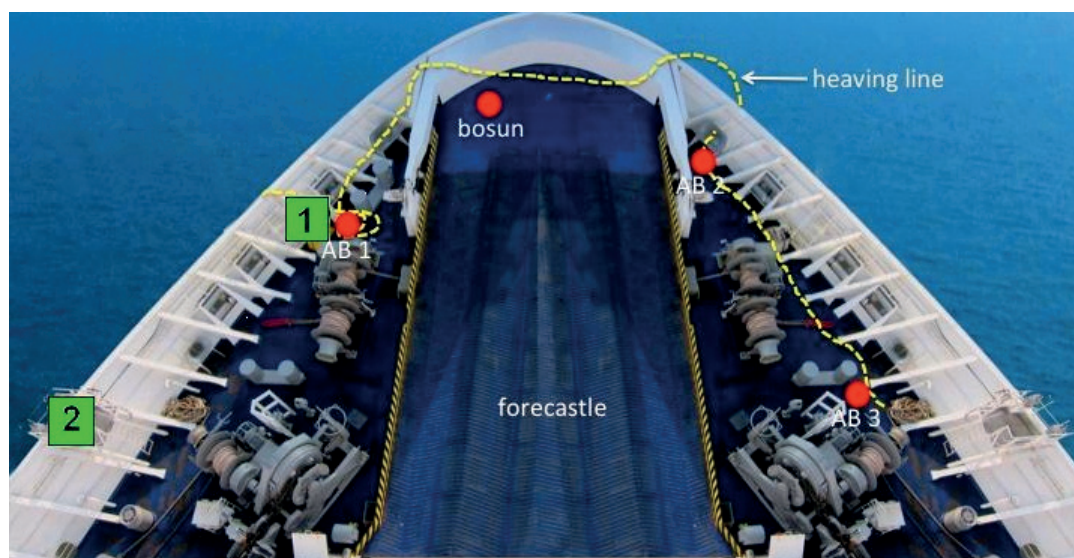
Figure 29: The two positions on the foredeck of Stena Britannica where the heaving line can be passed (the heaving line was passed from position 1 during the accident).

The heaving line on board Stena Britannica can only be passed from two positions on the portside of the foredeck. The two positions are shown in Figure 29.

The heaving line can be passed from the front section of the foredeck (position 1) and standing on a fixed ladder located a few metres behind it (position 2). In order to take in the heaving line, a tug must position itself next to Stena Britannica, a short distance away from the position where the heaving line is passed. Due to the fact that the heaving line can only be passed from Stena Britannica's foredeck, the tug needs to sail close to the bow.
