Report on the joint investigation of the collision
between the LNG Carrier
mts **AL ORAIQ** and the mv **FLINTERSTAR** off
the coast of Belgium on 6 October 2015 with the
total loss of the mv **FLINTERSTAR**

Federal Bureau for the Investigation of Maritime Accidents

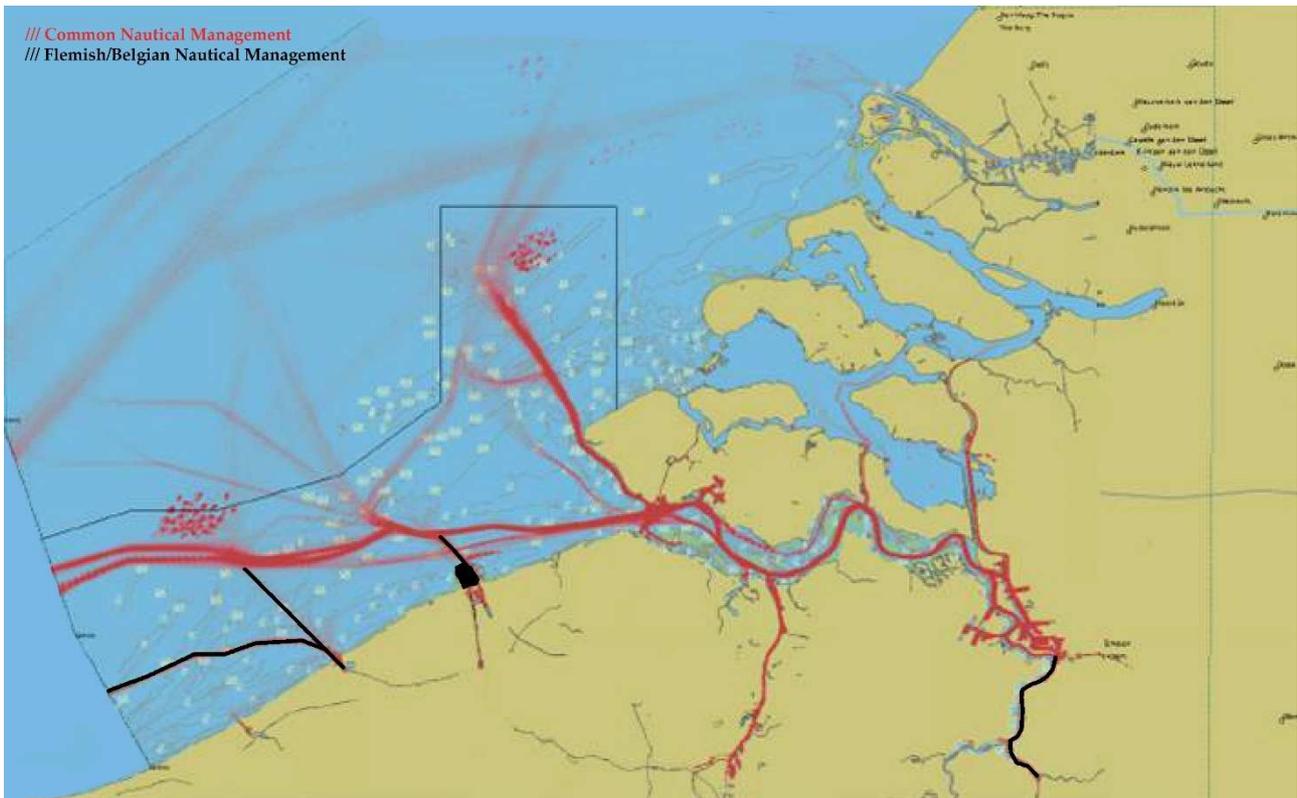
Figure 1 - Region where collision occurred and applicable legislation

The vessel proceeded under Pilotage via Wielingen and Scheur, two buoyed fairways, towards the Wandelaar Pilot Station, consisting of a SWATH vessel and auxiliary launches.

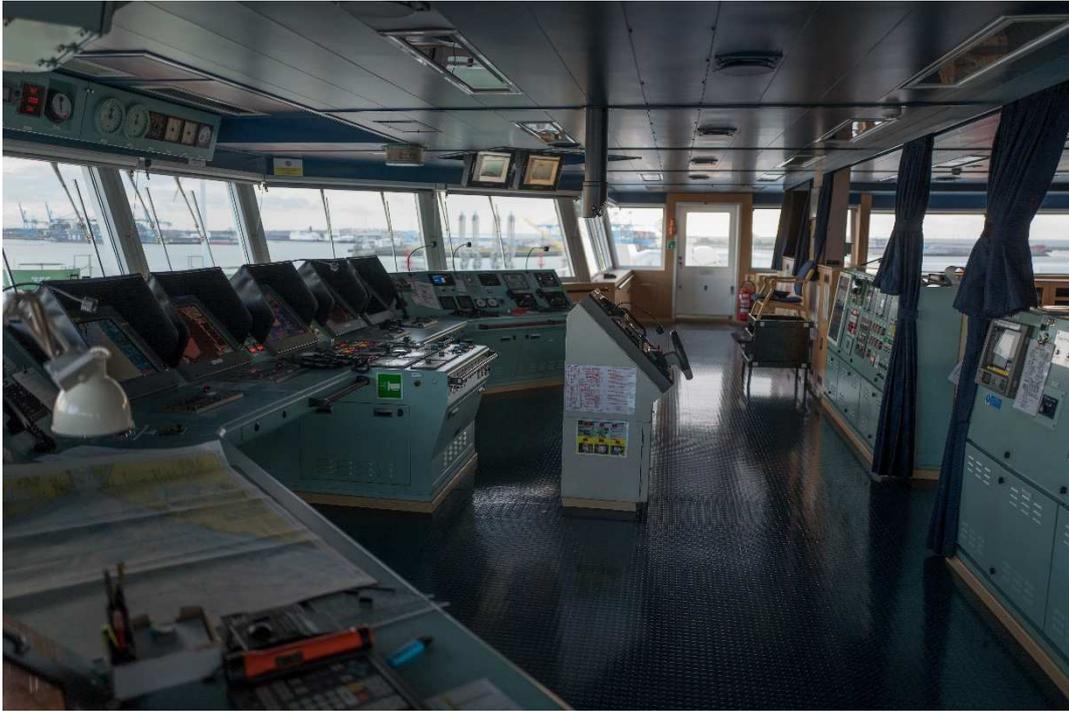
Figure 9 – Mts AL ORAIQ's wheelhouse

The mts AL ORAIQ's primary aids to navigation was ECDIS. Two independent units were fitted. The ship was fitted with an X band radar, an S band radar and ARPA. The displays are located on a console in the forward part of the wheelhouse. There were two VHF radios, both of which are located on the navigation console.

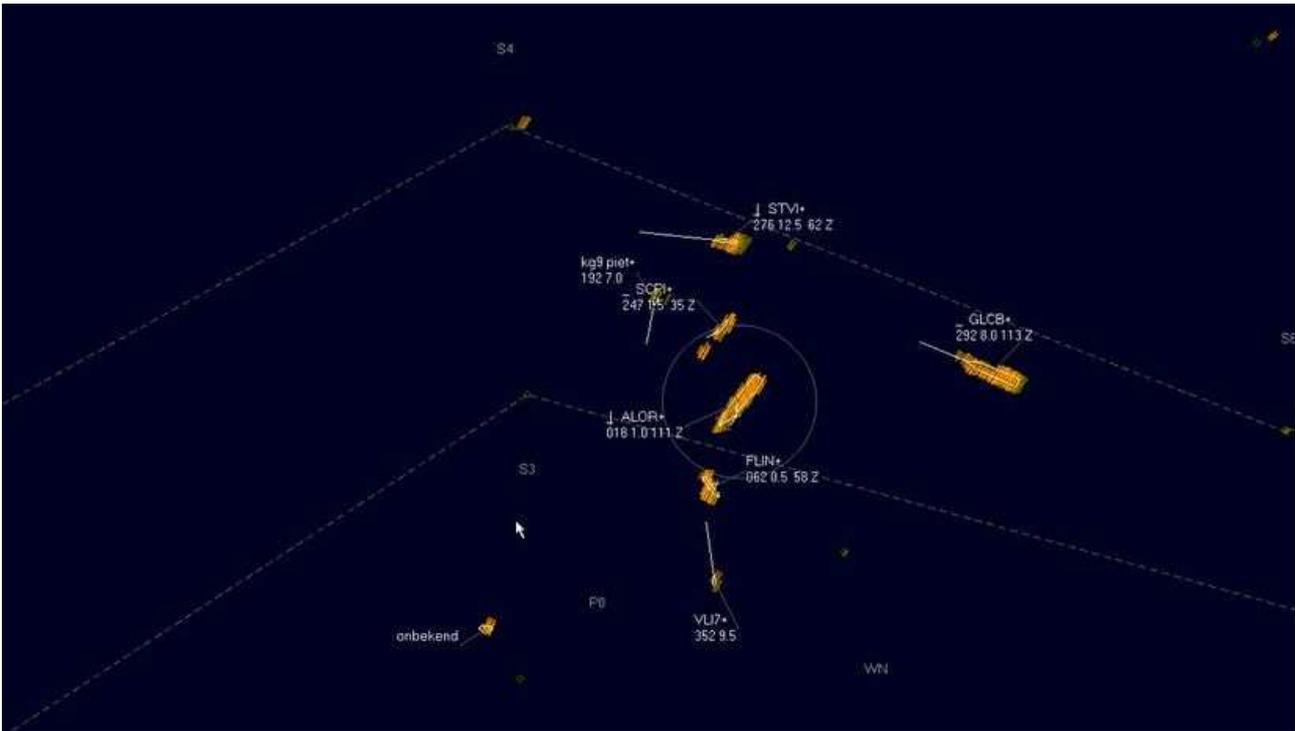
Figure 6 - mv SCOTT PIONEER & fv VLISSINGEN 7 on scene near mv FLINTERSTAR and mts AL ORAIQ
as seen on the VTS radar

Immediately thereafter the Backup Coastal Pilot on board the mts AL ORAIQ inquired with Traffic Centre Zeebrugge via radiotelephone Channel 69 whether a fishing vessel in the vicinity of the collision could be identified and summoned for immediate assistance. The Coastal Pilot informed Traffic Centre Zeebrugge that the rescue boat from the mts AL ORAIQ had been launched and that several people were now in the water. Traffic Centre Zeebrugge replied that the fishing vessel could be identified as fv VLISSINGEN 7 and that the vessel had been instructed in the meantime.

The Backup Coastal Pilot on board the mts AL ORAIQ informed approaching fishing vessels, that were coming to lend assistance, that the wreck of the mv FLINTERSTAR was not fully submerged, but unlit.

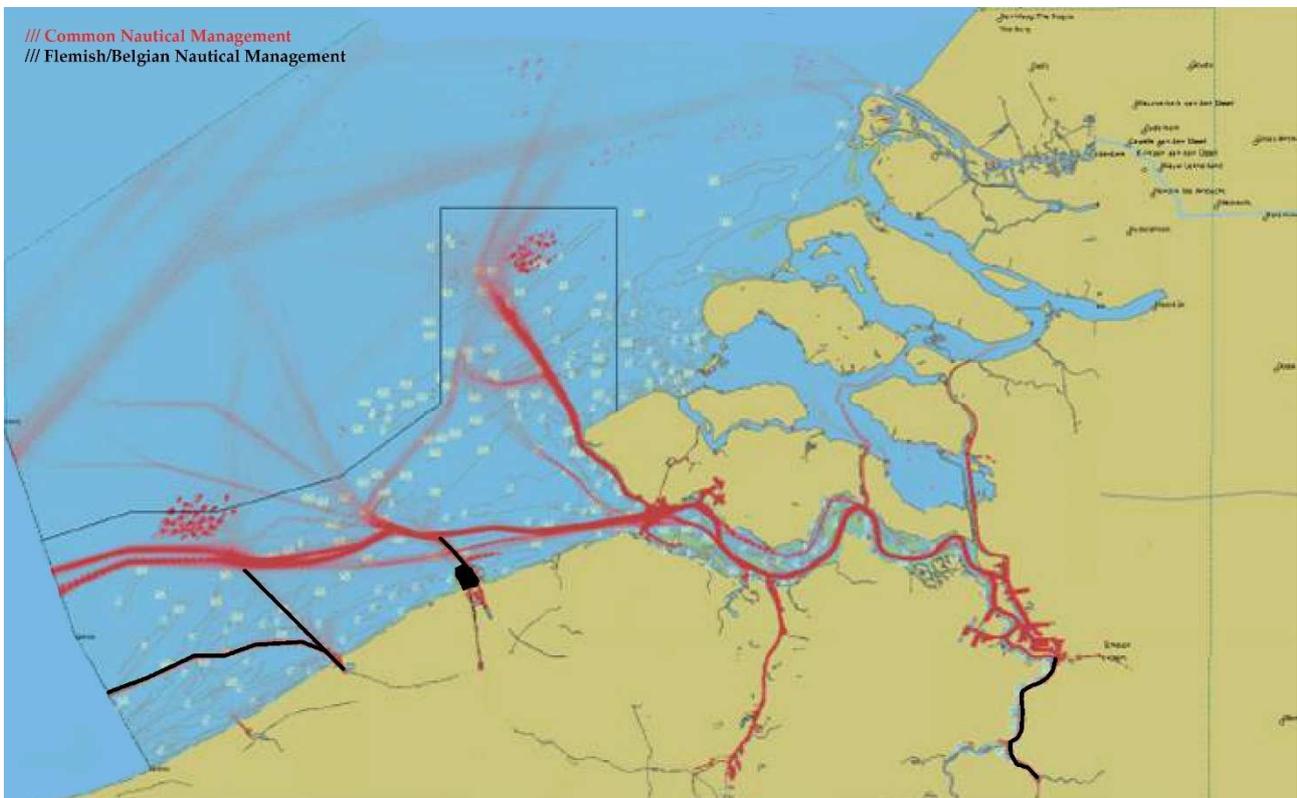
Figure 10 - Areas in black not governed by the Common Nautical Management

The common nautical management of the Scheldt Region has as purpose primarily to ensure a safe navigation in the fairways from and to ports in the Scheldt Region, including the approaches, in direct contact with the aforementioned waterways, with the exception of fairways to the Ports of Nieuwpoort, Oostende and Zeebrugge branching from the main fairways in the Scheldt Region. These branching fairways are not governed by the Common Nautical Management but are governed by the local government which governance over said branching fairways shall be in line with the Common Nautical Management. On following Figure 10 the area off the Belgian Coast, as part of the approaches to the river

Scheldt, were the Common Nautical Management is not in place at the time is delimited in yellow.

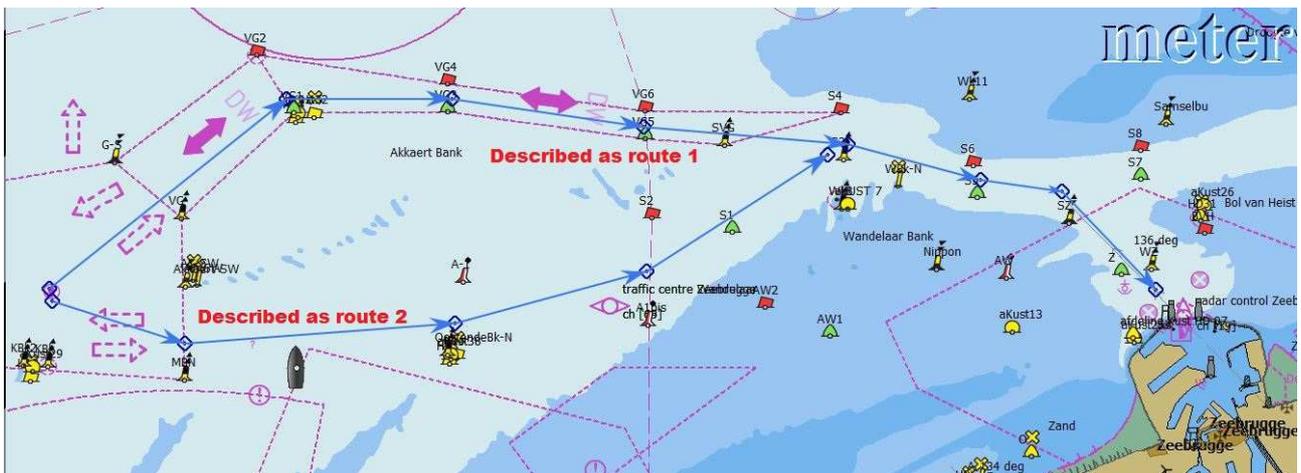
Figure 12 - Mandatory (route 1) and alternative (route 2) inbound routes for LNG Carriers

The LNG shipping procedures, published with the Notices to Mariners n°1 of 2015, clearly state that Inbound LNG carriers shall follow the route: precautionary area Wandelaar - Vaargeul 1 - S3/S4 - Ribzand - Pas van het Zand described as route 1 on Figure 12. Depending on traffic agreements made earlier and on fairway obstructions, LNG carriers

can deviate from this and follow the route Akkaert-SW - A1 - Scheur West - Ribzand and Pas van het Zand describes a route 2 on Figure 12.

At the time of the collision between the mts AL ORAIQ and the mv FLINTERSTAR on 6 October 2015, the mts AL ORAIQ was sailing inbound following the alternative route, described as route 2 on Figure 12.
