FIRE AT THE DETENTION CENTRE SCHIPHOL OOST

26th October 2005

The Hague, 21st September 2005, project number M2005CH1026-1

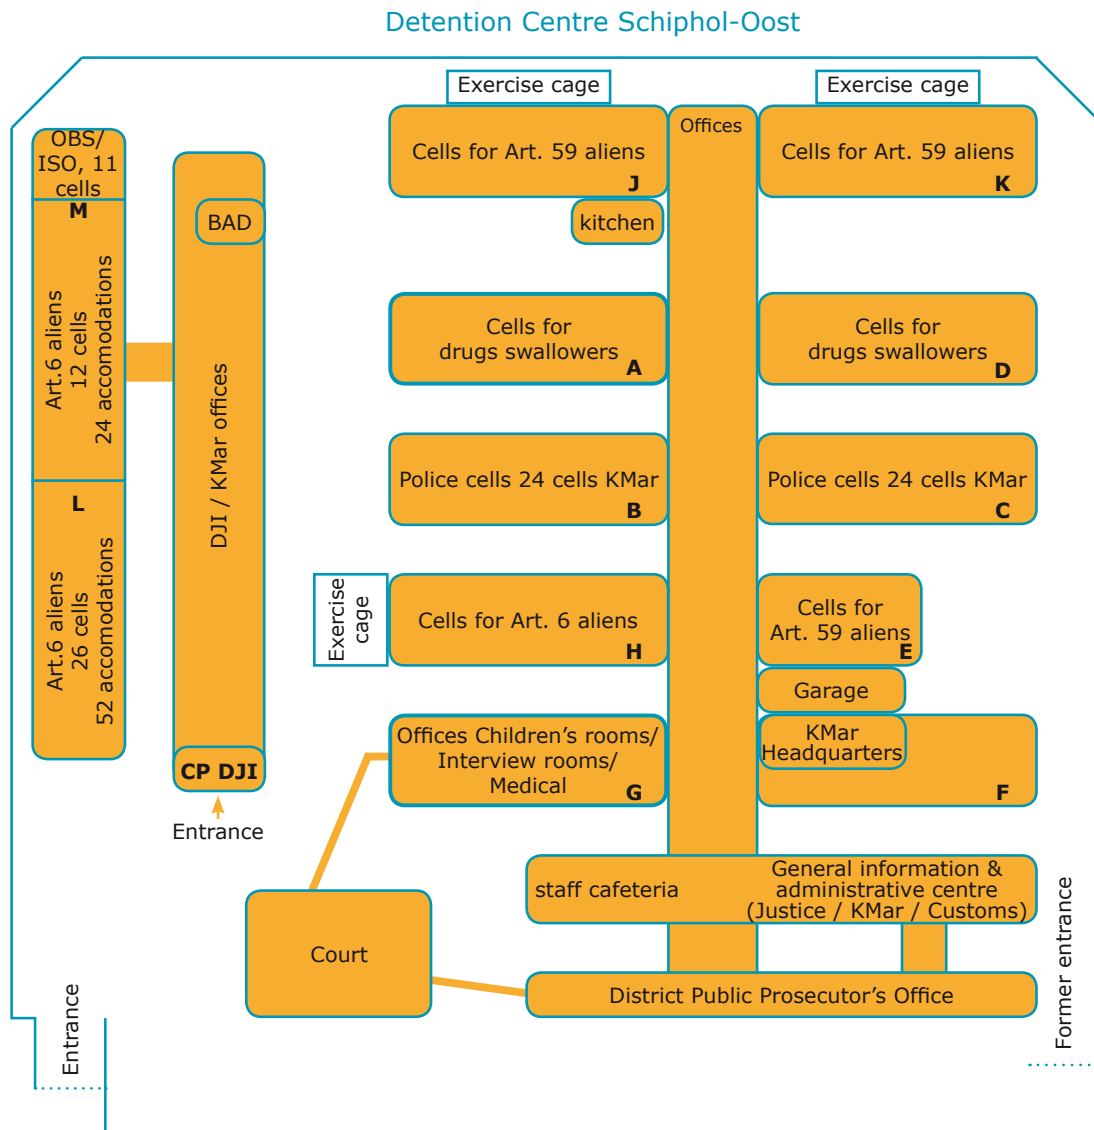
Figure 1: Diagrammatic overview of the Detention Centre Schiphol-Oost.

The Detention Centre Schiphol-Oost consists of several wings (see Figure 1). B Wing consists of Royal Military Constabulary (KMar) police cells. People accommodated in this wing are in particular those who have been arrested at Schiphol and who are suspected of having committed a criminal offence. A and D Wing contain the "drugs swallows" who may still be carrying packages of narcotics inside of their bodies. The regime in respect of these people aims to ensure that packages containing narcotics are eliminated from the body as quickly and safely as possible. Both A and D Wing come under the responsibility of the DJI, but collecting and securing the narcotics is the responsibility of the KMar.

After their cell doors were opened, the cell occupants were sent to the adjacent J Wing (see Figure 1), where a number of the cell occupants from K Wing attempted, in panic, to open the emergency exit door at the far end of J Wing and by that means escape from the fire. However, this door was locked. Anxiety and panic also ensued among the cell occupants of J Wing, who were still locked inside their cells, and they banged on their cell doors.

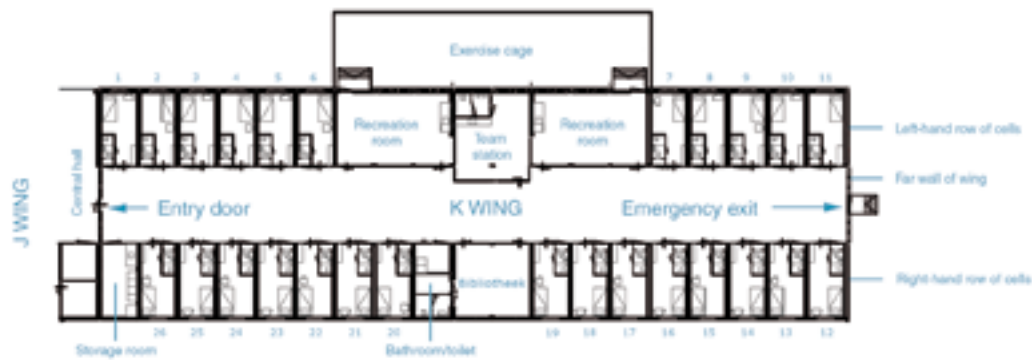
Figure 2: Diagrammatic aerial view of K Wing with its corridor and the cells on either side

Figure 2 shows an aerial view of K Wing where a fire broke out in Cell 11 on the night of 26 October and early morning of 27 October 2005. The wing consists of a corridor (approximately fifty metres in length) that can be accessed by means of a door from the hall located between J and K Wing. Cells are located on either side of this corridor intended for a maximum of two persons each.

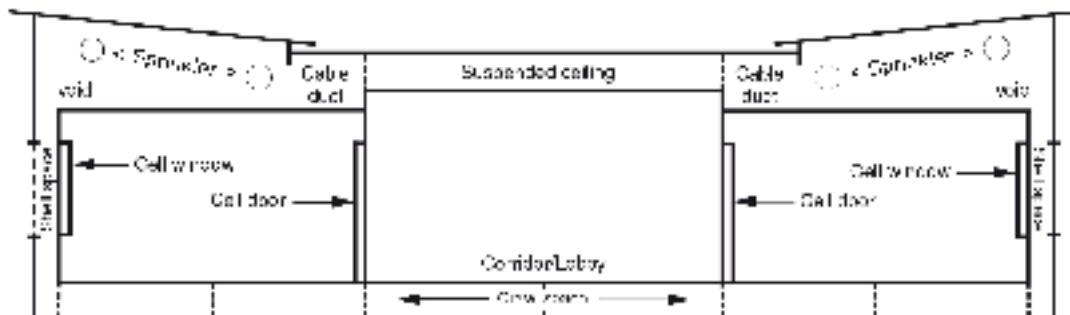
Figure 3: Diagrammatic cross section of a cell container showing shell construction

Figure 3 shows a cross section of K Wing's basic construction. The cells themselves are containers (originally sea containers) that have been converted into cells including a cell door, a window and sanitation facilities. These cell containers form the basis of the building. 26 of these containers are used as cells in K Wing. A shell construction is built around the cell containers.

A number of systems and facilities are present in K Wing. A dry sprinkler duct is installed in the space above the cells (see Figure 3). This system does not work automatically; however, in the event of a fire, the Fire Brigade can link these ducts to a water source. The sprinkler system's sprinkler ducts are fitted with sprinkler heads in which an ampoule is mounted. This ampoule will rupture at a temperature of 80 degrees Celsius and set the sprinkler into action as long as the duct has been connected to a water source.

The fire was raging in three tracks along the length of K Wing: notably, through the ceiling space above the cells on the left-hand side, through the ceiling space above the cells on the right-hand side and in K Wing's corridor. Most of the combustion heat generated from the fire was concentrated in the upper ceiling space above the two rows of cells (see Figure 3).

The suspended ceiling above the burning part of the corridor fell apart, allowing the fire free access to the section of the space between ceiling and shell located above the cells.

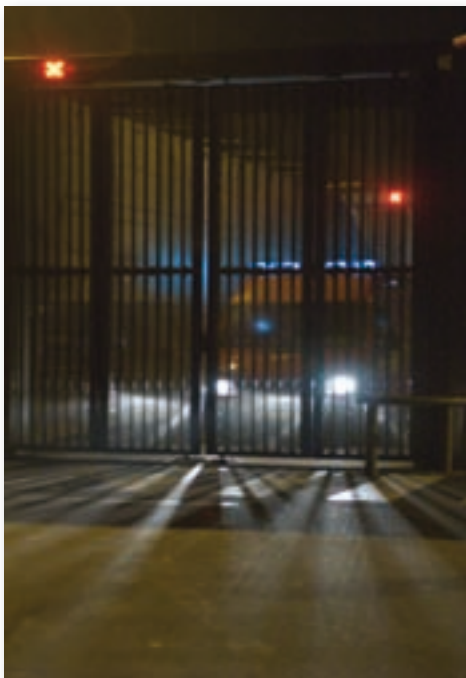
Figure 9: Vehicle behind lock gate at the main entrance to the detention centre.

An employee rushing up to them from the detention centre redirected the Fire Brigade to go back outside to the correct (main) entrance. In the meantime, several KMar vehicles had arrived at the former entrance in addition to the fire engines. These vehicles stood behind the fire engines and, consequently, blocked their free passage backwards. Once these were able to reverse, they proceeded to the main entrance. This entrance also consisted of two entrance gates (fences) with locks. The second gate can be opened only once the first gate has been closed behind an incoming vehicle.

Over four minutes after they had arrived at the former entrance, the vehicles from Post Sloten drove into the gate lock to the main entrance (at 00.13 hours). An ambulance arriving at the same time joined the queue and jammed activation of the lock gate. Consequently, the first gate could not be closed, which meant that the second gate could not be opened. An employee from the KMar sweep team⁴⁷ then rushed up to assist with admitting the vehicles. At that time, the employee was using an intercom system to communicate with the DJI switchboard from which the lock was operated by remote control. By this means, all of the vehicles waiting in the queue were let in two by two. At 00.15 hours, the first two fire engines drove on to the grounds. Once inside, the crew of these first attending vehicles asked the KMar employee to open both gates for the vehicles following. The KMar employee indicated that this was not possible⁴⁸.

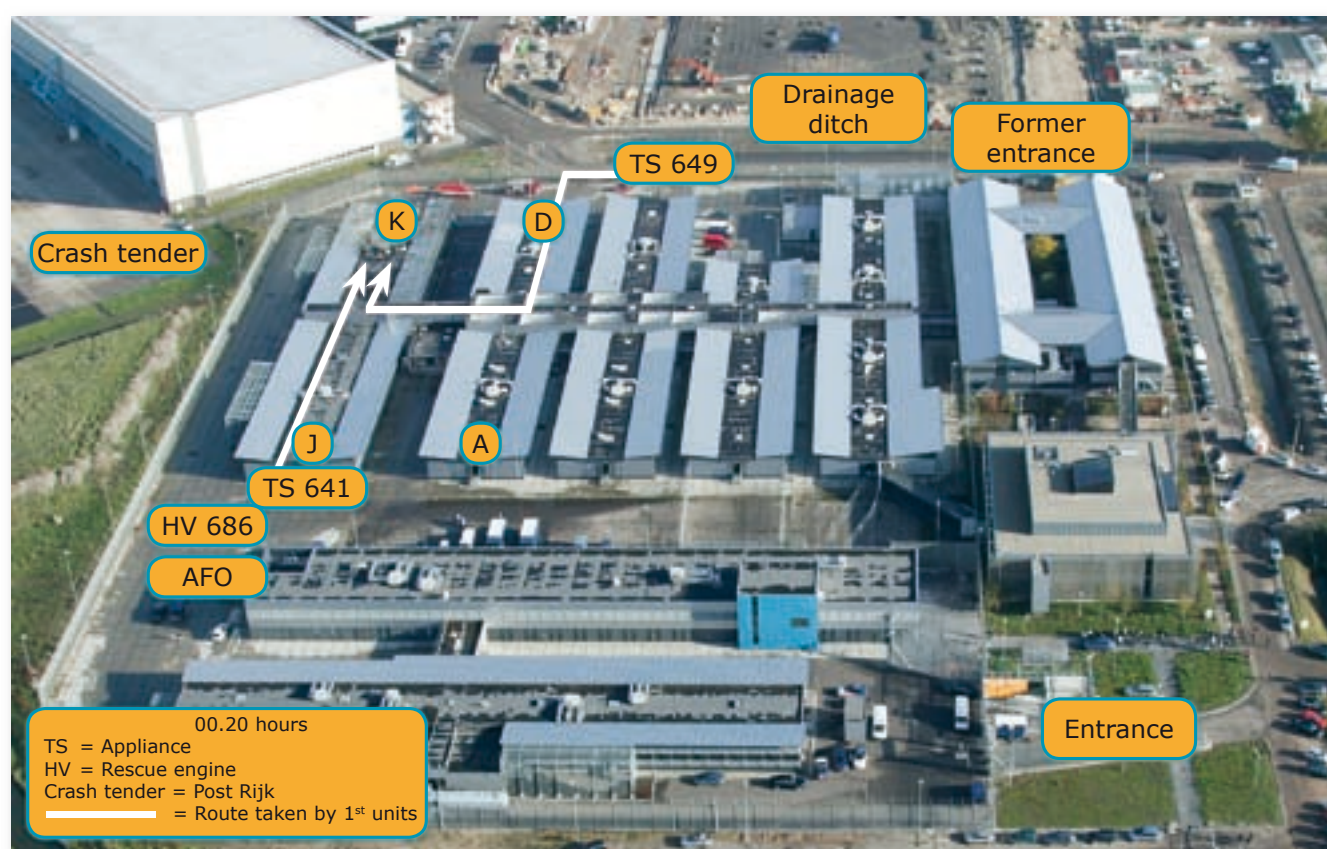
Figure 10: Positioning of the fire brigade at around 00.20 hours and the route taken by the units from Post Sloten and Post Rijsenhout

In the meantime, the crash tenders' Crew Commander had decided on his own initiative to operate from a different location and thus take up a better position in relation to the fire. One of the crash tenders was deployed from adjacent grounds at Schiphol Airport (see Figure 10). The other two crash tenders drove to and fro a hangar elsewhere on the grounds of the airport to fetch water. This driving back and forth took approximately five to ten minutes per journey. The crash tenders' Crew Commander was unfamiliar with the detention centre site. In consultation with the AFO, the crash tender crew removed a section of the airfield fencing and made a hole in the detention centre fencing to gain access to the site. This was laborious and took a great deal of time, because the crash tenders did not have the correct equipment available. Once a passage through had been achieved, low-pressure conduits (known as "hand lines") were put in place leading from the crash tender. Dividing equipment and two hoses were connected to this. It was attempted to supply K Wing's sprinkler system using one of the hoses. With the other hose, the fire was fought through holes that had appeared in the K Wing wall.

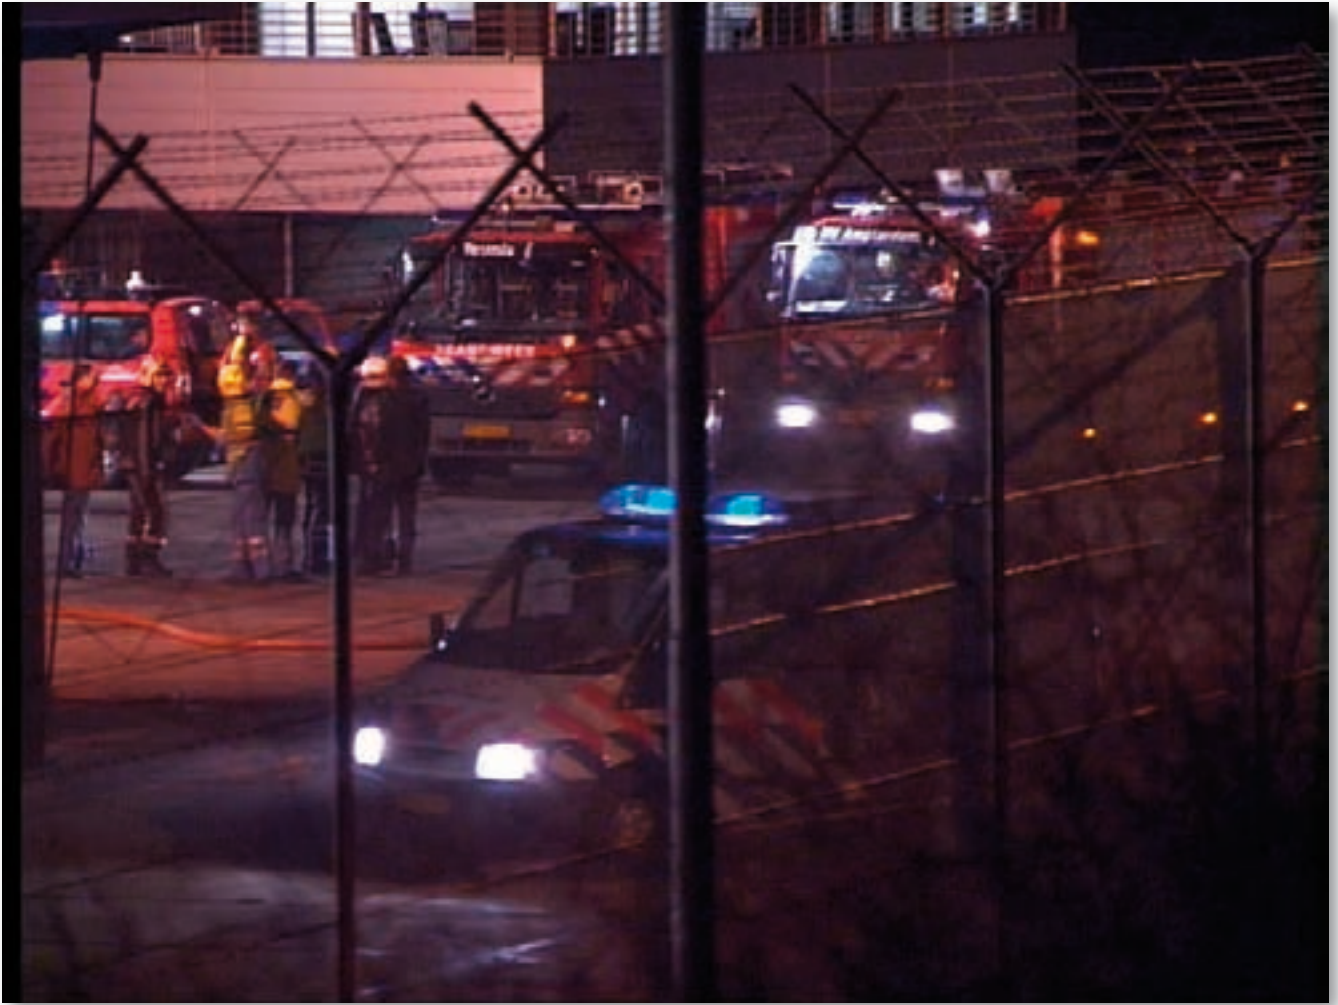
Figure 15: Discussions at the far end of J Wing

In other words, the Fire Brigade unit from Post Sloten wished to enter the centre through the emergency exit at the far end of J Wing. However, this door was locked. Both the members of staff located at the J Wing emergency exit and an employee who stood outside indicated that they could not open the door. At approximately 00.18 hours, it was announced that the door would be broken open. The Fire Brigade cut open the latticework and broke through a door window. Subsequently, the Post Sloten attack team entered J Wing through the forced emergency exit (at around 00.20 hours⁴⁹). Simultaneously, a guard handed over a key with which the now forced emergency exit door was opened. The Crew Commander in Charge then entered J Wing. Once inside, he indicated that J Wing had to be evacuated due to the smoke and heat. The AFO remained outside. Inside, Fire Brigade personnel consulted with the guards in attendance about victims who might still be located in K Wing. They did not obtain any useful information about possible victims and their locations. Using one set of keys, that the team had obtained, the attack team walked on to K Wing.

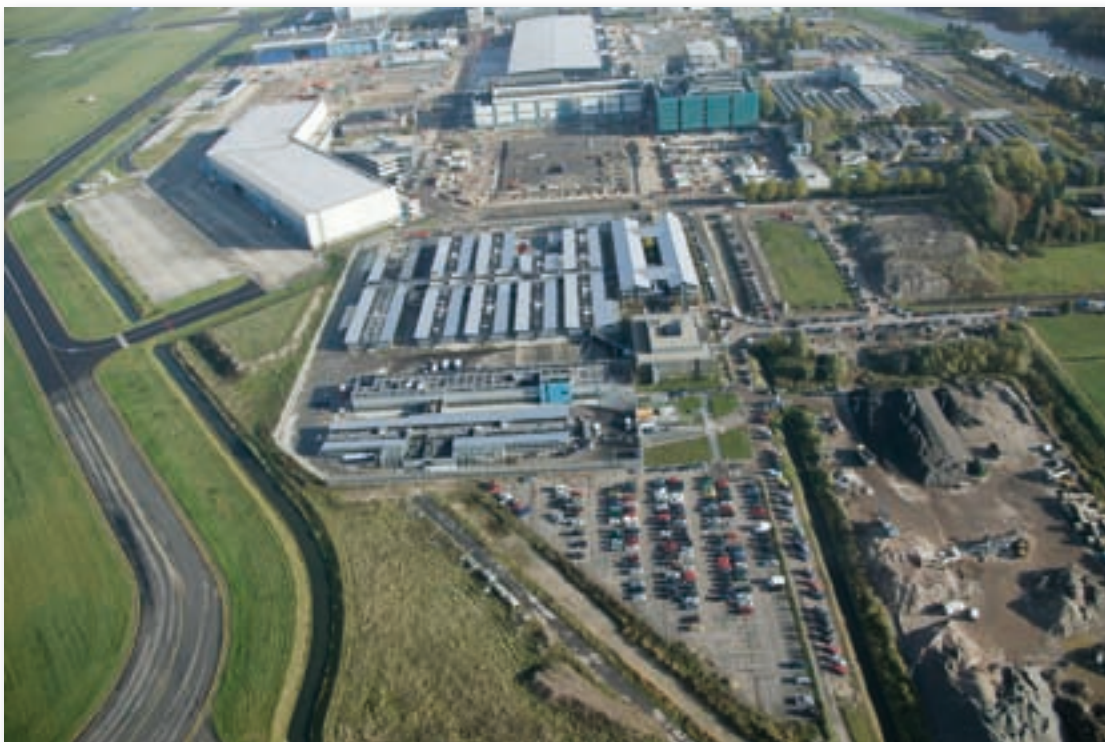
Figure 24: Aerial photograph of detention centre and immediate surroundings

Underlying cause: the hazardous status of the detention centre played no part in the determination of arrival times

Like any other organization, the fire brigade must deploy manpower and resources as efficiently as possible. This means that the greatest possible area must be served by the lowest possible number of fire stations and fire appliances. This always involves a consideration of the costs of additional fire stations and vehicles and the benefits in the form of serving as many premises as possible as quickly as possible. Those involved work on the basis of the type of premises which occur most frequently. In general these will be domestic premises, for which an arrival time of eight minutes applies²²⁴. The selected standard for arrival time for the area where the detention centre was located was therefore eight minutes.

However it was recognized that the standard of eight minutes for the area where the detention centre was situated was not feasible given the available resources²²⁵. A municipal memo included the observation that the presence of a single appliance at Post Sloten was inadequate in view of the required capacity in the case of occurrences as well as the excessively long arrival times for the non-domestic sites at Schiphol-Rijk, Schiphol-Oost and Oude Meer (where the detention centre was located). As of 1 March 2006 an amendment was therefore introduced to the requirements on the fire brigade and an additional vehicle was stationed at the Schiphol-Rijk fire
