FINAL REPORT

98-85/S-14

N 193 DN, Boeing 767

Final report of the investigation into the probable cause of the serious incident with Delta Airlines Boeing 767, N193DN, on 10 December 1998 at Amsterdam Airport Schiphol.

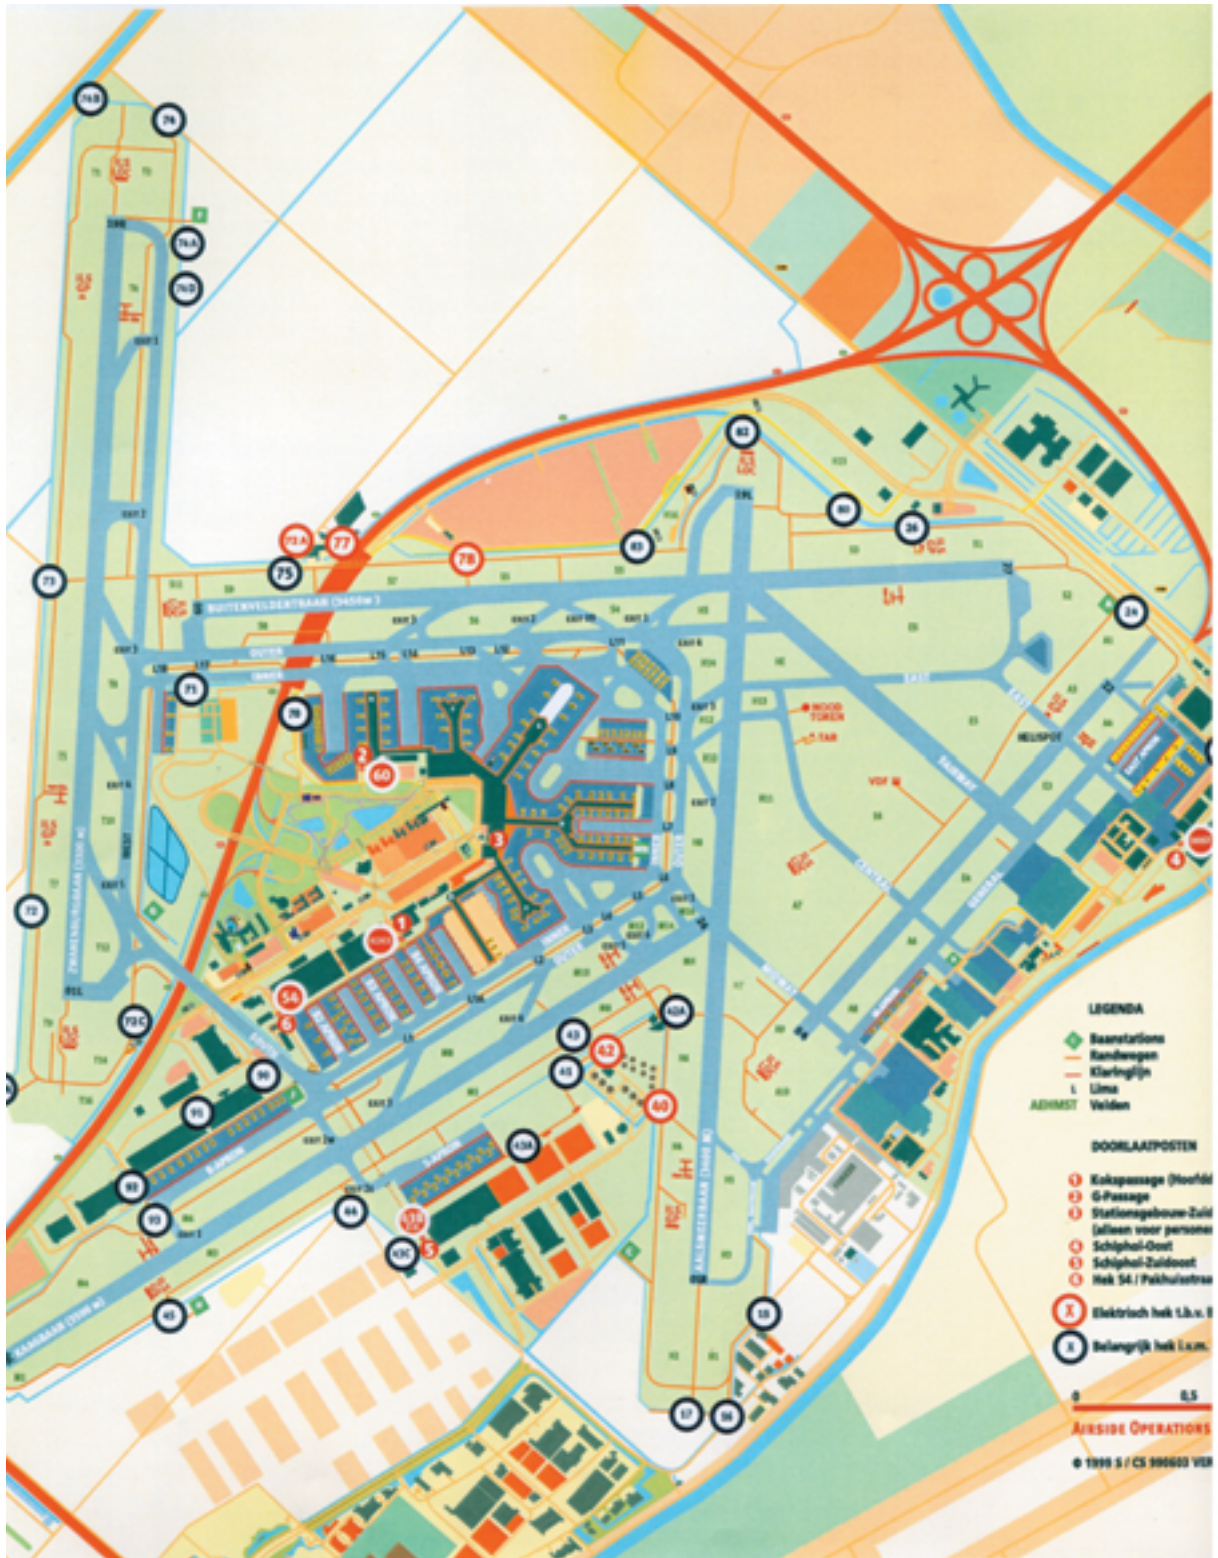
Aerodrome Lay-out

In 1990 the Airport Authorities decided to construct a new platform at the southern side of runway 06/24, designated S-apron. The intention was to create a freight platform for loading and unloading of cargo aircraft. The taxiways to/from the S-apron were supposed to be used by out- or in-taxiing aircraft only. Consequently the only technical facilities installed to protect runway operations during low visibility weather conditions were two remote controlled stopbars at exit 2 West and exit 2 East.

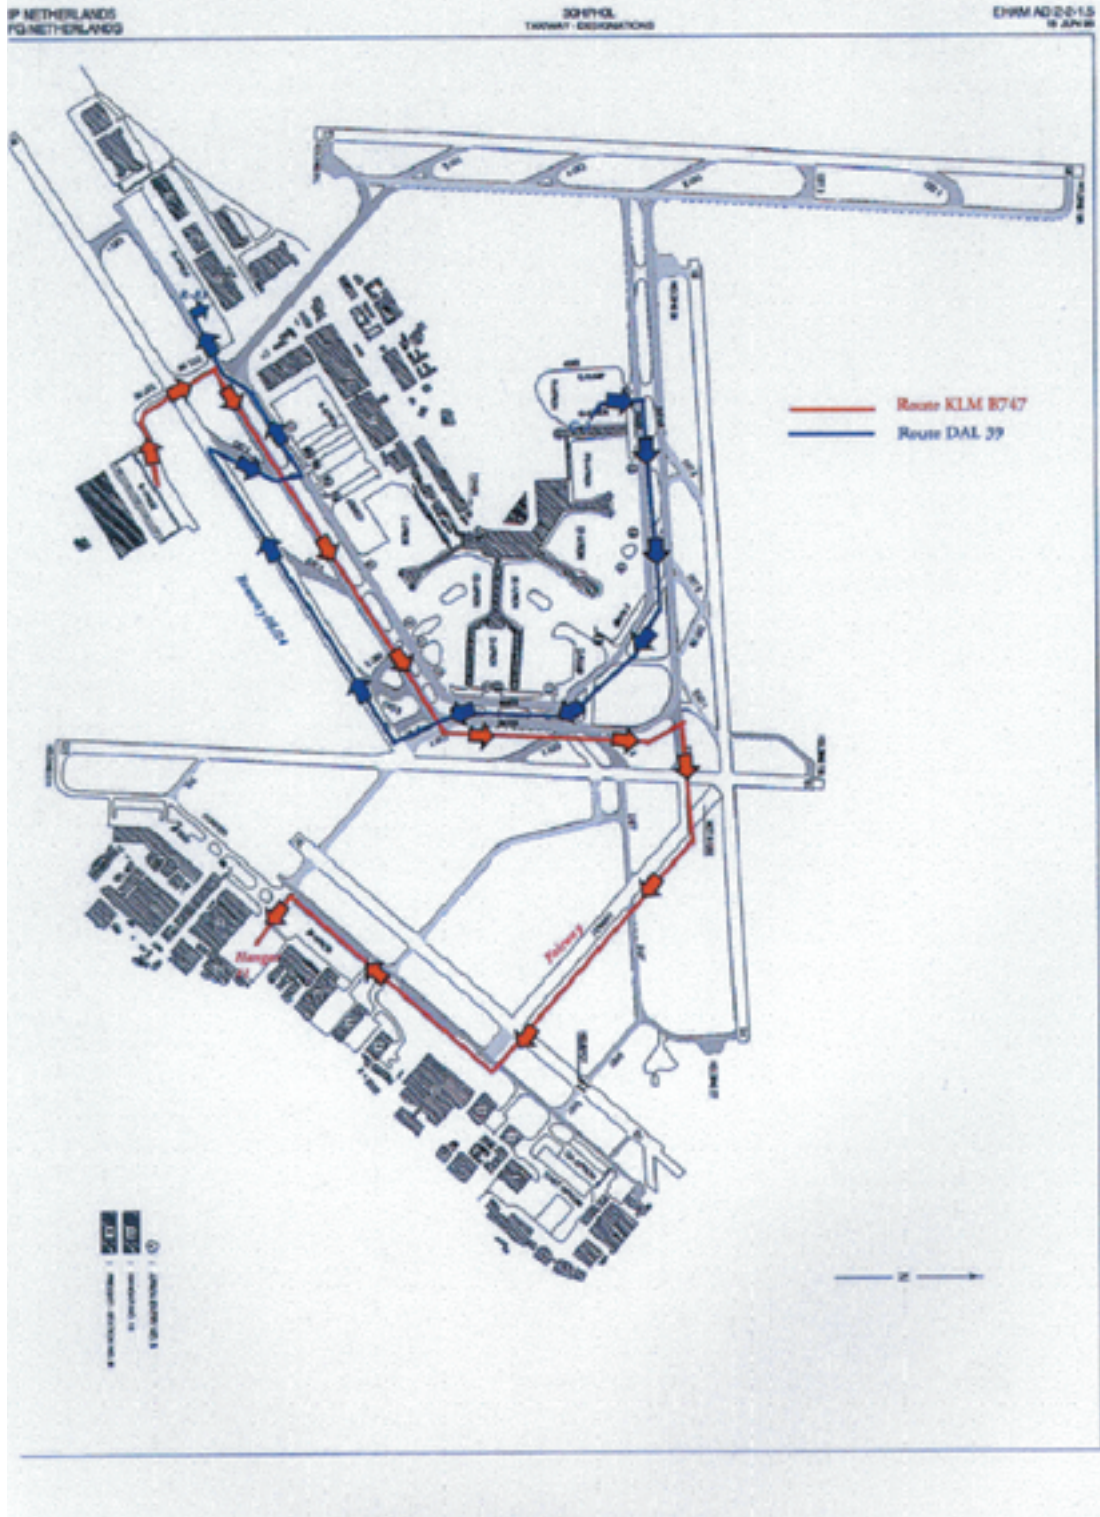
Route DAL 039/KLM B747

Delta Air Lines flight DAL 39 had been cleared for take-off from runway 24 at Amsterdam Airport Schiphol. Almost at the same time a KLM Boeing 747, being towed and accompanied by a yellow van was cleared to cross runway 24 at the position of exit 2. During the take-off roll the pilots of DAL 39 observed the towed Boeing 747 crossing the runway. The take off was aborted and the aircraft brought to a standstill before reaching the position of the tow.
