FIRE IN HIGH-SPEED TRAM

AT THE WEESPERPLEIN

METRO STATION, AMSTERDAM

ON 12 JULY 1999

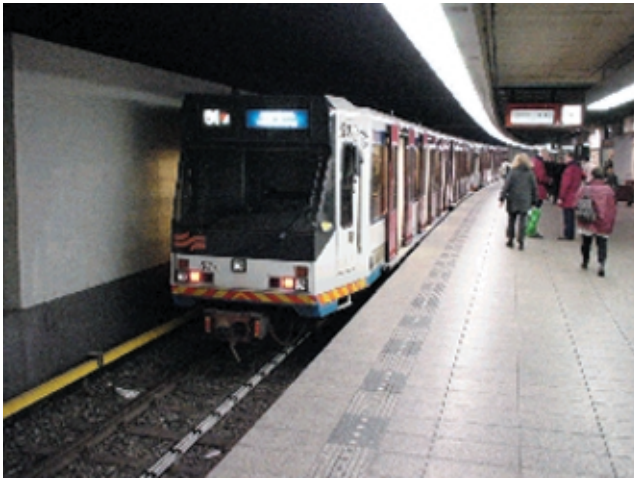
Fig. 4. The high-speed tram stock at the platform

For the operation of line 51, the Municipal Transport Company has 25 units, each consisting of two carriages. These can be powered via the third rail or by the catenary lines. The high-speed tram can travel with multiple units connected together. The journey in question involved a tram unit consisting of carriages numbers 68 and 57.
