# PASSENGER TRAIN DERAILMENT

*at Baarn*

*20 August 1999*

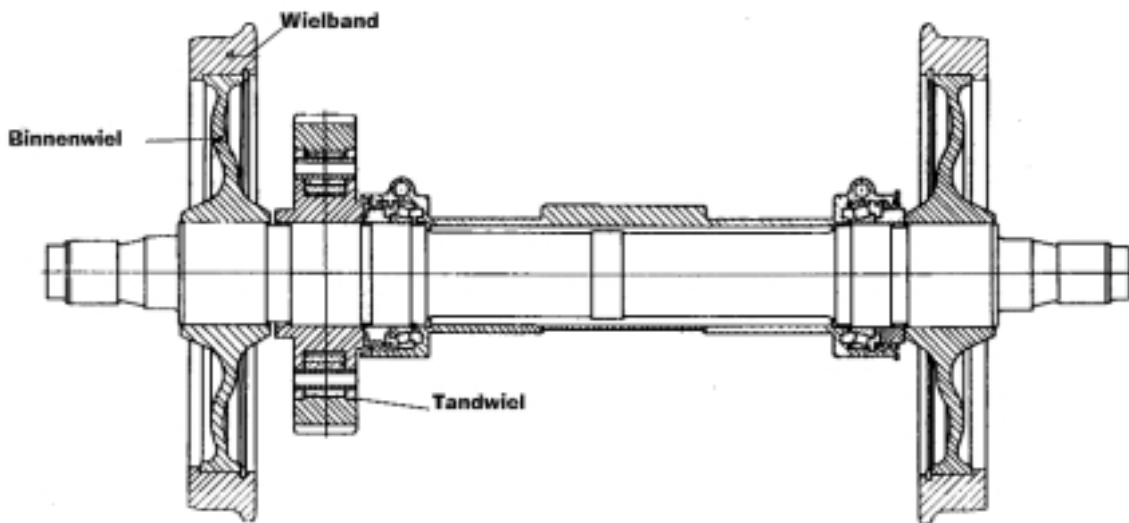
Fig. 5. Type 275 wheel set. The wheel set is part of a motor bogie. During re-profiling, the profile of the tyre is returned to its original shape. The tyre becomes thinner. In re-tyring, the worn-out tyre is replaced by a new tyre.

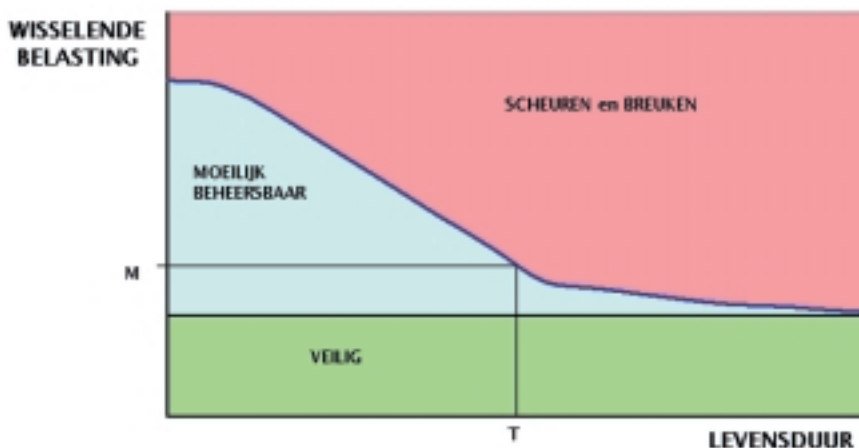
Fig. 6. The behaviour of steel under fluctuating loads. Below the fatigue threshold, the service life is infinite, i.e. this is the safe zone. Above these thresholds, the service life is limited. In the event of a fluctuating load equivalent to M, the expected service life is T years. On railway stock, this could in principle be more than 30 years.

still be assumed that the construction component has an infinite service life. The tensions in the construction are then in the green zone, shown in figure 6. The construction thus has an infinite service life. Once a fatigue crack has been observed, one thing is certain: the service life is limited. As such this is not a problem. Cracks are not by definition non-permissible.

The table and graph are disturbing. Both clearly demonstrate that wheels do not have an infinite service life. The number of cracks increases, the closer the end of the technical service life becomes. This is precisely the behaviour of material which in terms of load, is in the difficult to manage zone of figure 6. It is no problem to make constructions in this zone, if two conditions are met: it must be possible with absolute certainty to trace fatigue cracks, and the speed with which the crack is developing must be accurately known.
