**ACRYLONITRILE LEAKAGE  
AMERSFOORT STATION  
20 AUGUST 2002**

The Hague, September 2004

## BOARD FOR TRANSPORT SAFETY

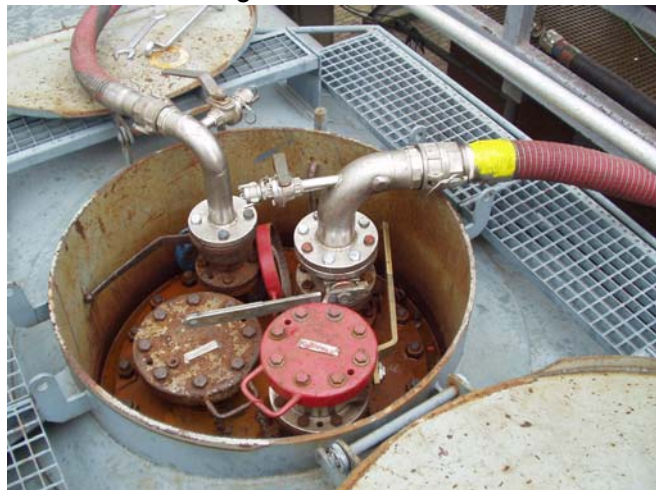
**The leakage was caused by overpressure in combination with technical shortcomings in the reservoir of the tank wagon. The leakage was possible due to a valve which was technically unsuitable for the purpose for which it was used, which leaked when closed due to inexpertly carried out welding, and which furthermore was closed with a blind flange which over time had become rough due to rust formation and gasket residues.**

Fig. 9 The top of a reservoir with cocks 4, 5, 6 and 7. This reservoir matches the type of the reservoir in Amersfoort. The coupling pipes are connected.
