DUTCH
SAFETY BOARD

Hatch cover crane entrapment

The Hague, April 2016

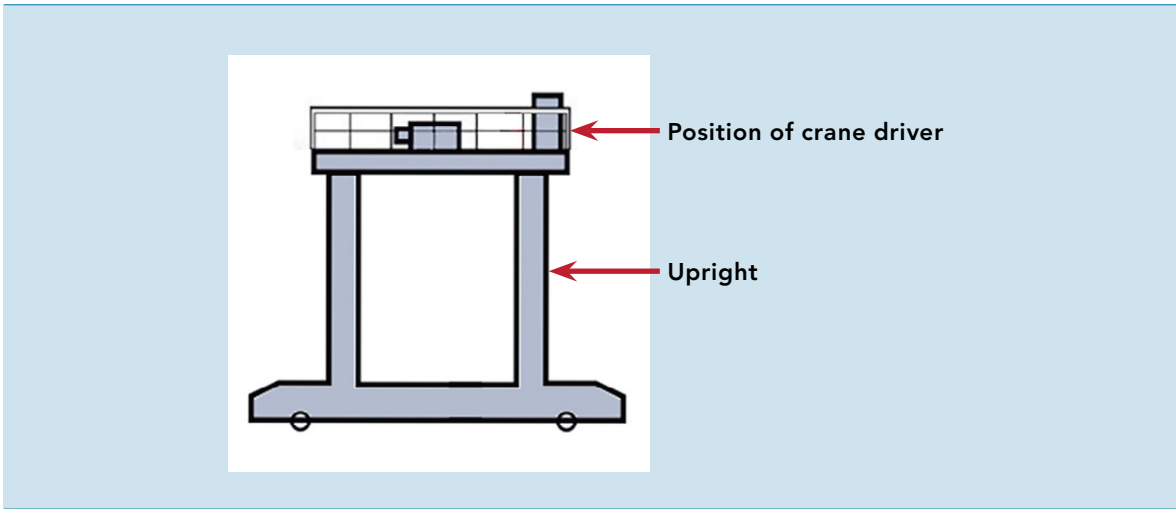
Figure 2: Drawing of hatch crane.

A hatch crane is a mobile crane used to move pontoon covers longitudinally to the ship. The hatch cover crane runs on rails located on the hatch coaming on both sides of the ship. The crane consists of two vertical uprights and a yoke, placed athwartships. The crane operator stands on the hatch crane and rides along with the hatch crane while the hatch is moved (see figure 2).

The hatch crane on board the Beauforce is of the 'Gantry crane 2x15kW DB Bnr.: 9412' type supplied by Coops & Nieborg BV and forms part of the standard equipment of the 'Damen Combi freighter 8200'.

An automatic stop mechanism would probably not have stopped the accident from happening, since the victim on the Beauforce was trapped between the uprights. Such a stop mechanism would be mounted on the front and rear of the crane next to the track sweepers (in accordance with the recommendation from ILT). None of the hatch cranes made by Coops & Nieborg BV have been fitted with an automatic stop mechanism to date.
