**Goods train derailment near
Apeldoorn on 30 April 2003**

The Hague, February 2005

The Safety Investigation Board

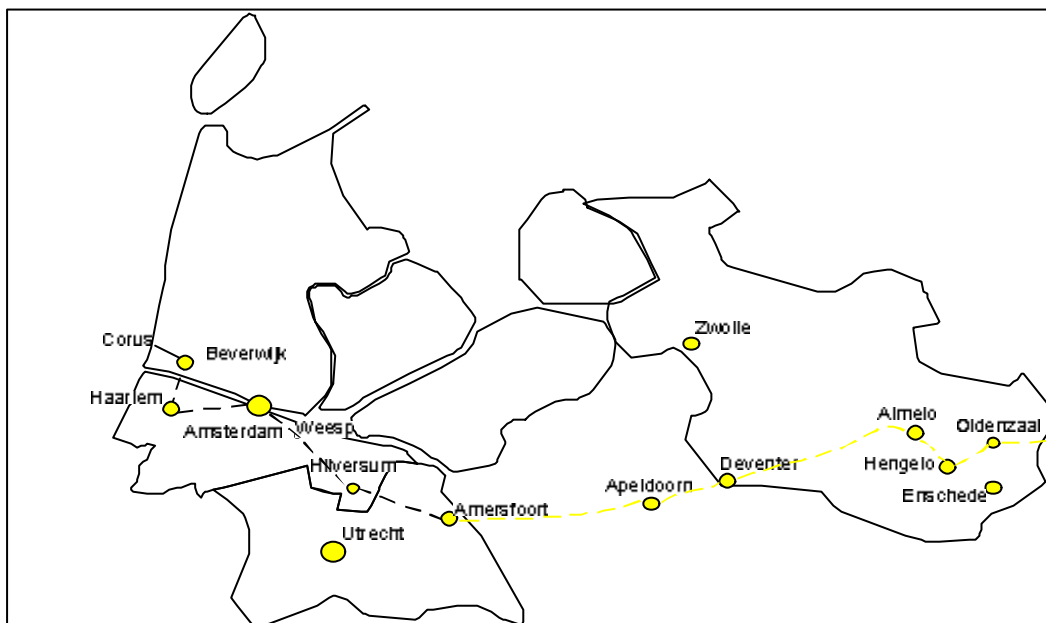
Figure 3 Route of the train through the Netherlands

Approximately 1250 metres before a set of points for a right-hand turnout (points 23a), the train passed a signal (signal 12) showing 'yellow 4', which means that by the next signal, the driver must have reduced the speed to a maximum of 40 kilometres per hour. The driver failed to respond directly to this signal, but only several seconds later, when having passed the signal, the ATB code change signal sounded, in the cab. The driver responded with light braking, thus complying with the ATB braking criterion (as a result of which the ATB system did not intervene). However, this braking was insufficient to be travelling at 40 kilometres per hour, by the next signal. When the driver saw a signal at red (which was intended for the adjacent track) and noted the excessive speed, he initiated urgent braking. However, it was too late to sufficiently reduce the speed. At signal 28 (showing 'green flashing'; maximum speed 40 kilometres per hour), the train was still travelling at approximately 80 kilometres per hour.
