The Dutch Safety Board

Occurrence #: 2005135 **Classification:** Serious incident

The flight and the incident

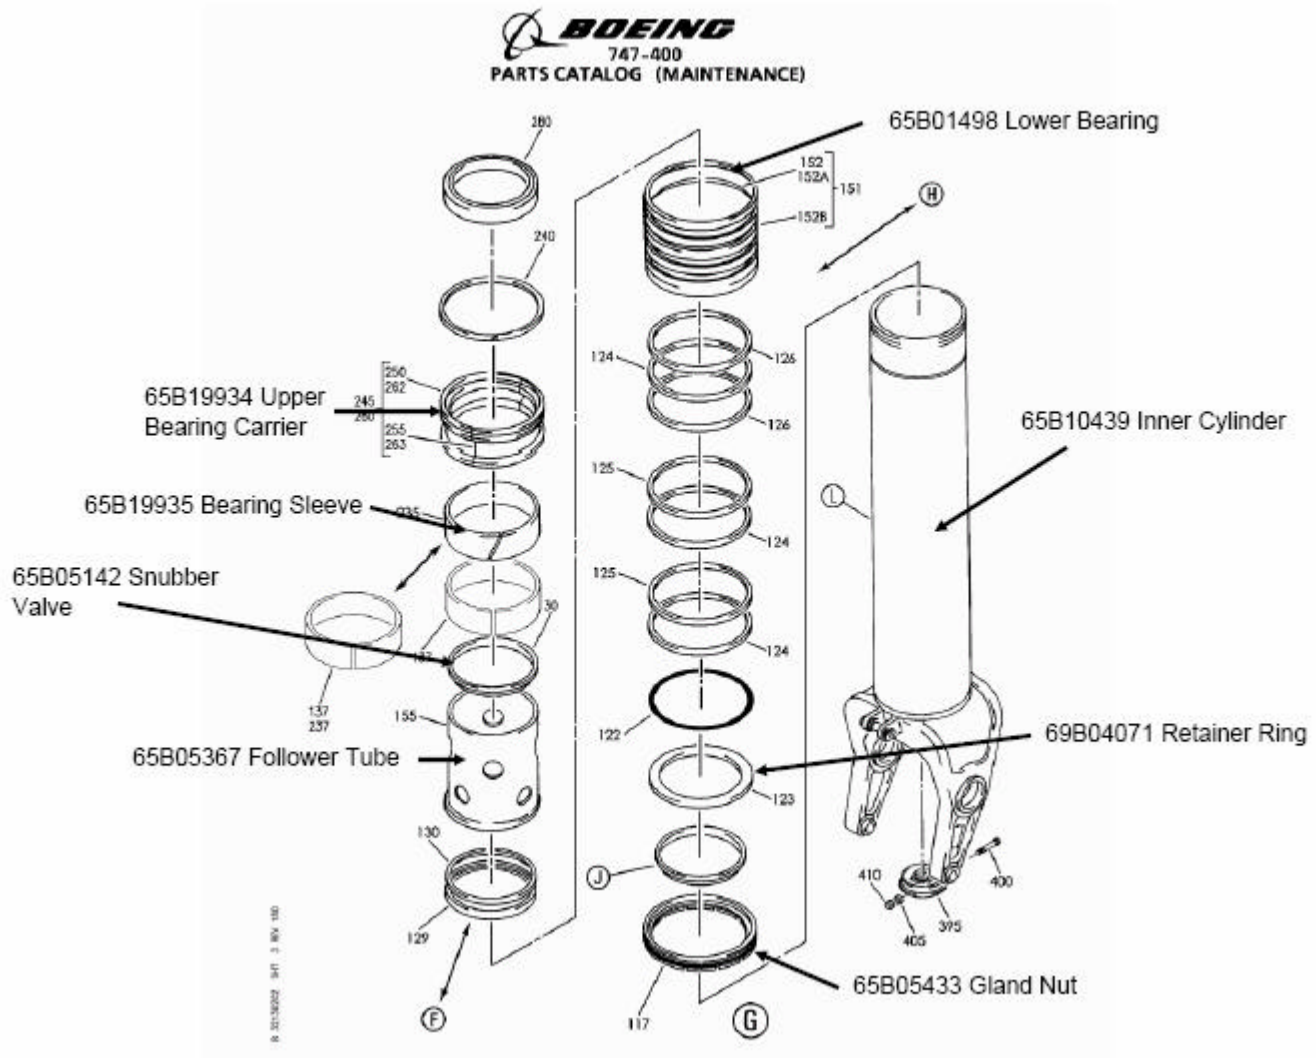
Copied with permission from The Boeing Company

Disassembly and investigation of the shock strut revealed that failure of the upper bearing carrier initiated the failure sequence of the shock strut internal component damage and subsequent over-extension.

Subsequent to the disassembly of the shock strut Boeing received a Notice Of Escapement (NOE) from the landing gear manufacturer advising that their supplier disclosed that a number of upper bearing carriers had not been properly heat treated and were delivered in the annealed condition. An electrical conductivity inspection was performed by Boeing on the two upper bearing carriers removed from aircraft JA01KZ. The inspection confirmed that both upper bearing carriers were annealed 2024 aluminum which agrees with the NOE from the part supplier. All upper bearing carriers with improper heat treatment were traced and the affected operators were informed by Boeing and were offered support to replace the parts.
