**The derailments at Amsterdam Central Station
on 6 and 10 June 2005**

The Hague, 30 November (project numbers M2005RV0606-04 en M2005RV0610-02)

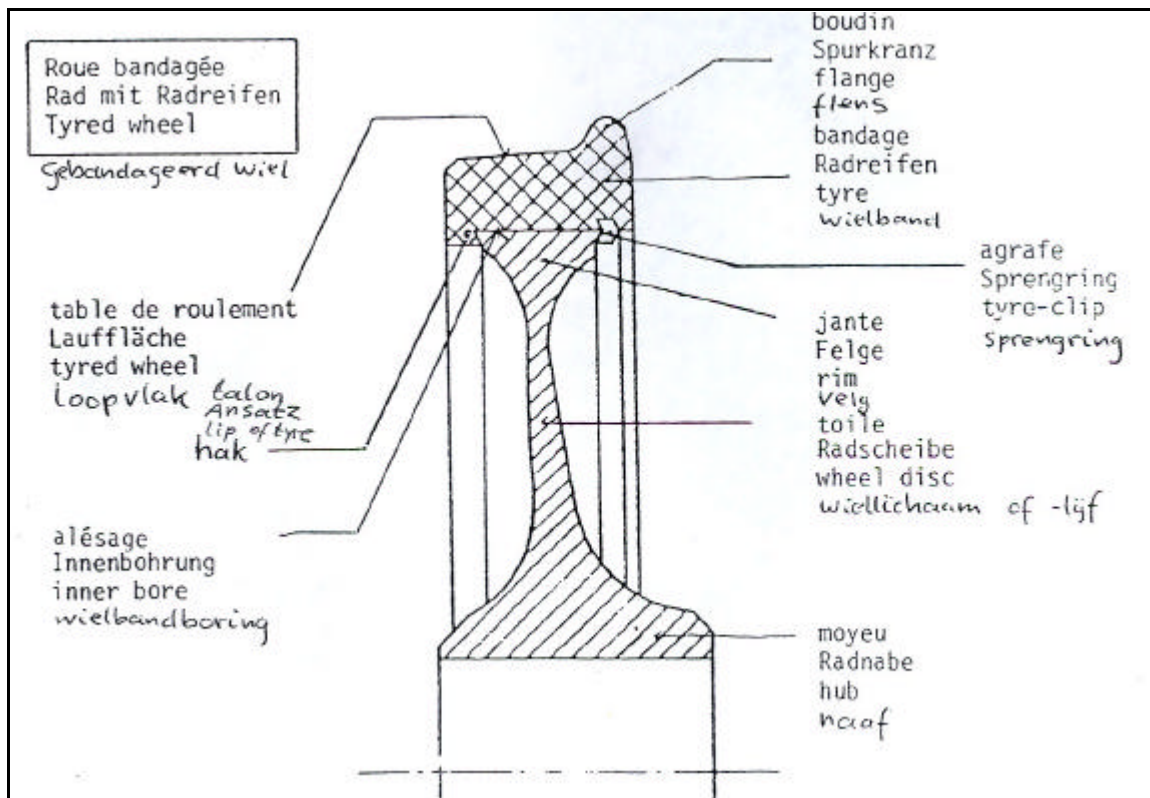
Illustration 5 Structure of the tyre - inner wheel and tyre clip system (source photo: Inspectorate for Transport, Public Works and Water Management)

In general terms, a tyre can start to come loose as a result of a combination of factors, namely the wheel load, a thin tyre and a considerable increase in temperature caused by the contact between the brakes and the tyre.
