## FACTUAL INFORMATION

Occurrence:	2006092
Classification:	Serious incident
Date and time:	12 August 2006, 11:27 hrs <sup>1</sup>
Place:	Amsterdam Airport Schiphol (EHAM)
Aircraft registration:	PH-BXP
Aircraft model:	Boeing 737-900
Aircraft type:	Passenger aircraft
Type of flight:	Public transport
Phase of operation:	Landing
Damage to aircraft:	Minor damage
Flight crew:	2
Passengers:	193
Injuries:	None
Lighting conditions:	Daylight

## SYNOPSIS

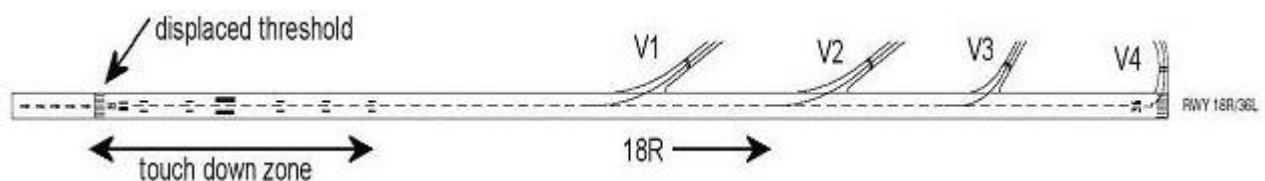
Picture 1: a plot of runway 18R/36L

During the approach for runway 18R the crew was cleared to vacate the runway via exit V3 after landing. The touch down of the aircraft was at the very end of the touch down zone. The aircraft could not slow down sufficiently to vacate the runway via exit V3 in a safe manner. The pilot flying then decided to aim for the last exit, V4. Between V3 and V4 forward thrust was selected. Approaching V4 manual braking was applied again but the speed of the aircraft remained too high to make the 90° turn to V4. The nose wheel skidded over the painted markings at the end of runway 18R and the aircraft came to a standstill with the nose wheel outside taxiway V4. There were no injuries and the aircraft was slightly damaged. Just before the landing of the aircraft a shower with an extreme rain intensity caused standing water on the southern part of the runway.
