Identification number:	2008078
Classification:	Serious incident
Date, time ¹ of occurrence:	12 July 2008, 20.10 hours
Location of occurrence:	Near Lekkerkerk, the Netherlands
Aircraft registration:	PH-SVU
Aircraft model:	Apex Robin DR400/135CDi
Type of aircraft:	Single-engined propeller aircraft
Type of flight:	Training flight
Phase of operation:	Landing
Damage to aircraft:	Serious
Number of crew:	Two
Number of passengers:	One
Injuries:	None
Other damage:	None
Lighting conditions:	Daylight

SUMMARY

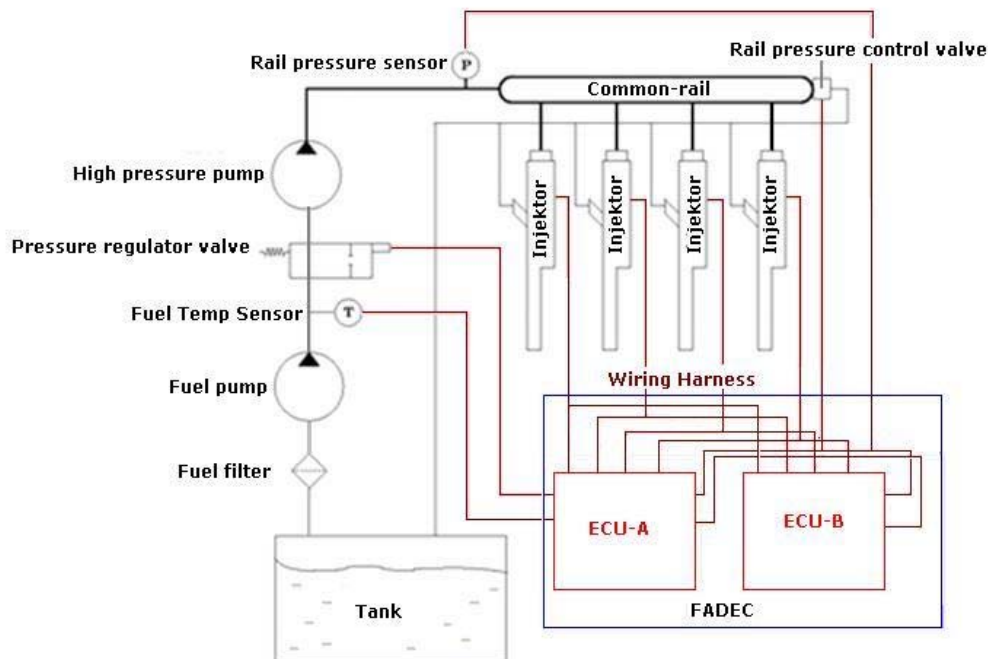
Figure 2: functional diagram of the TAE-125-01 fuel- and electronic control system

Figure 2 shows a functional diagram of a common-rail diesel engine operation. From the fuel tank, fuel is passed to a high pressure fuel pump. The fuel pressure is increased and subsequently passed to the distribution tube, as from now to be called the common-rail, of the engine. The engine RPM is determined by the existing fuel pressure in the common-rail. The pressure in the common-rail in part determines the engine revolutions (power). The pressure in the common-rail is regulated by the rail pressure control valve and sensed by the rail pressure sensor. The electrically operated injectors inject fuel under high pressure into the engine for combustion.

Electronic control of the engine is regulated by a digital Full Authority Digital Engine Control³ (FADEC) unit. The FADEC is equipped with two independent engine control units (ECU)⁴, distinguished as ECU-A and ECU-B. Under normal conditions the engine is controlled by ECU-A, the ECU-B being redundant (fail-safe principle). By manipulating a switch, the ECU control can be selected by the pilot to automatic or manual. Standard selection is AUTOMATIC, resulting in the engine being controlled by ECU-A.

If the monitoring system within the FADEC detects a failure, ECU-B will take over control automatically. This is indicated by a warning light in the cockpit. ECU-B may also be selected by the pilot manually. The different engine systems are electrically connected to the FADEC by a bundle of wires, the wiring harness, so as to allow the engine to be controlled and monitored. Each monitoring sensor and engine control unit is wire-connected to the FADEC via one cable. Redundancy in these connections is not provided for and thus not fail-safe.
