## TAXIWAY EXCURSION

Number incident:	2009062
Classification:	Incident
Date, time <sup>1</sup> incident:	2 August 2009, 14.36 hour
Location incident:	Maastricht Aachen Airport
Registration of aircraft:	PH-AAY
Type of aircraft:	Airbus A320 – 232
Type of operation:	Commercial passenger flight
Phase of flight:	Taxi-out
Damage to aircraft:	Minor
Number of crew:	Two cockpit crew, four cabin crew
Number of passengers:	58
Personal injuries:	None
Other damage:	Runway edge light
Light conditions:	Daylight

During a 90° right turn an Airbus A320 ran off the left side of a taxiway while taxiing at Maastricht Aachen Airport towards the runway. An intermittent failing main landing gear down and locked sensor caused the sensor to lose its near position. This resulted in the deactivation of the hydraulic pressure to the nose wheel steering hydraulic module, leaving the crew with no control over the nose wheel steering. The only way to steer the airplane was by differential braking.

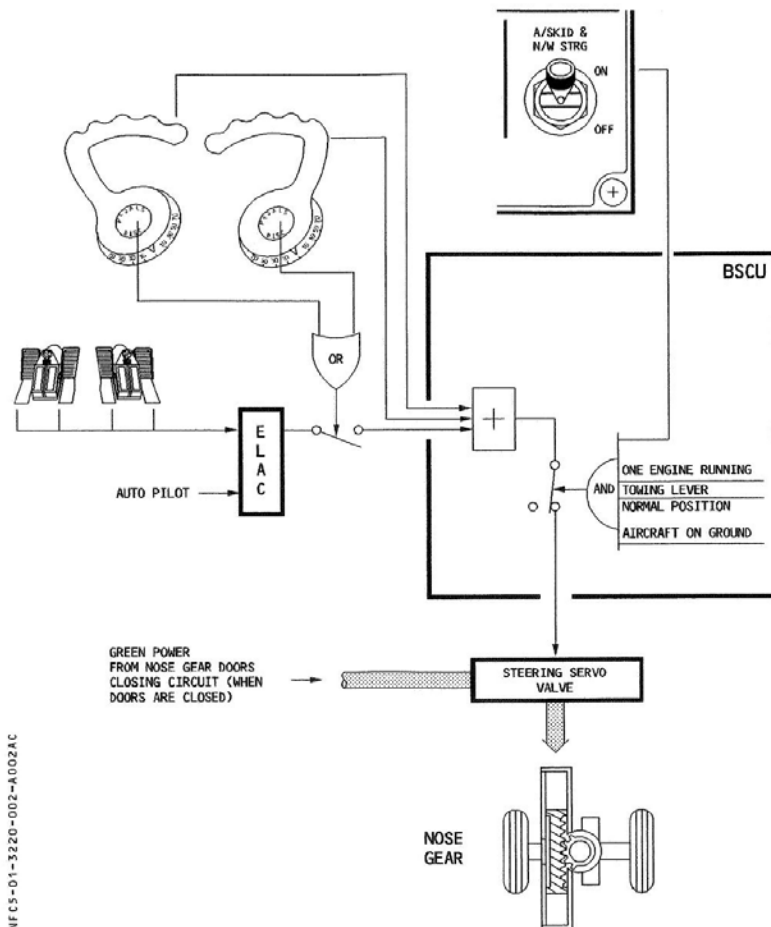
All four conditions must be met before hydraulic pressure is applied to the steering actuating cylinder. The hydraulic pressure to the nose wheel steering actuator is routed via the nose wheel door up lock assembly.

Picture 2: diagram of the nose wheel steering of a A320
