BRAKE PROBLEMS DURING LANDING

Incident number:	2010005
Classification:	Accident
Date, time ¹ of incident:	20 January 2010, 14.05 hours
Place of the incident:	Amsterdam Schiphol Airport
Registration:	CS-DXR
Aircraft type:	Cessna Aircraft Cooperation Citation 560 XLS
Aircraft category:	Twinjet
Flight type:	Ferry flight
Flight phase:	Landing
Aircraft damage:	Major
Number of crew:	Two
Number of passengers:	None
Personal injury:	None
Other damage:	Damage to airport infrastructure
Light conditions	Daylight

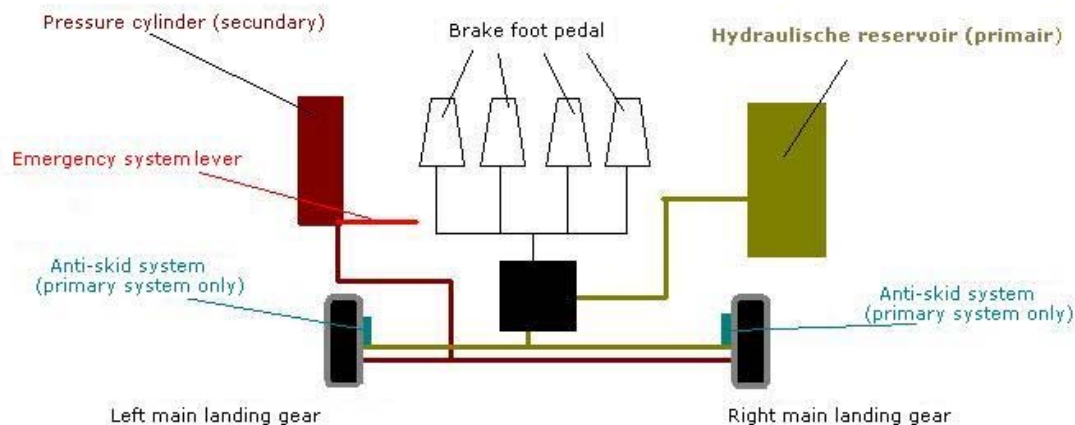
Figure 3: Diagram showing the brake system of the main landing gear.

In principle braking is achieved by hydraulic pressure controlled by the crew using foot pedals. In case of a failure of the primary system a back-up system is incorporated (figure 3). This secondary system consist of a pressure cylinder containing nitrogen, which is operated by a control lever located in the cockpit.

When the secondary (emergency) system is used the anti-skid system is unavailable. Furthermore when the secondary system is used the brake power is not adjusted if a difference in wheel speed between the left and right main landing gear is present.

During the inspection the hydraulic fluid reservoir which is part of the primary brake system was found to be empty. The pressure in the cylinder of the secondary (back-up) system was 600 PSI whereas it normally is 2000 PSI.
