## EMERGENCY LANDING AFTER TECHNICAL MALFUNCTION

Identification number:	2011026
Classification:	Accident
Date, time <sup>2</sup> of occurrence:	11 May 2011, approximately 15.15 hours
Location of occurrence:	Veghel
Aircraft registration:	PH-HHF
Aircraft model:	Schweizer 269D
Type of aircraft:	Helicopter
Type of flight:	Commercial
Phase of operation:	Cruise
Damage to aircraft:	Burnt out
Cockpit crew:	One
Passengers:	None
Injuries:	None
Other damage:	Fire damage to grass of field
Lighting conditions:	Daylight

During cruise flight at approximately 1000 feet the pilot heard a noise, directly followed by a pitch up and left roll motion of the helicopter. The pilot recovered helicopter control, rolled off the throttle to idle and entered an autorotation which resulted in a hard landing in a field. After the pilot had shut down the engine, switched off the electrical systems and removed some items from the helicopter, a post crash fire destroyed the helicopter almost completely. The pilot suffered no injuries.

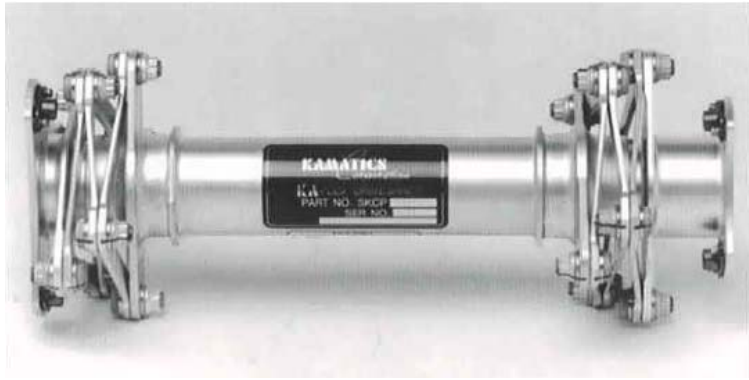
Figure 4: driveshaft with KaFlex couplings (source: [www.kamatics.com](http://www.kamatics.com))

To transfer engine power to the gearbox a driveshaft is used. To allow for some movement of the engine on its mounts, flexible couplings (KaFlex couplings) are used on both sides. Investigation revealed that the engine to main gearbox drive train was interrupted. The reported nose pitch up and left roll movement were likely caused by the short delay in reduction of collective (main rotor blade pitch) after the loss of engine power, resulting in a corresponding decrease in rotor RPM. Loss of RPM happens quickly in conditions of high blade pitch. With a decrease in blade airspeed on the retreating side, the retreating blade stalls<sup>4</sup>, which is characterized by nose pitch up and left roll movement of the helicopter. Because of the post crash damage the reported lack of tail rotor steering by the pilot could not be verified.
