REAR DOOR SEPARATED DURING FLIGHT

Identification number:	2011051
Classification:	Incident
Date, time ¹ of occurrence:	29 June 2011, 15.43 hours
Location of occurrence:	North-east of the village Biddinghuizen
Aircraft registration:	PH-TIN
Aircraft model:	Diamond DA 40 D
Type of aircraft:	Single engine piston
Type of flight:	Private
Phase of operation:	En route
Damage to aircraft:	Door hinge brackets broken and rear door separated
Cockpit crew:	One
Number of passengers:	None
Injuries:	None
Other damage:	None
Lighting conditions:	Daylight

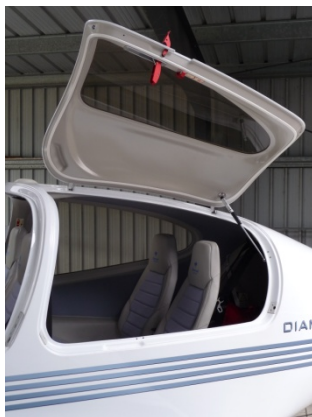
Figure 6: rear door

Two hinge brackets attach the door to the top of the fuselage; see figure 6. The hinge brackets are bolted to the door frame. In an emergency the forward hinge bracket can be released by pulling the emergency door pin (see figure 4) forward by means of a lever in the cabin. With this bracket released, the passenger door can be forced open from the top. In the normal position the emergency door pin is placed in a blind hole in the fuselage on the rear side of the forward door hinge bracket.

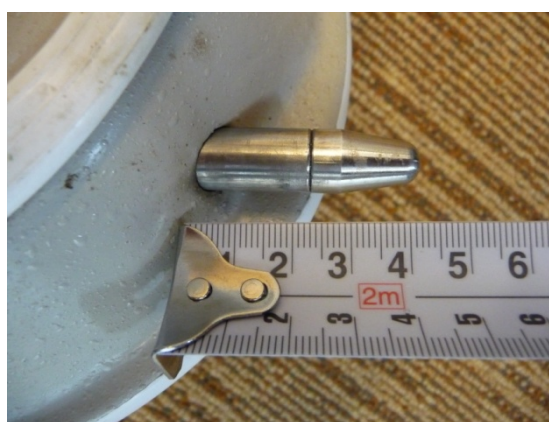
Figure 8: one of the two locking pins

The door handle operates two locking pins (see figure 8). The locking pins are at the bottom forward and rear corners of the door. If the door is closed and locked the pins should be in the forward and aft guide plates in the aircraft fuselage (see figures 11 and 12). If the door handle is pulled outward, the rear locking pin will be pulled forward and the front locking pin will be pulled aft. The aft movement of the front locking pin operates a micro switch for a 'door open' alert message on the primary flight display.

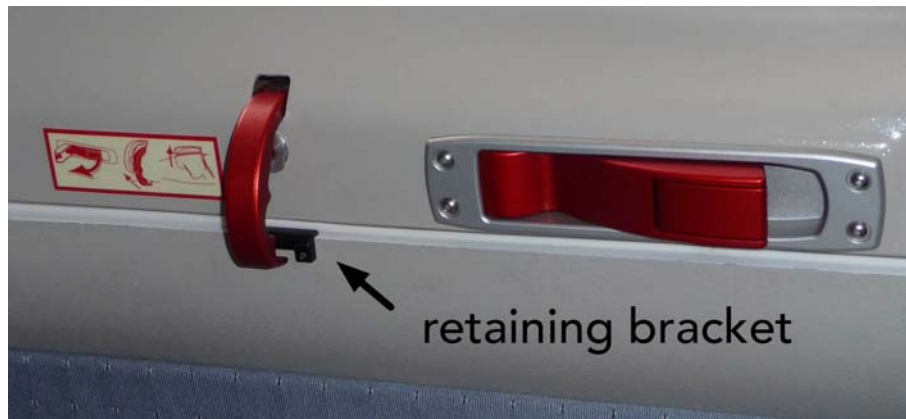
Figure 9: retaining bracket

On 10 November 2010 the European Aviation Safety Agency (EASA) issued Airworthiness Directive 2010-0235⁴ mandating accomplishment with Diamond Aircraft Industries Mandatory Service Bulletin MSB 40-070, MSB D4-079 or MSB F4-024 which prescribe the identification of the part number of the passenger door retaining bracket (see figure 9) and if necessary its replacement. As reason for Airworthiness Directive 2010-0235 is given that since 2004, more than 30 reports have been received of in-flight losses of a rear passenger door on Diamond aircraft, the majority of which were DA 40. In addition, at least 18 doors have been replaced due to damage found on the hinge brackets.

The Airworthiness Directive states that Diamond Aircraft Industries performed analyses and structural tests to determine the root cause of the door opening in flight. The conclusions were that:

- The primary locking mechanism provided adequate strength to react to the loads in flight.
- The root cause was the crew not properly securing the rear passenger door by the main locking mechanism, prior to flight.
- Damage to the hinge brackets has been caused primarily by external loads (wind gust conditions) while the aeroplane was parked.

On 17 January 2011 Mandatory Service Bulletin 40-070/1, D4-079/1 and F4-024/1 was issued by Diamond Aircraft Industries.⁶ The airplanes affected were DA 40, DA 40 D and DA 40 F.⁷ The subject was the replacement of the passenger door retaining bracket. An improved retaining
