PRECAUTIONARY LANDING AFTER CONTROL PROBLEMS

Incident number:	2011057
Classification:	Serious incident
Date, time ² incident:	15 July 2011, 17.11 hours
Place of the incident:	Near Lelystad Airport
Registration:	PH-FLD
Aircraft type:	Diamond DA 40 D
Aircraft category:	Single engine propeller airplane
Flight type:	Private flight
Flight phase:	Take-off
Aircraft damage:	None
Number of crew:	One
Number of passengers:	One
Personal injury:	None
Other damage:	None
Light conditions:	Daylight

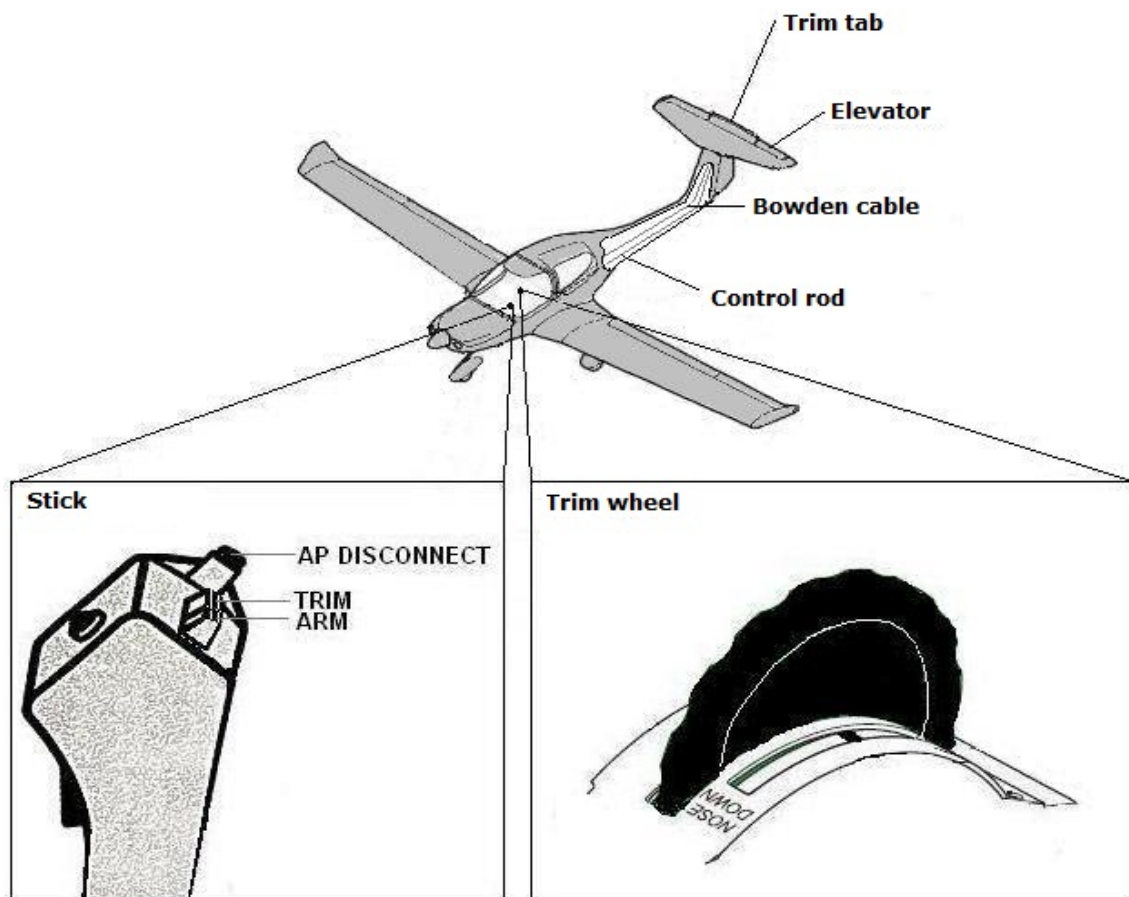
Figure 2: three-dimensional overview of the DA40 control system including a cutaway tail showing the elevator control system (source: DA40 Airplane Maintenance Manual – Diamond Aircraft Industries. Adapted by the Dutch Safety Board)
