DUTCH
SAFETY BOARD

Shipping Occurrences Report

November 2016 - April 2017

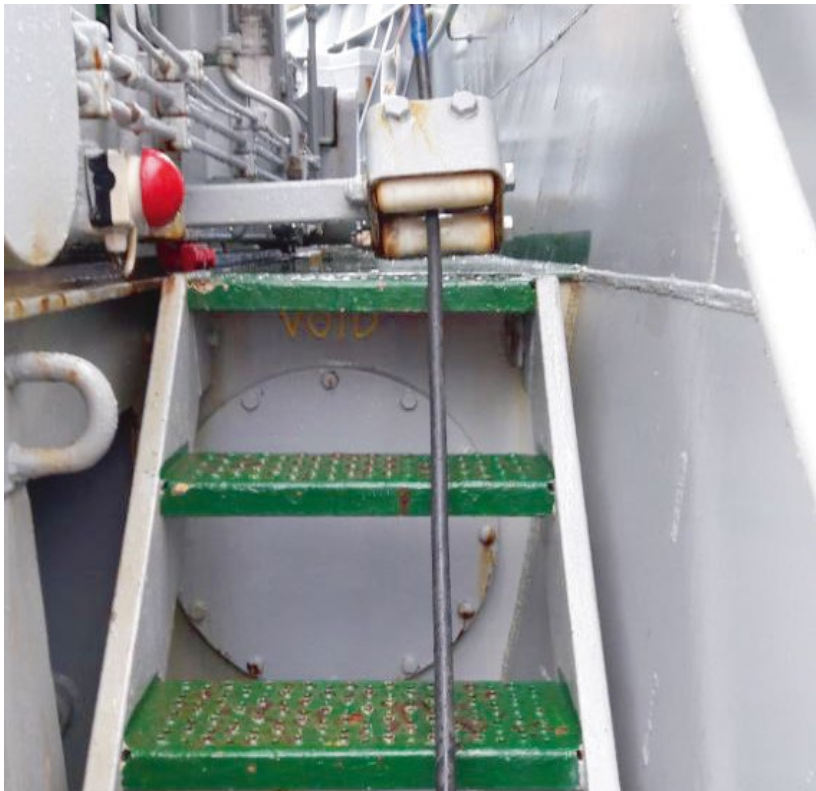
Location of the accident on board the Sagasbank. (Photo: Wagenborg)

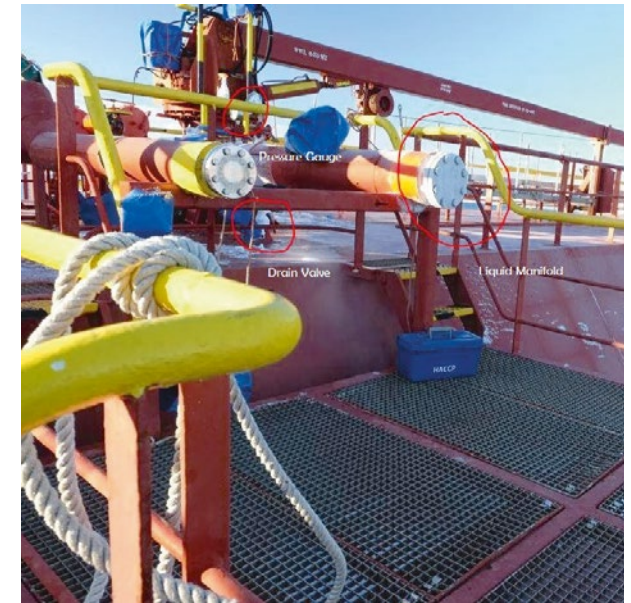
Location of the accident on the Coral Carbonic. (Photo: Antony Veder)

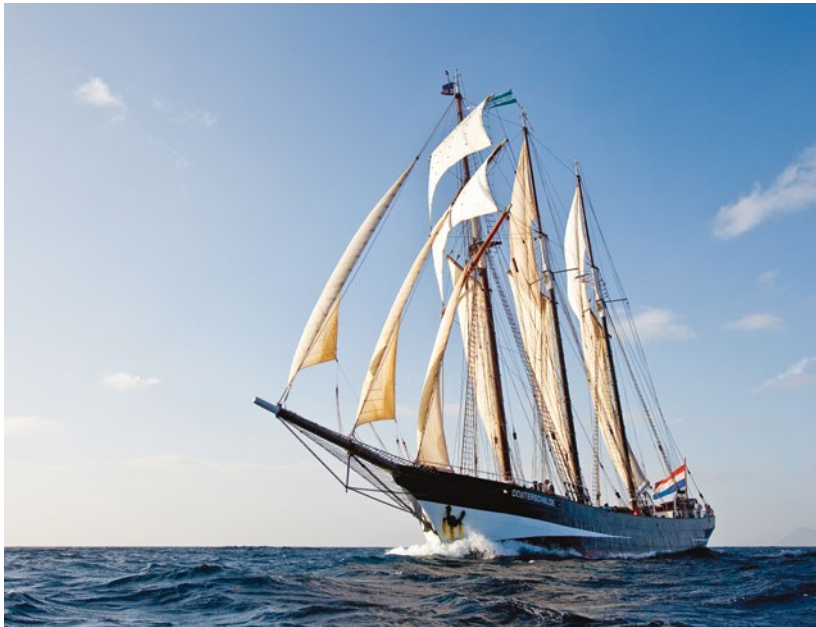
At 9:15 hours a passenger alerted the captain to the fact that the engine exhaust had suddenly begun to emit smoke. It was established that the exhaust gas temperature was higher than normal, whereupon the engine speed was reduced and the engine was visually inspected. This inspection revealed nothing unusual. When the engine speed was subsequently increased again, black smoke came out of the exhaust and the engine stopped. Restarting proved possible but the engine ran irregularly and white smoke came out of the exhaust. At this point the engine was stopped. It later transpired that water was leaking from the turbine casing. The shipping company was contacted and, later in the day, it was decided to proceed under sail towards

Mindelo (São Vicente), where on 17 February 2017 the ship arrived under sail in the bay and anchored. It was found that water had entered the cylinders and that the entire engine block needed to be replaced. This incident occurred during the maiden voyage, with a new engine.

Oosterschelde. (Photo: Reederij Oosterschelde; Arthur op Zee)
