DUTCH
SAFETY BOARD

Partial loss of engine power during cruise flight Robinson R44 helicopter

The Hague, June 2014

Identification number: 2012013
Classification: Serious Incident
Date, time¹ of occurrence: 21 January 2012, 14.32 hours
Location of occurrence: Oosterschelde, vicinity of Yerseke
Aircraft registration: PH-WMW
Aircraft model: Robinson R44
Type of aircraft: Helicopter
Type of flight: Passenger flight
Phase of operation: Cruise
Damage to aircraft: None
Cockpit crew: One
Passengers: Two
Injuries: None
Other damage: None
Lighting conditions: Daylight

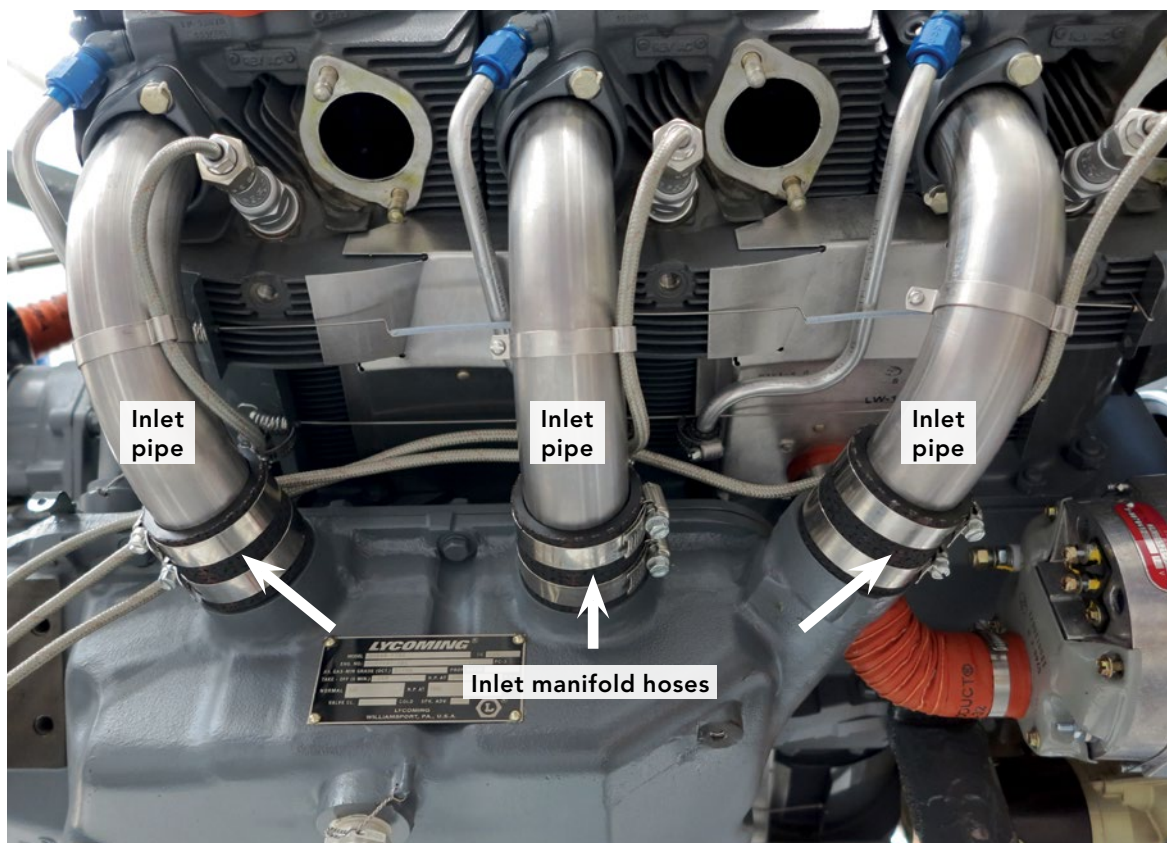
Figure 3: Lycoming O-540 engine, bottom, right side. (Source: Robinson helicopters)

The helicopter engine was inspected at the maintenance facility in Belgium. The inspection showed that the CHT sensor located on cylinder #2, had melted away. Also, the hoses connecting the manifold to the cylinder intake pipes (inlet manifold hoses) showed extensive wear of the rubber, which resulted in at least one porous hose. A leaking hose can cause a lean fuel/oxygen mixture, resulting in high temperatures during combustion, and possible overheating of pistons and cylinders.

The engine was removed from the helicopter and investigated. Two cylinders were found to have overheated (numbers 2 and 4) which probably caused the failure of the CHT-sensor and the partial power loss.
