HELICOPTER CRASH DURING A PHOTO FLIGHT

Incident number:	2010042
Classification:	Accident
Date and time of incident:	27 June 2010, around 12.55 hours ²
Location of incident:	Maasvlakte, municipality of Rotterdam
Registration:	PH-ECJ
Aircraft model:	Eurocopter EC 130 B4
Aircraft type:	Helicopter
Flight type:	Photo flight
Flight phase:	Hover
Damage to the aircraft:	Completely destroyed
Number of crew members:	One
Number of passengers:	Four
Injuries:	Four people died, one person was severely injured
Other damage:	Environmental damage
Light conditions:	Daylight

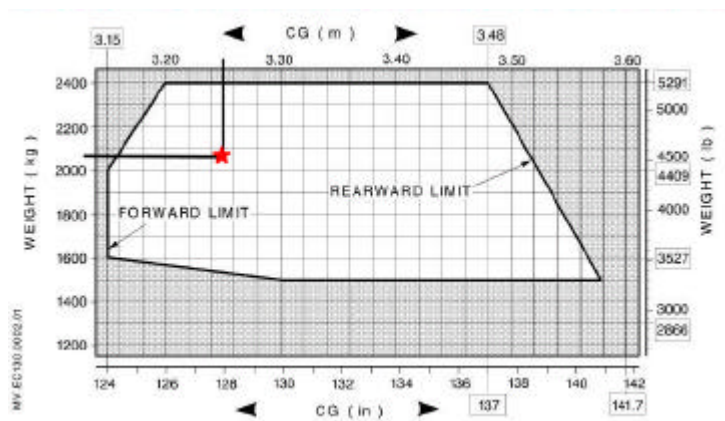
The helicopter had a maximum permitted takeoff weight of 2427 kg. At the time of the accident, the estimated weight of the helicopter was approximately 2084 kg. The centre of gravity was 3.2546 meters from the reference point.

Figure 2: diagram showing weight and centre of gravity.

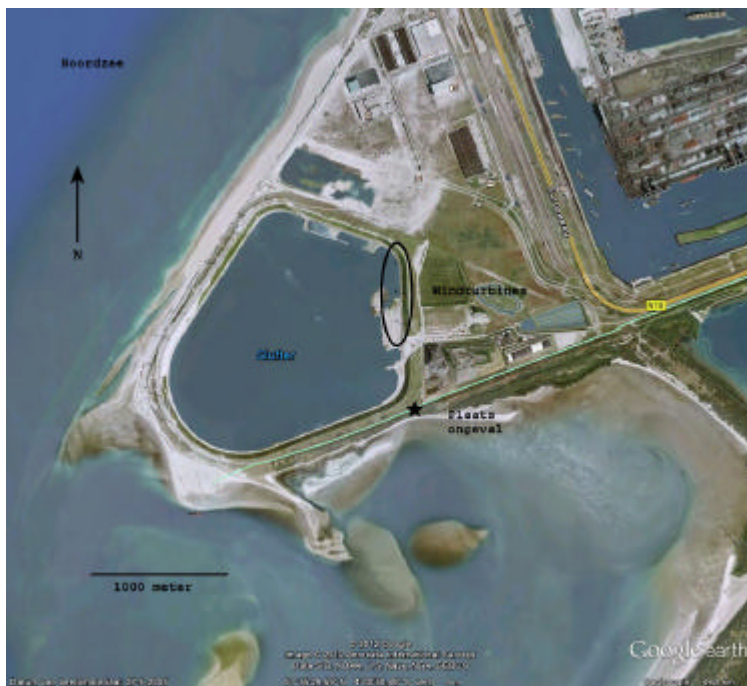
The Maasvlakte is a developing harbour and industrial area. It consists of a large sandy area surrounded by water, with the Slufter, a large body of water, in its centre. The site of the helicopter crash features a road with a narrow strip of dunes and sandy terrain to the south. The site is also surrounded by water, with the North Sea and the Slufter to the west and the Haringvliet estuary to the south. A large number of wind turbines are positioned around the Slufter. Three of these wind turbines are aligned to the north of the accident site.

Figure 6: the area of the Maasvlakte where the accident occurred.

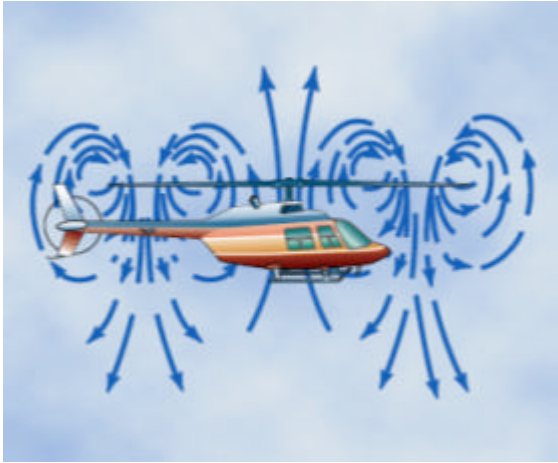
If a helicopter encounters this situation, the aerodynamic effect on the rotor blades can cause significant and sudden movements around the yaw axis, longitudinal axis and transverse axis of the helicopter. These yaw, roll and pitch motions can lead to loss of control over the helicopter.

Figure 8: air circulation in a 'vortex ring state' (source FAA 'Rotorcraft Flying handbook').

According to the literature, one of the situations in which a risk of 'vortex ring state' exists is the performance of a photo flight, as the three conditions described above could potentially occur at the same time.
