DUTCH
SAFETY BOARD

Shipping Occurrences Report

May - October 2016

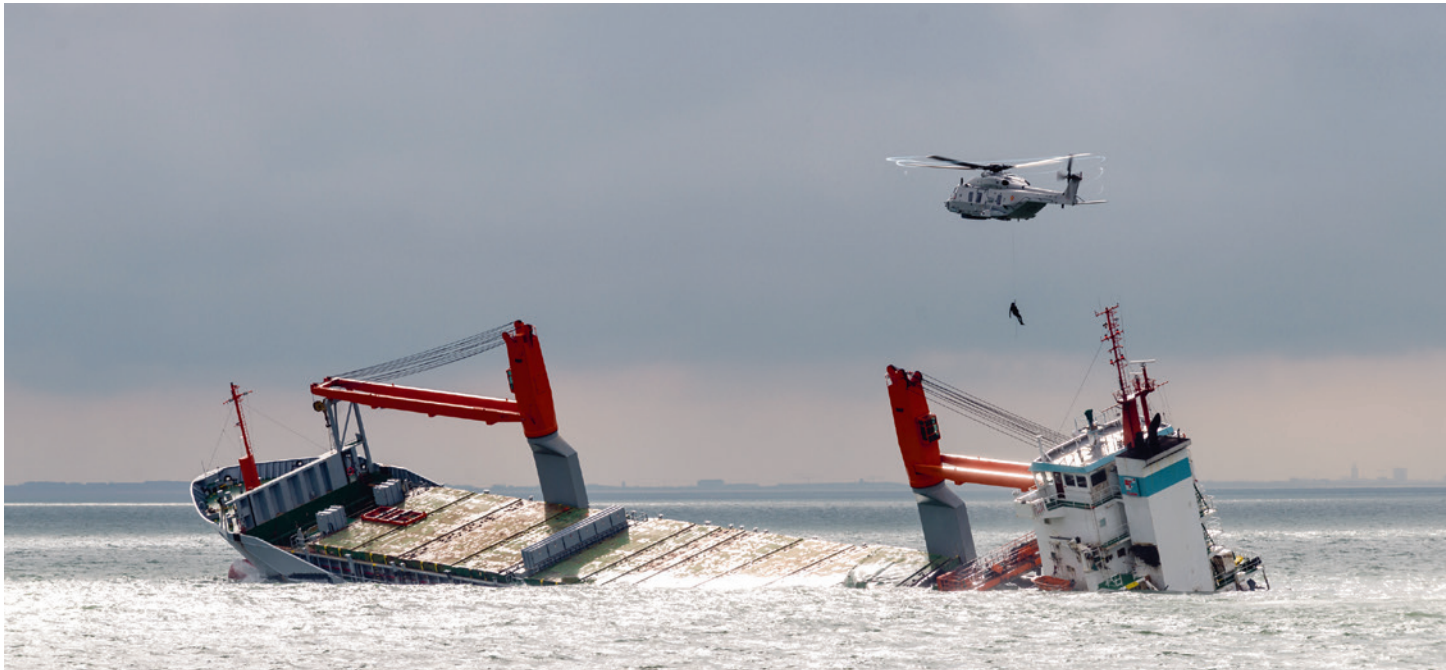
Securing the Voyage Data Recorder of the Flinterstar.

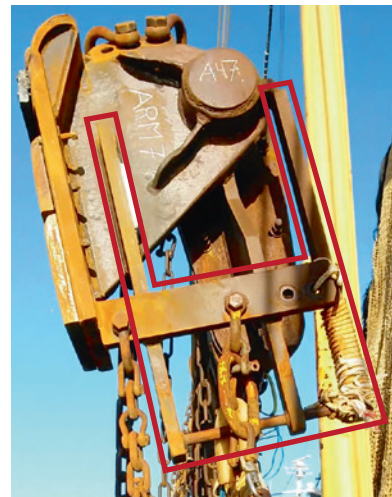
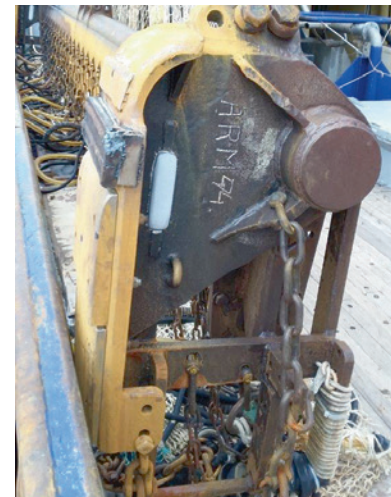
Cross-cut end of the pulse trawl on the port side of the deck, right: cross-cut end of the pulse trawl on the port side of the deck.

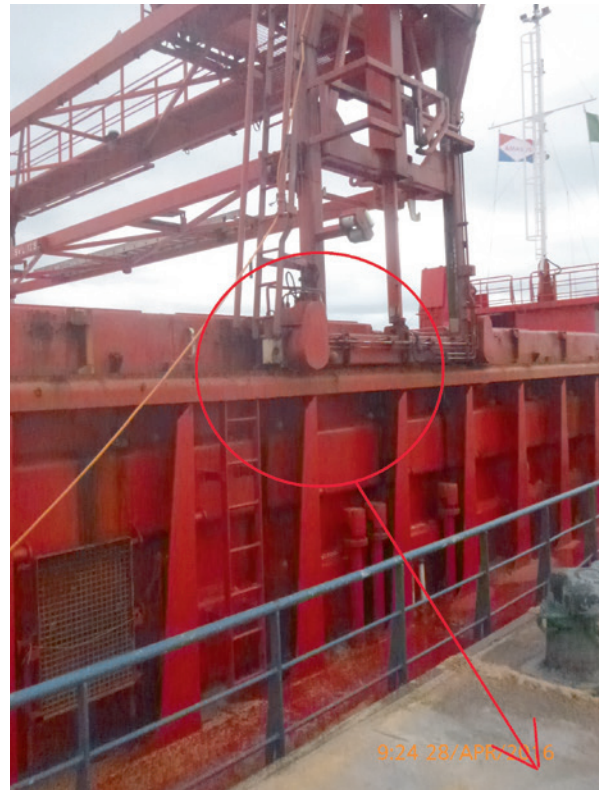
On 28 April, the first mate on board the Eems Dollard, a cargo ship sailing under the Dutch flag, broke his ankle in several places. While the ship was moored, he slipped on the first rung while climbing the ladder of the hatch crane. As a result, he lost his balance and tried to jump to the quay to avoid falling in the water. He managed it but the two and a half metre fall broke his heel. He was taken to hospital and will probably be out of action for five months.

The hatch crane of the Eems Dollard.

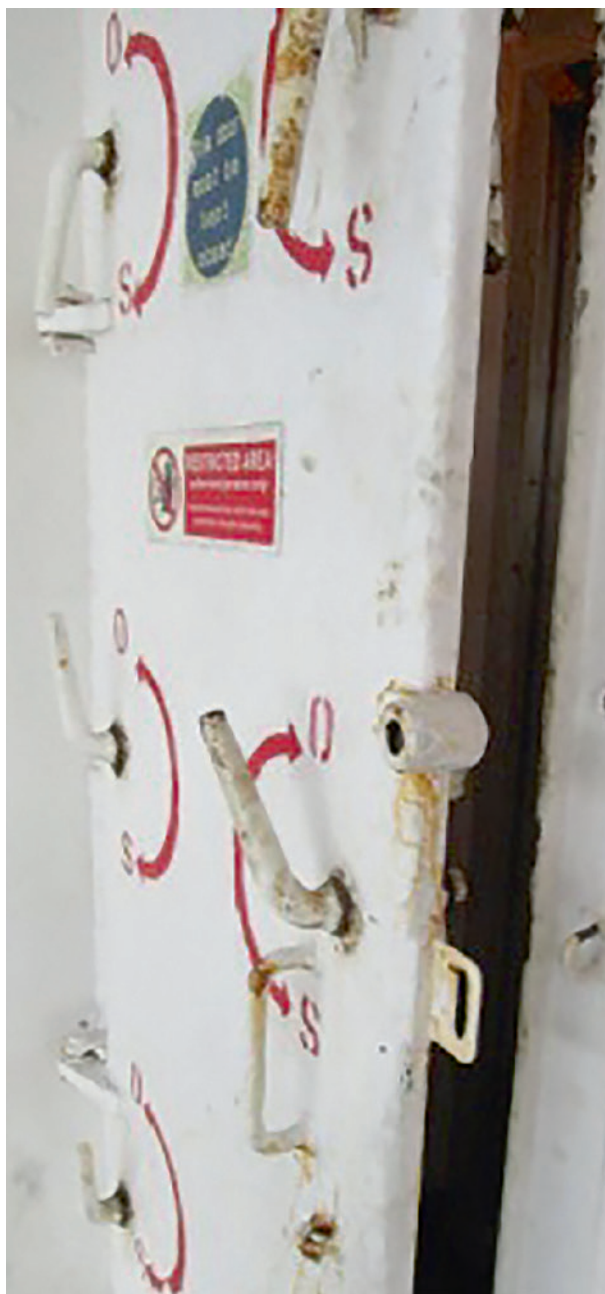
Door to accommodation.
(Photo: crew of the Chemical Distributor)
