DUTCH
SAFETY BOARD

Airproxes near Lelystad Airport

The Hague, February 2022

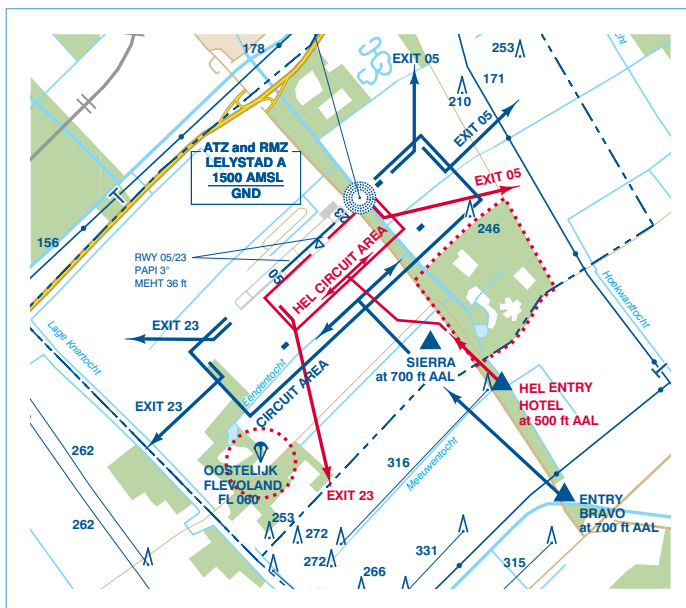
Lelystad Airport has one paved runway (05/23), which can be used in both directions for both departing and landing traffic. In the period before 7 November 2019, the airspace around Lelystad Airport was uncontrolled with classification G, up to 1,500 feet AMSL. There was one arrival route at 700 feet AAL via point BRAVO for fixed wing traffic. For helicopters there was a separate arrival route at 500 feet AAL via point Hotel. Departing traffic did not have to leave the area around the airport via a mandatory reporting point after take-off. See Figure 1. The circuit was on the south side of the runway.

Figure 1: The arrival and departure routes of Lelystad Airport before 7 November 2019.

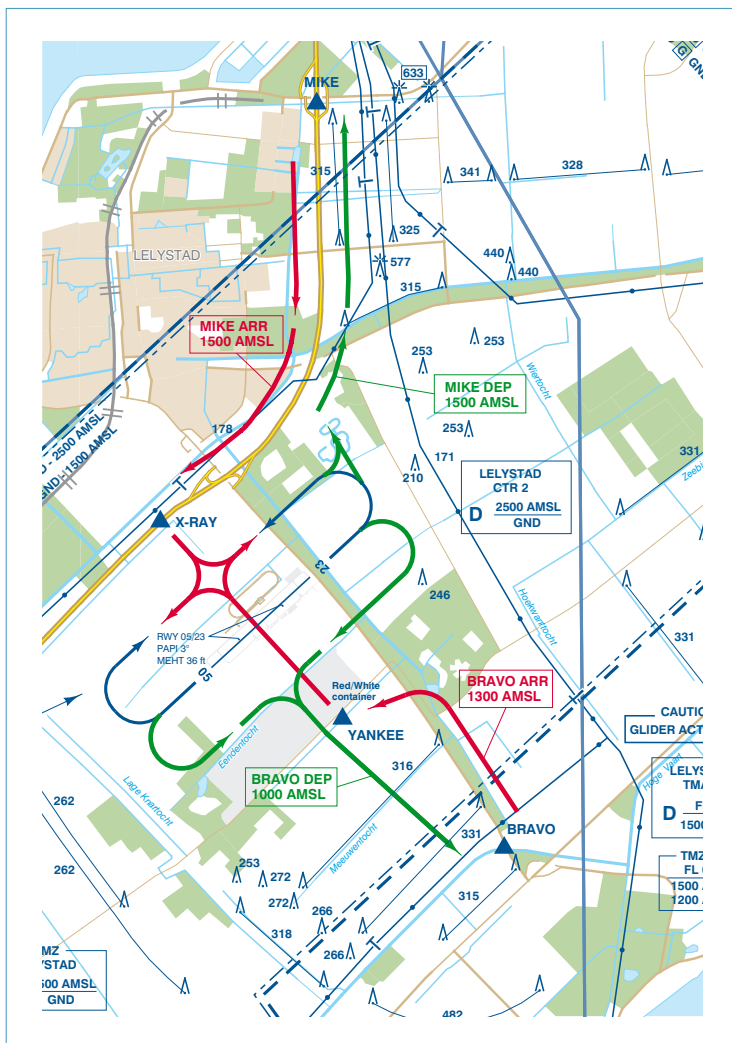
As of 7 November 2019, new departure and arrival routes run via the ('old') point BRAVO and via point MIKE (near Lelystad). The circuit was moved to the north side of the runway. As of this date, traffic arriving via MIKE starts the arrival route at 1,500 feet AMSL; traffic departing via MIKE has to climb to 1,500 feet AMSL. Traffic arriving via BRAVO starts the arrival route at 1,300 feet AMSL; traffic departing via BRAVO has to climb to 1,000 feet AMSL. See Figure 2.

Figure 2: VFR arrival and departure routes and VFR circuits as of 7 November 2019. (Source: AIP Netherlands)

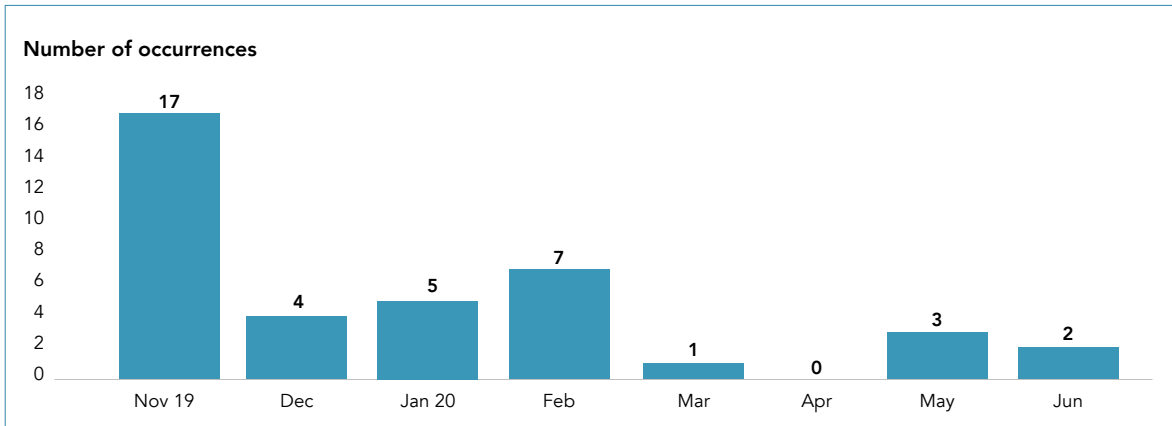
The data provided by the ILT was further narrowed down by only selecting airproxes and similar occurrences.⁵⁰ The resulting overview is presented in Figures 12 to 14. Figure 12 shows the progression of the number of airproxes that occurred between 7 November 2019 and 7 June 2020. Of the seventeen incidents in November, eight have been analysed in this report. The other nine have been classified as an incident (and were thus not reported to the Board). Of the number of airproxes that took place in December 2019, one happened before the implementation of measures on 7 December. Figure 13 shows the number of airproxes grouped by the location in the circuit area, where they took place. When only considering airproxes that occurred after the changes on 7 December, the location of the airproxes in the circuit area is distributed as depicted in Figure 14.

Figure 12: Number of airproxes that took place in the Lelystad CTR between 7 November 2019 and 7 June 2020. (Source: Dutch Safety Board, based on data provided by the ILT)⁵¹

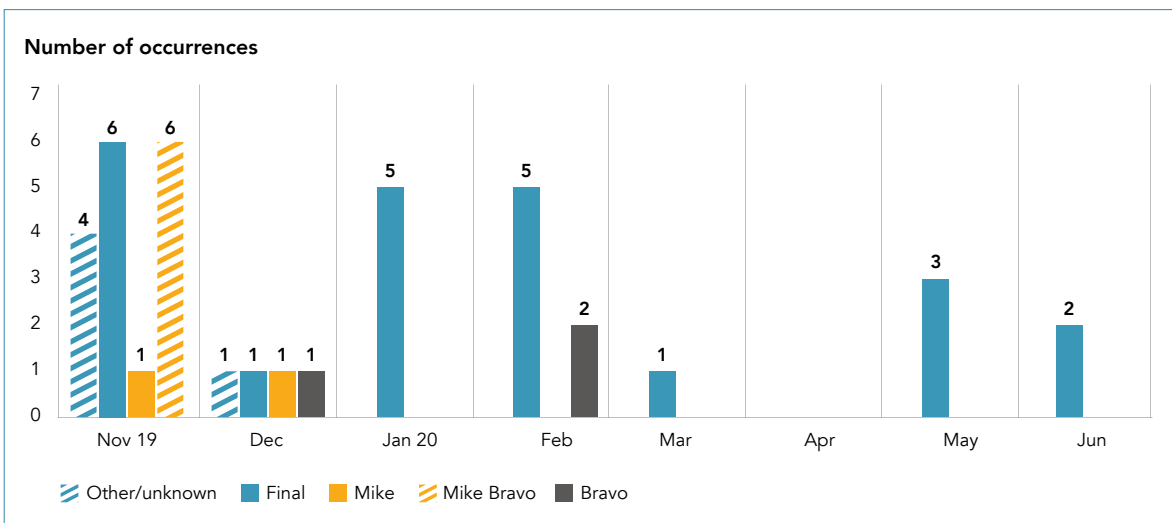
Figure 13: Number of airproxes grouped by location in the circuit area per month, between 7 November 2019 and 7 June 2020. (Source: Dutch Safety Board, based on data provided by the ILT)

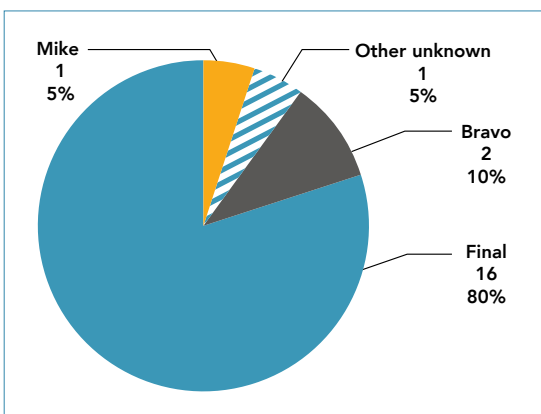
Figure 14: Location in the circuit area of airproxes between 7 December 2019 and 7 June 2020. (Source: Dutch Safety Board, based on data provided by the ILT)
