DUTCH  
SAFETY BOARD

# Loss of separation over Uitgeest

*The Hague, May 2013*

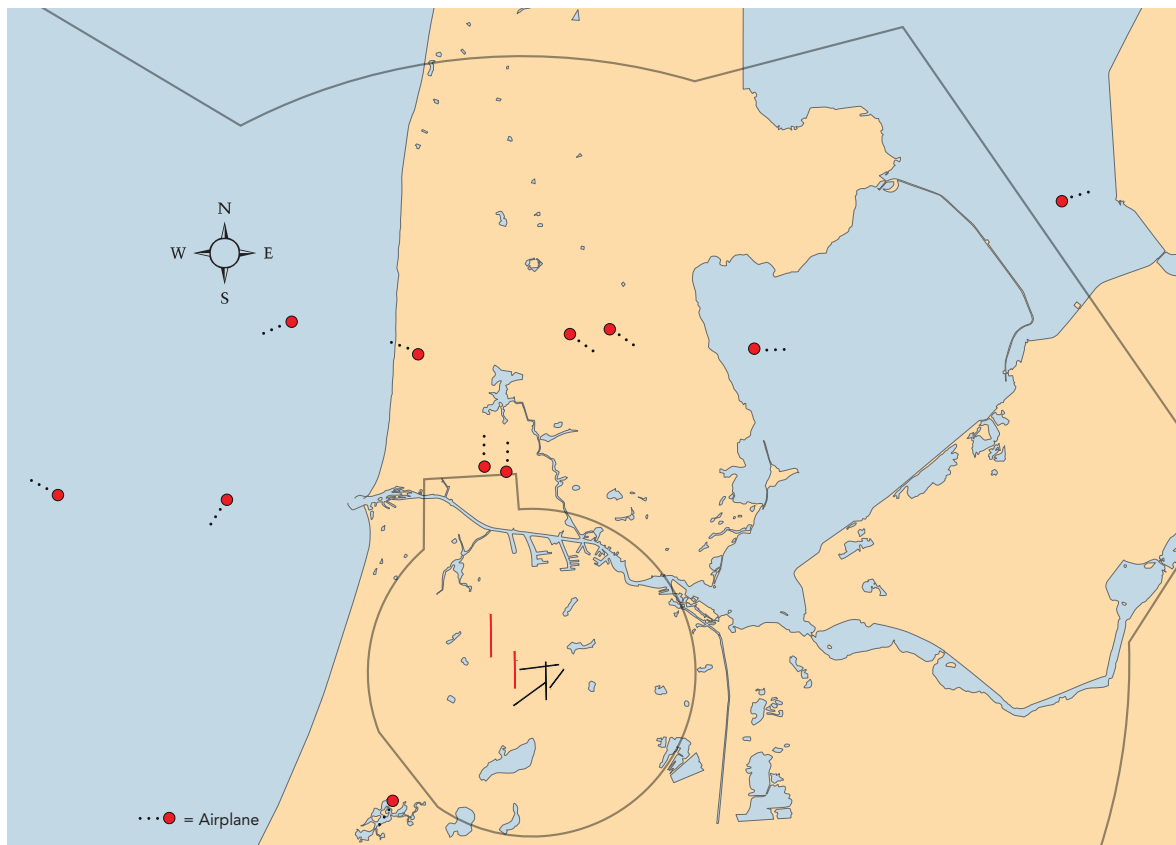
Figure 2: Example of a random morning rush hour for runways 18R and 18C (source LVNL)

At one point during the morning rush, there was a pause in traffic approaching from the west. The so called gap in traffic from the west eventually lasted for about 15 minutes. This gap in traffic from the west made it possible for the ATC controller responsible for the easterly traffic heading for runway 18C, to handle his traffic more efficient. By letting traffic descend to 2000 feet instead of 3000 feet before entering final approach, he hoped to establish a more fluent flow in traffic. Starting at 06.35:11, he let three aircraft fly the altered approach from 2000 feet for runway 18C.

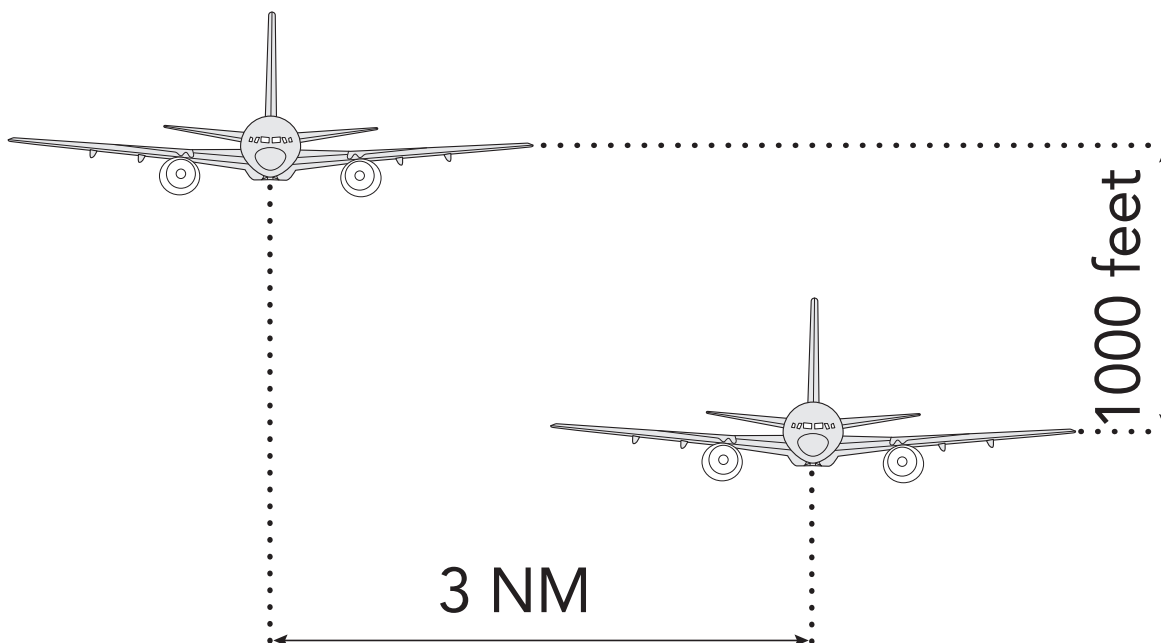
Figure 4: Minimum distance between aircraft, separation minima

When using parallel runways for landing, the minimum distance between aircraft in the approach is 3NM<sup>8</sup> (circa 5,5 km) horizontally or 1000 feet<sup>9</sup> (circa 305 m) vertically (figure 4).<sup>10</sup> Minimum separation is maintained until both aircraft in the approach intercept the final radial<sup>11</sup> to the runway, guiding them to the threshold.<sup>12</sup> LVNL has translated ICAO Document 4444 in their own procedure, written down in "Voorschriften Dienst Verkeersleiding" (VDV).

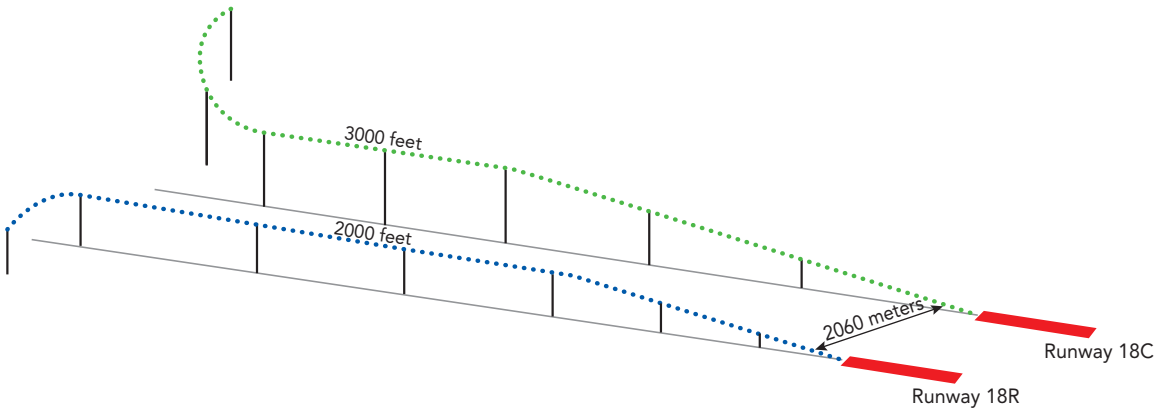
Figure 5: 3D image of approaches for both runways, note the runway offset

The distance between the centre lines of runways 18C and 18R at Schiphol is 2060 meter<sup>13</sup> (1.28 NM). This means that the altitude difference of 1000 feet is needed at all times since a horizontal separation of 3 NM (circa 5,5 km) is not possible when conduction simultaneous parallel approaches. Traffic approaching from the west shall normally be at 2000 feet, traffic from the east at 3000 feet, before starting the approach. The extra 1000 feet for the approach to runway 18C will be lost in the longer distance between the beginning of the final approach and the runway threshold.

Given the fact that both runways are not precisely next to each other, and distances between the beginning of final approach and threshold vary, traffic will fly opposite with an altitude difference of 1000 feet before commencing their turn to final.

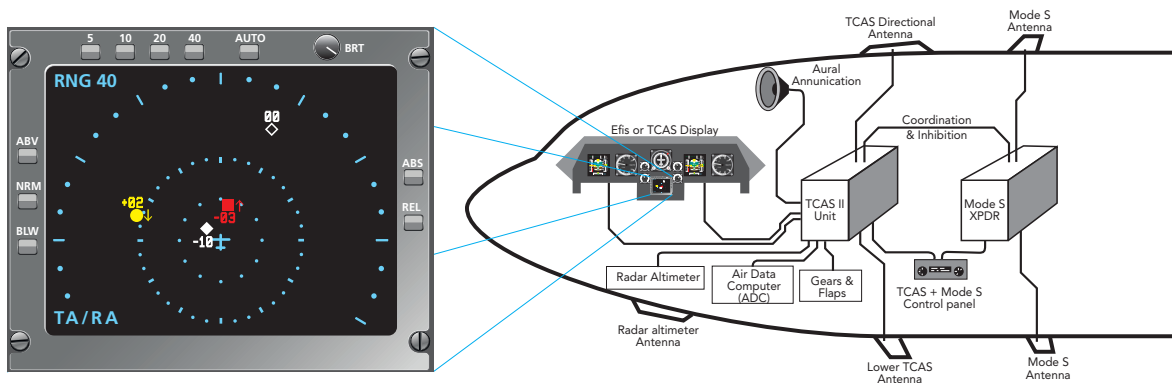
Figure 8: Schematic working of the system<sup>14</sup>

The crew of both aircraft were given two TCAS 'traffic advisory'-warnings (figure 8). Crews were prepared to take the necessary actions if needed (evasive manoeuvre in case of 'resolution advisory'). Until the moment of the first TA warning, both crews were following ATC instructions.
