**Explosion on board a two mast clipper,
Medemblik, 8 June 2006**

The Hague, August 2007 (M2006SV0608-02)

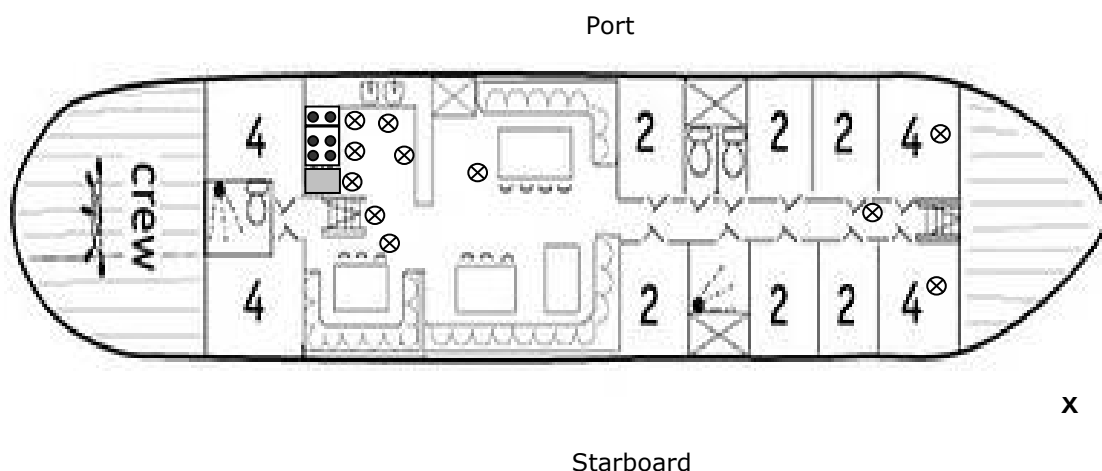
Figure 4: *Top-down view, showing the position of the pupils*

- *The circles with crosses in them indicate the positions of the pupils who were on board the ship when the explosion occurred.*
