DUTCH  
SAFETY BOARD

# Crash NH90 helicopter, Aruba, 19 July 2020

## Findings initial investigation

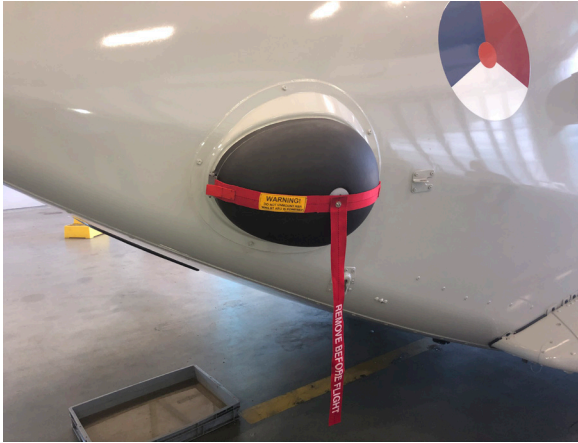
Figure 3, left: Position of the RBA on the outside of the reference aircraft. (Source: Dutch Safety Board)  
Figure 4, right: The RBA upon transfer at the Parera Naval Base. (Source: Dutch Safety Board)

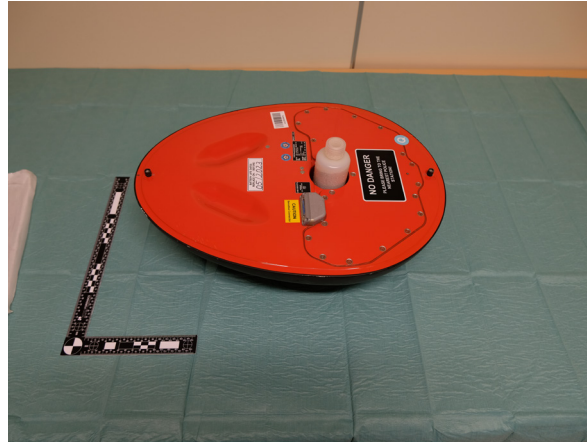
The NH90 is equipped with a Voice and Flight Data Recorder (VFDR) on which the last two hours of voice and last ten hours of flight data are recorded. The data is stored on a Crash Survivable Memory Unit (CSMU) located in the aircraft. The aircraft was also equipped with an external recorder. This Recorder Beacon Airfoil (RBA) also has a VFDR memory unit and is fitted with two Emergency Locator Transmitters (ELT), which transmit on the frequencies 121.5 MHz / 243.0 MHz and 406.028 MHz. The RBA is designed to release under high g-forces or if immersed in water. Following the ditching in the water, the RBA broke free from the aircraft and started transmitting the emergency signal. The emergency signal was also received at the coastguard centre in Den Helder. Assisted by the crew of HNLMS Groningen, the Coastguard helicopter and the Coastguard aircraft (both stationed on Curaçao), eventually located the RBA the next morning.
