# Crew member overboard while disconnecting container lashings

MS Freya, Humber, 3 September 2014

*The Hague, November 2015*

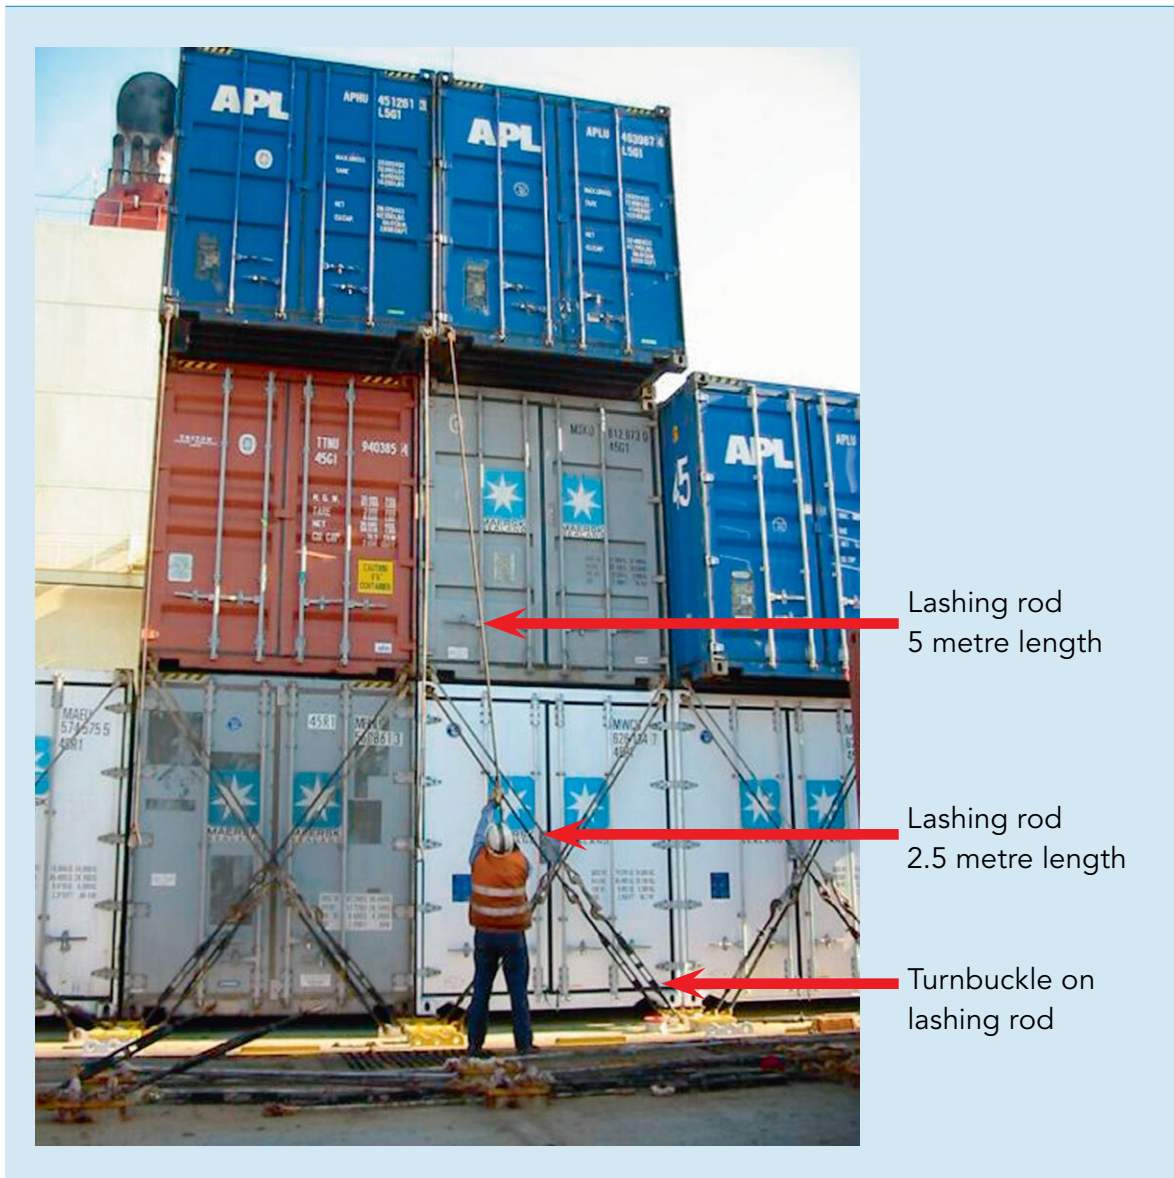
It is extremely important for the seaworthiness of seagoing vessels that manual securing, better known as lashing, is used to prevent cargo from shifting. On board container ships containers are lashed on deck using prescribed lashing equipment, including lashing rods. A lashing rod is a long metal rod with a hook on two sides. A turnbuckle is attached on the deck side of the rod to secure the iron rod to the deck. Lashing rods can be of varying lengths, depending on the number of containers being lashed. A lashing rod for one container is usually two and a half metres in length, with a lashing rod for two containers quickly reaching five metres in length (see figure 1). A lashing rod of two and a half metres weighs an average of 12 kilos. A five-metre lashing rod weighs an average of 21 kilos. Securing and disconnecting lashings is heavy physical work.

Figure 1: Stevedore secures a 5-metre-long lashing rod. (Source: [www.portpictures.nl](http://www.portpictures.nl) - Danny Cornelissen)

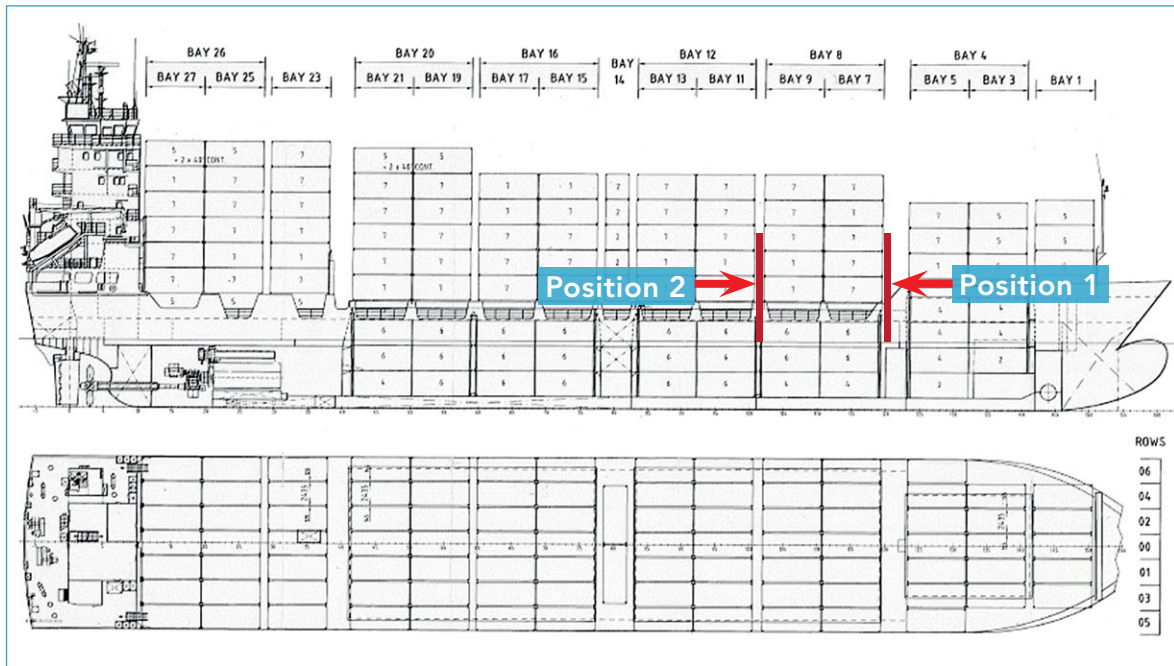
At 20:28 hours, Freya arrived at the pilot station and the pilot vessel brought the pilot on board. On arrival on the bridge (at 20:33 hours) the pilot warned the captain that large vessels were expected to depart on the river in the Immingham docks area, which would mean reducing speed on entering Bull channel.<sup>9</sup> In the meantime the two seamen on the forecastle had finished their preparations for arrival and started disconnecting the lashing rods. Seaman 1 started at position 1 and seaman 2 at position 2 (see figure 2).

Figure 2: Schematic drawing of MS Freya. (Source: Holwerda Shipmanagement B.V.)
