DUTCH
SAFETY BOARD

Engine failure during initial climb, Boeing 747-412BCF, Meerssen

The Hague, April 2023

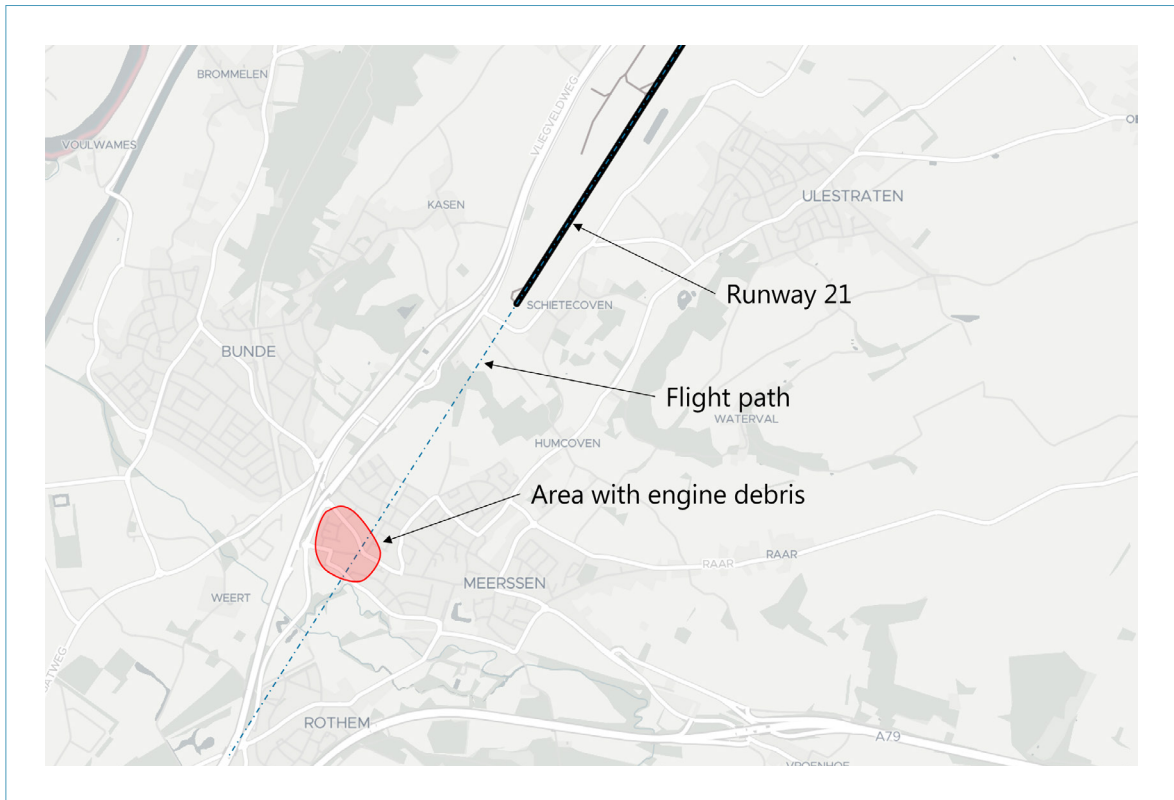
The aeroplane lost metal parts over residential areas of the village of Meerssen (see Figure 5), causing damage to cars (see Figure 6) and houses. Parts were collected and identified as turbine fragments of the number 1 engine (see Figure 7).¹³ Examination of

these parts revealed that some were of considerable size¹⁴ and weight and thus posed a hazard to people on the ground and their property.

Figure 5: Map showing the area in which most damage occurred. (Source: OpenStreetMap, modified by Dutch Safety Board)

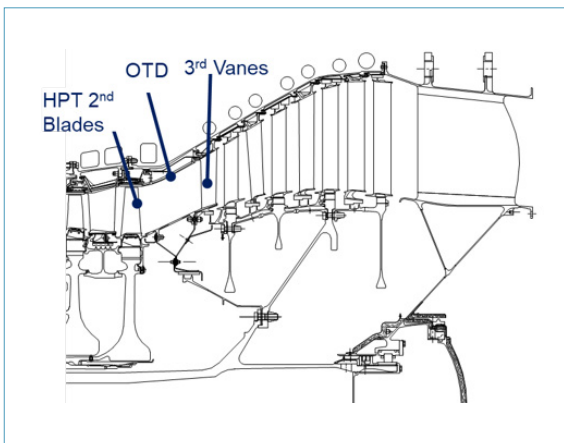
The boroscope inspections revealed various damages within the high pressure turbine (HPT) and low pressure turbine (LPT) (see Figure 9). The HPT showed damage to the trailing edge of second stage blades. Two outer transition ducts (see Figure 10) had come loose and displaced in the flow path of the LPT (see Figure 11). Multiple third stage vanes (first stage of the LPT) were missing and damaged. The last two stages of the LPT were missing turbine blades and vanes. Pratt & Whitney stated that the damage was consistent with other outer transition ducts that had separated in the past (see Section 2.12.2).

Figure 10: Cross-section view of HPT/LPT transition area. (Source: Pratt & Whitney)

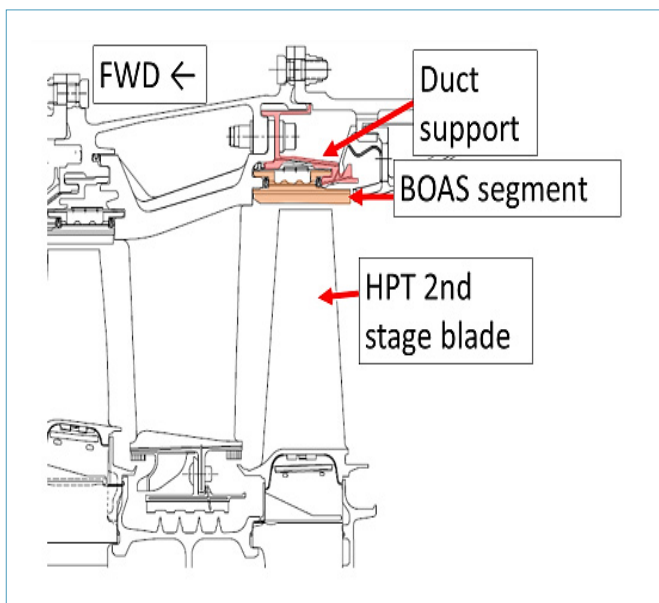
Pratt & Whitney performed a metallurgical investigation of the HPT second stage blade outer air seals (BOAS) and duct supports and made a report of the findings.⁵⁴ The main findings are listed below.

Figure 18: BOAS segment and HPT second stage blade. (Source: Pratt & Whitney)

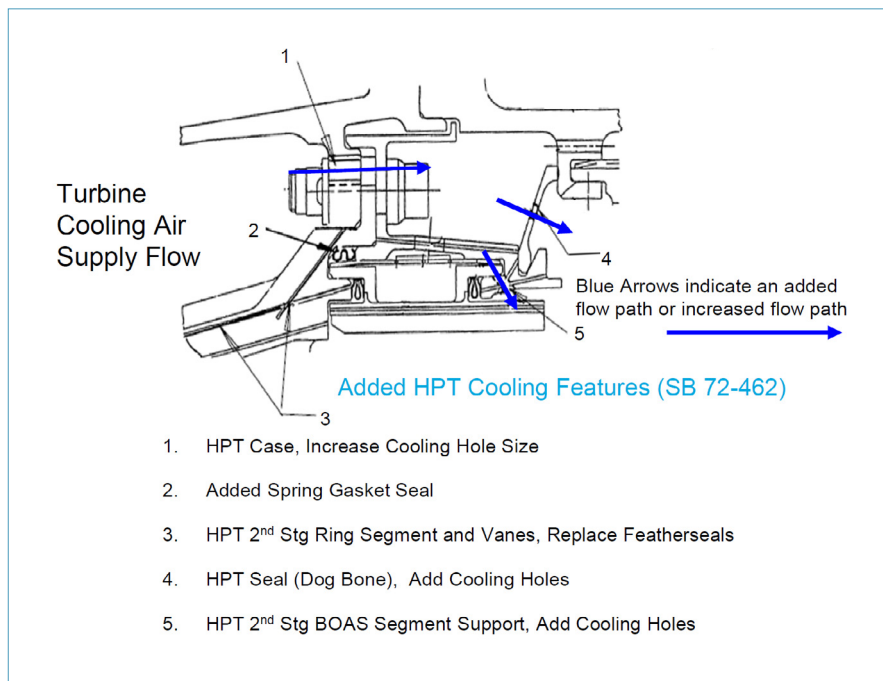
SB 72-462 was introduced on 18 March 1993 because the second stage HPT duct segments have had the ceramic coating deteriorate in high time service engines. To improve the durability of these segments, additional air is required to cool the segments. Modifications to the HPT case, duct supports, and second stage HPT 'dog bone' seal provide the additional air required to cool the second stage duct segments.

Figure 19: Added HPT cooling features (SB 72-462). (Source: Pratt & Whitney)

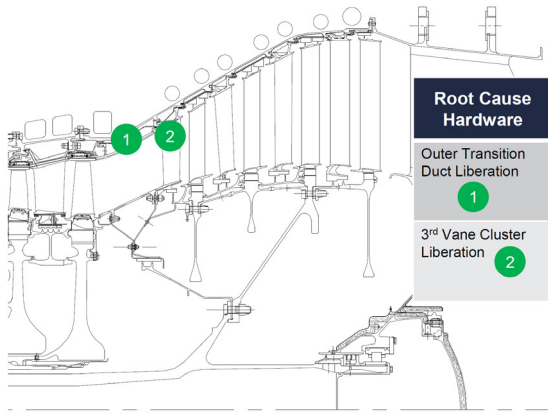
DURABILITY ENHANCEMENTS FOR REDUCED OTD EVENTS

AD'S REQUIRE UPCHANGE OTD AND INSPECTIONS ON LPT CASE & 3RD VANE

| Root Cause Hardware | Fleet Management Plans | Date |
|---|--|---|
| Outer Transition Duct Liberation 1 | New design introduced via SB 72-488, allow mix (Cat 8) New design introduced via SB 72-488, no mix (Cat 6) AD 2012-22-16 issued | Oct 1993 Aug 2009 Dec 2012 |

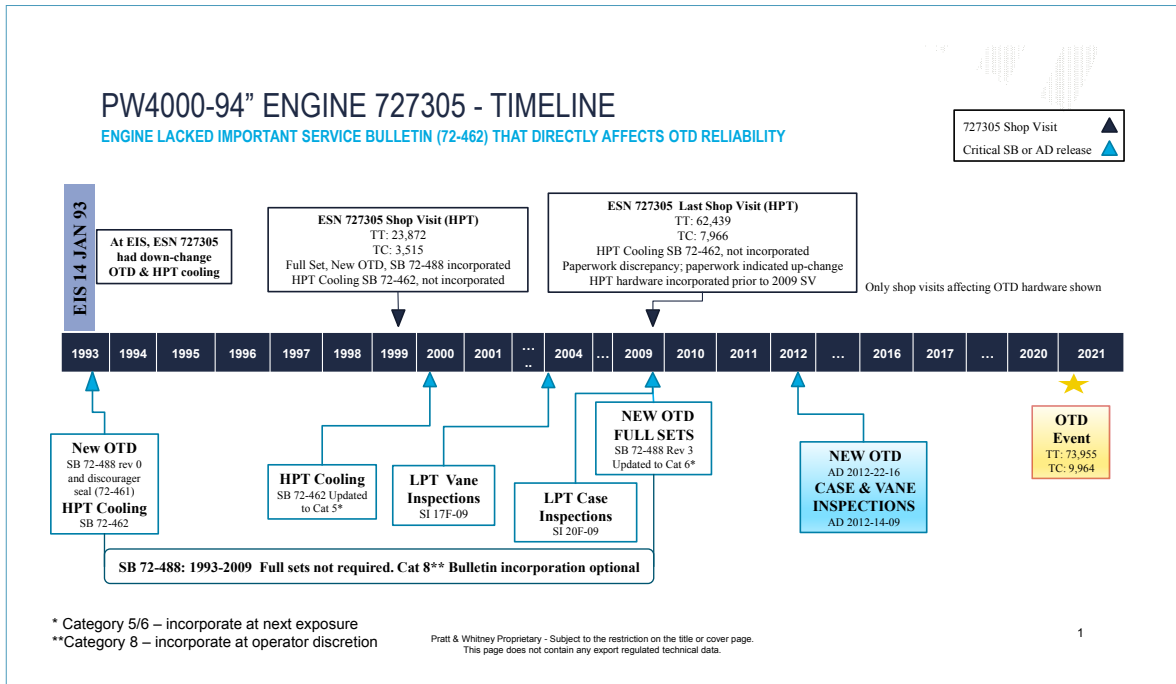
Figure 21: Time line PW4000-94" engine with serial number 727305. (Source: Pratt & Whitney)

In Figure 21, the box of the last shop visit mentions that there was paperwork discrepancy, indicating that ESN 727305 already had up-change components. The discrepancy referred to the part number for the dog bone seal of the HPT. The Dutch Safety Board did not investigate if and to which degree this discrepancy may have influenced decision-making by previous owners/operators about whether or not to embody SB 72-462 (as replacement of the dog bone seal is part of this service bulletin).
