Entrapment by hatch cranes

Extended investigation after
fatal entrapment on cargo ship

The Hague, July 2022

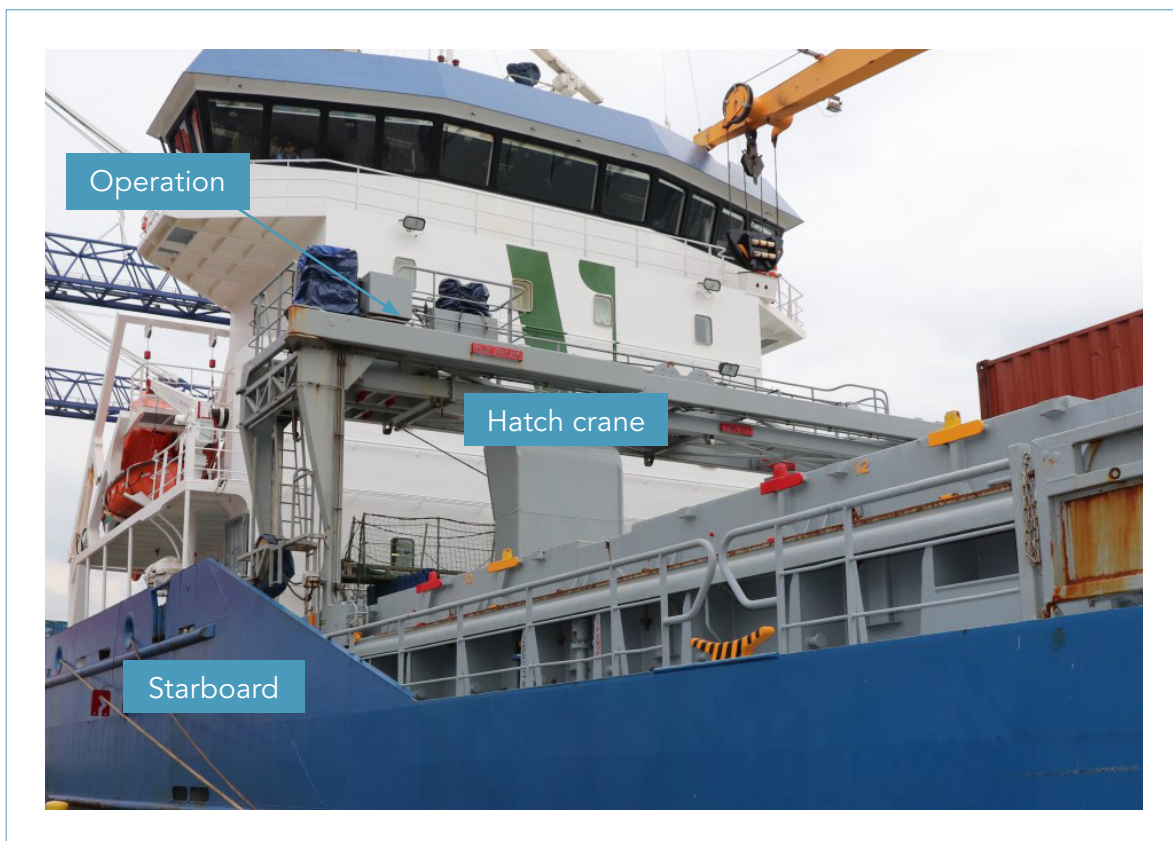
In the morning of 30 June 2018, in the port of St. Marc, Haiti, there was a fatal occurrence on board the Beauforce. A crew member of the Dutch merchant vessel got trapped between the moving hatch crane and the stacked hatches when he stepped from the hold entrance amidships onto the deck. At that time, the hatch crane was used to close the hatches of hold number 1.

Figure 1: Hatch crane in home position, seen from the shore (starboard).

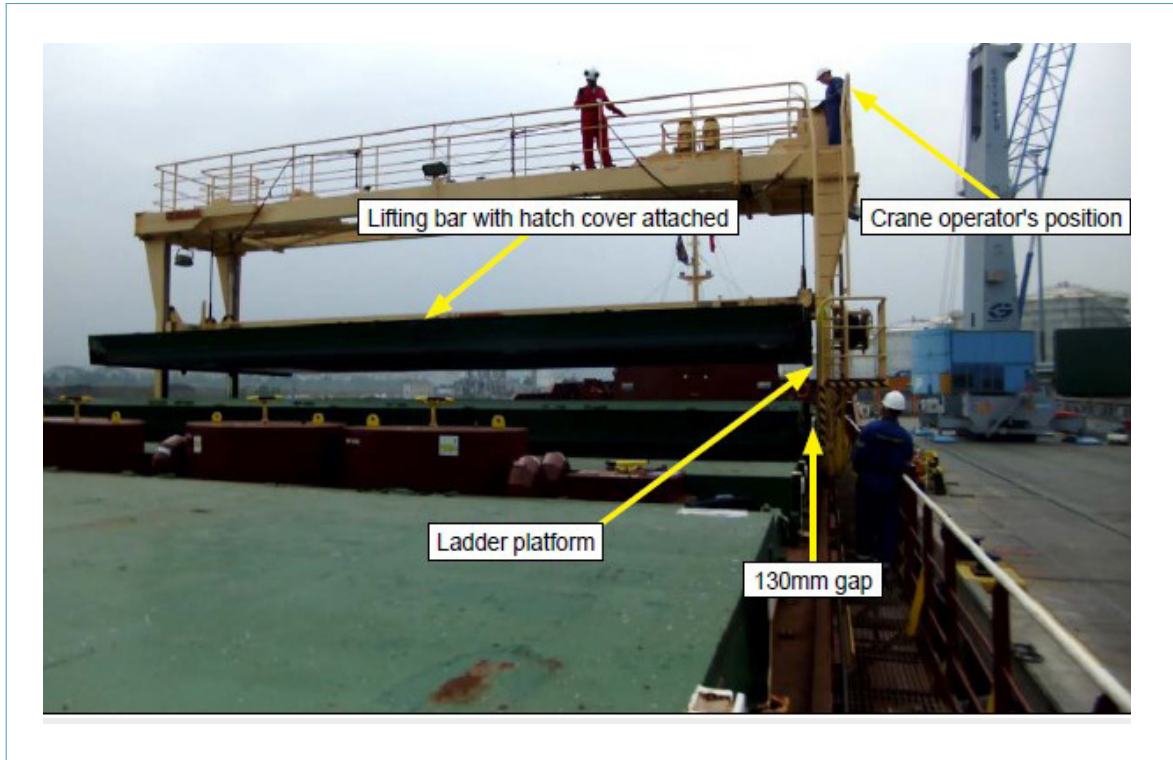
On 24 May 2019, a crew member on board of the cargo vessel Karina C in the port of Seville, Spain, got entrapped between a stack of hatches and the moving hatch crane. Earlier that day, the ship's agent had told the captain at 09.00 hours that the time of departure had been brought forward from 14.00 hours to 11.30 hours on that same day. At that time, the hatch crane was used to close the hatches.

Figure 15: Hatch crane viewed from the stern of the ship. (Source: MAIB)

After it became clear that the vessel had to depart earlier, the later victim went on deck to sweep up cement dust. This took place simultaneously with hatch crane operations. Shortly before the occurrence, the operator stopped the hatch crane near a stack of hatches at the same time the later victim was also there. The later victim then climbed on the hatchway coaming in order to step between the hatch crane and the stack of hatches. The crane operator did not notice this. At the same time the victim moved between the hatch crane and the stack of hatches, the operator started moving the hatch crane which caused the victim to become entrapped (see figure 16 and 17 for the MAIB reconstruction). The victim died of his injuries.

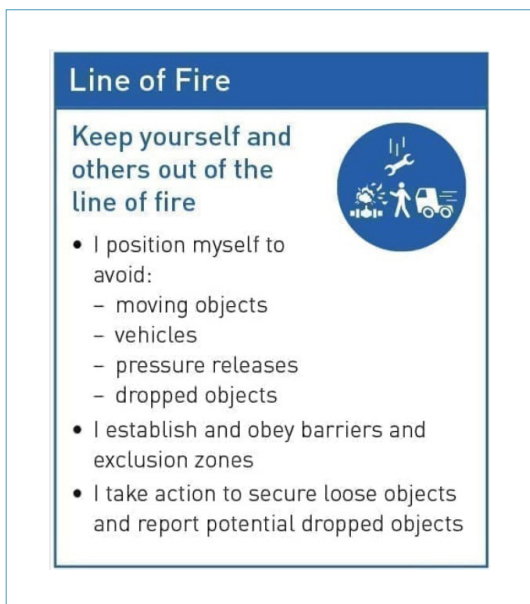
In various sectors, such as the petrochemical industry, *Life Saving Rules* were drawn up. These consist of a small number of rules that apply to everyone as they are considered to be essential for personal safety. The International Association of Oil & Gas Producers has designated 'Line of Fire' as *Life Saving Rule* (see figure 19). Also other sectors, such as construction, have adopted (a variant of) this *life saving rule*.

It appears that various other sectors consider the risk of being in the 'line of fire' to be unacceptable and recognise that risks are difficult to control when people are in the 'line of fire'. People working in the 'line of fire' are dependent on their own vigilance. An erroneous assessment can have fatal consequences for someone working in a danger zone such as the *snap-back zone* or the path of work traffic or a hatch crane. By prohibiting work to be carried out in the 'line of fire', this risk will be eliminated.

Figure 19: Life Saving Rule 'Line of Fire' as drawn up by IOGP. (Source: IOGP)
