# Fatal accident in cargo tank of chemical tanker

Lessons learned from the occurrence on  
board the NCC SAFA

*The Hague, July 2023*

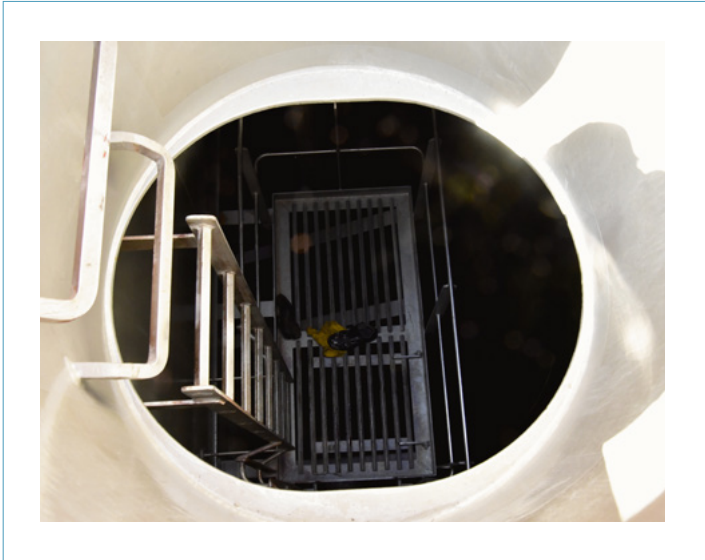
Figure 2: Top view of tank with view of the first platform.

The captain reached the tank opening and looked in from above. He saw the AB lying on the second platform in the tank and immediately sounded the alarm. The rescue team, made up of crew members from the vessel, immediately entered the tank equipped with the appropriate rescue gear. The AB was carried onto the deck by the rescue team, where oxygen was administered. He was subsequently transported to hospital in Alkmaar (NL) by SAR helicopter. On arrival, he was admitted to intensive care with serious injuries.

The first officer was discovered at the bottom of the tank on the fourth and final platform, from where he was carried to the ship's deck by the rescue team. Investigation revealed that the first officer had probably entered the tank after the AB and, just like the AB, had become unwell due to a lack of oxygen. As a result, he fell into the 18-metre-deep tank. As a result of the fall, he suffered such severe injuries that the attempts to resuscitate him, on location, proved unsuccessful.

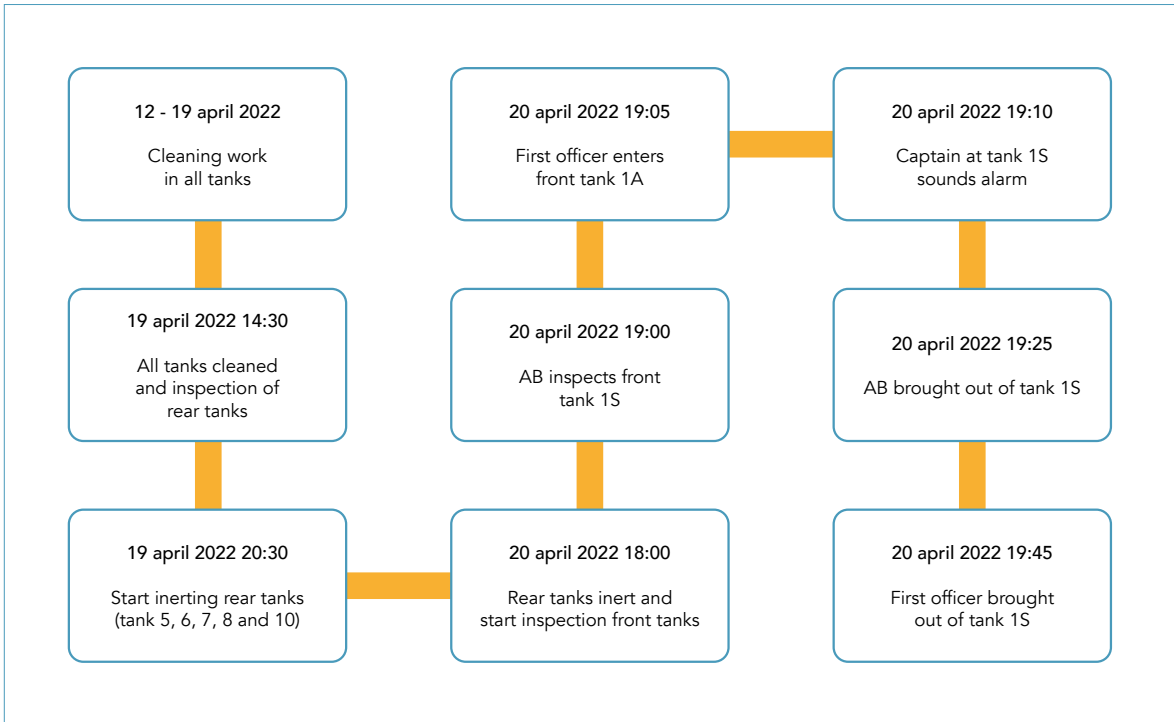
Figure 4: Timetable for the course of the incident.

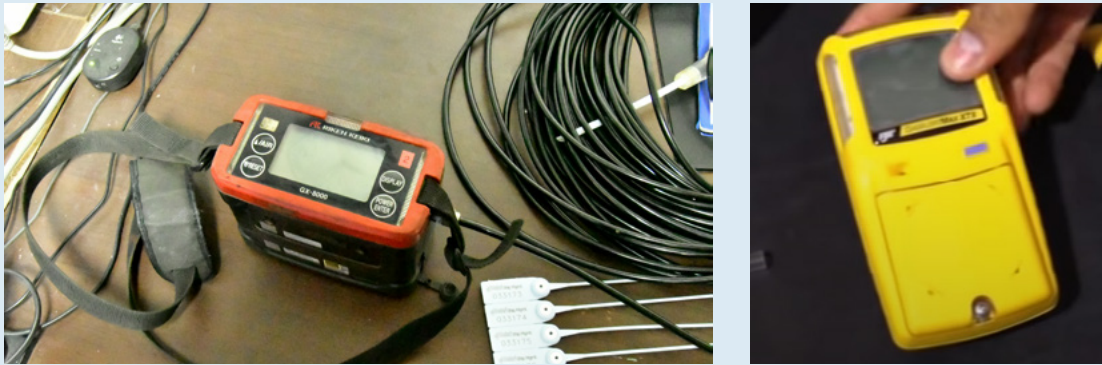
Figure 8: photograph left multi gas meter, photograph right personal combined gas meter.

When entering the tank, the AB was wearing his personal protective equipment including a helmet, safety glasses, overalls, gloves and safety shoes. The AB was carrying a torch and walkie-talkie. He did not carry a personal gas meter because wearing a gas meter was not considered necessary in this case, as the tanks had already been measured for safe cleaning on 18 April, two days before the incident. However, standard procedure requires the tank to be measured before and during entry by the first officer or the boatswain. During the measurements on 18 April, other crew members had been able to enter the tank without problem. At that time, the entire procedure had been completed in accordance with the agreements, and an Entry Permit had been issued valid from 18 April 18.30 hours, for a maximum of 8 hours.

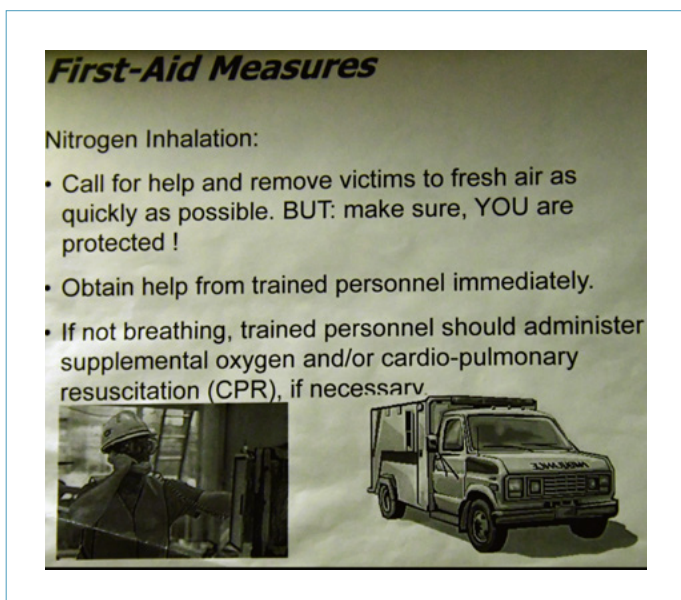
Posters containing safety rules and information are placed at various locations on board the vessel. In several interviews, the crew indicated that they were aware of the safety rules and agreements on entering enclosed spaces. Familiarization had been performed with the crew members and they all had a signed familiarization form.

Figure 9: Example of safety information on board the NCC SAFA.

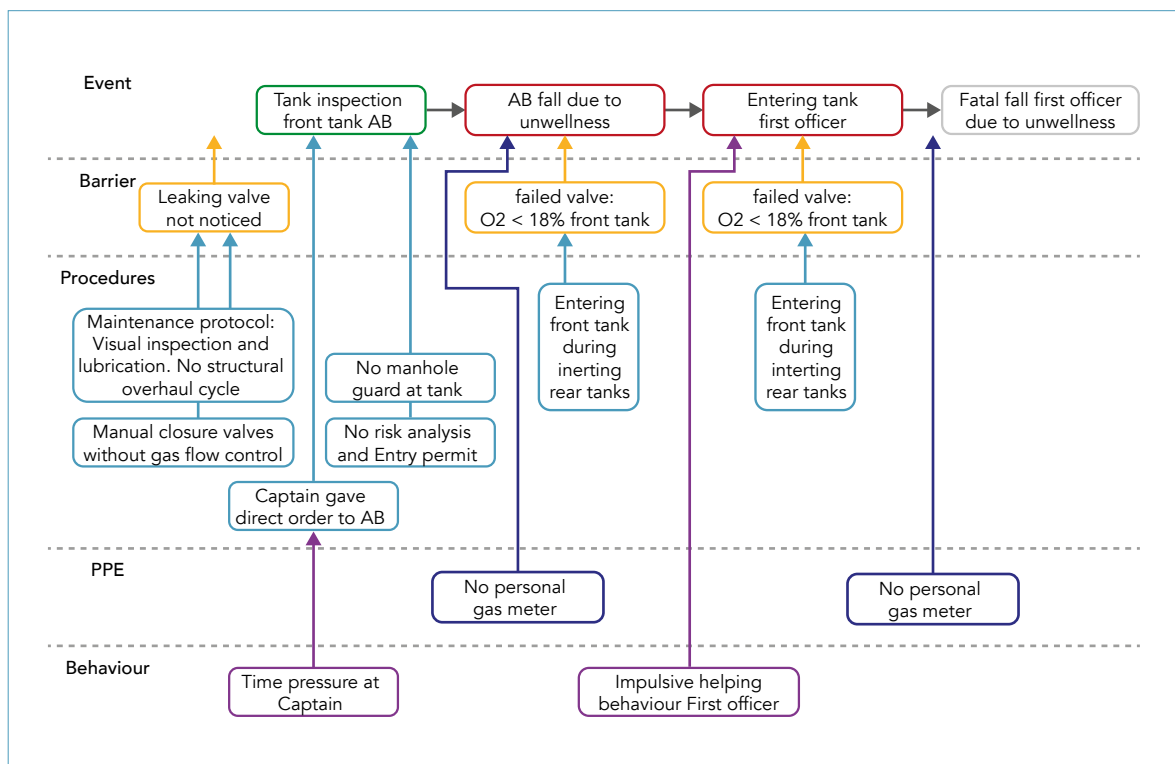
The occurrence involved an inert gas system with only a single valve forming a hard safety barrier, a situation that is in principle unsafe and insufficient. This, in combination with the sense of time pressure and incorrect assumptions based on a previously issued Entry Permit that led the crew to not follow the procedures, made it possible for this occurrence, involving both the AB and the first officer, to take place.

Figure 10: Diagrammatic representation of the cause and underlying factors.

The investigation reveals that the three causes identified by RIVM, as mentioned in chapter 3, also played a role in the incident on board the NCC SAFA. A leaking valve allowed nitrogen to enter tank 1S while inerting the aft cargo tanks on board. As a consequence the oxygen level in the tank 1S also fell. Despite being aware of the safety rules and the safety information available on board, the procedures were deviated from. The order to inspect the forward tanks was given without fulfilling the conditions. Prior to the inspection of tank 1S by the AB, no risk analysis and accompanying gas measurements were carried out, and no Entry Permit was issued. Moreover, although both the AB and the first officer were wearing their helmet, overall and safety shoes, neither was carrying a personal gas meter when they entered the tank.
