DUTCH  
SAFETY BOARD

# Fatal fire in a block of flats in Arnhem

Lessons for fire safety

*The Hague, September 2021*

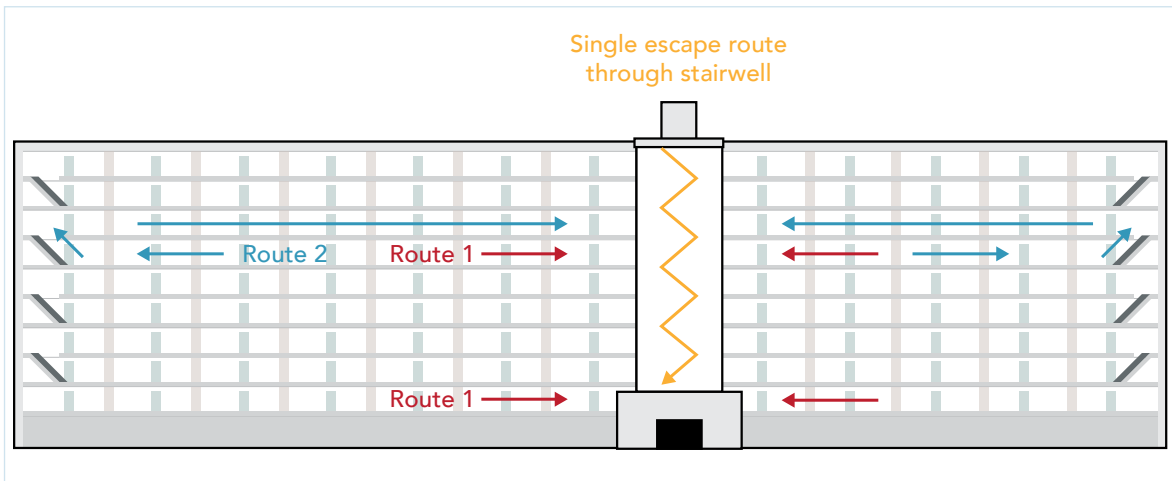
Figure 3: Escape routes from the block of flats.

The primary escape route from the flats on all floors passed via the gallery, through the gallery hall, the lift hall, the central stairwell and eventually via the entrance hall outside. From the flats on the 2nd through to the 9th floor, it was also possible to reach the central stairwell via a second route. This was made possible by the presence of emergency stairs at each end of the galleries on those floors, each of which linked two galleries together. This meant that from the flats on those floors, it was possible to escape to the central stairwell, via two different routes. The first route travelled via the gallery on the floor where the flat was located directly to the central stairwell. The second travelled along this gallery to the emergency stairs at the end of the gallery, and subsequently via the gallery to the floor above or below, back to the central stairwell. The gallery on the first floor had no emergency stairs at the end, so that from the flats on that floor, the only way to escape was directly to the central stairwell. The escape routes are shown in figure 3 below.

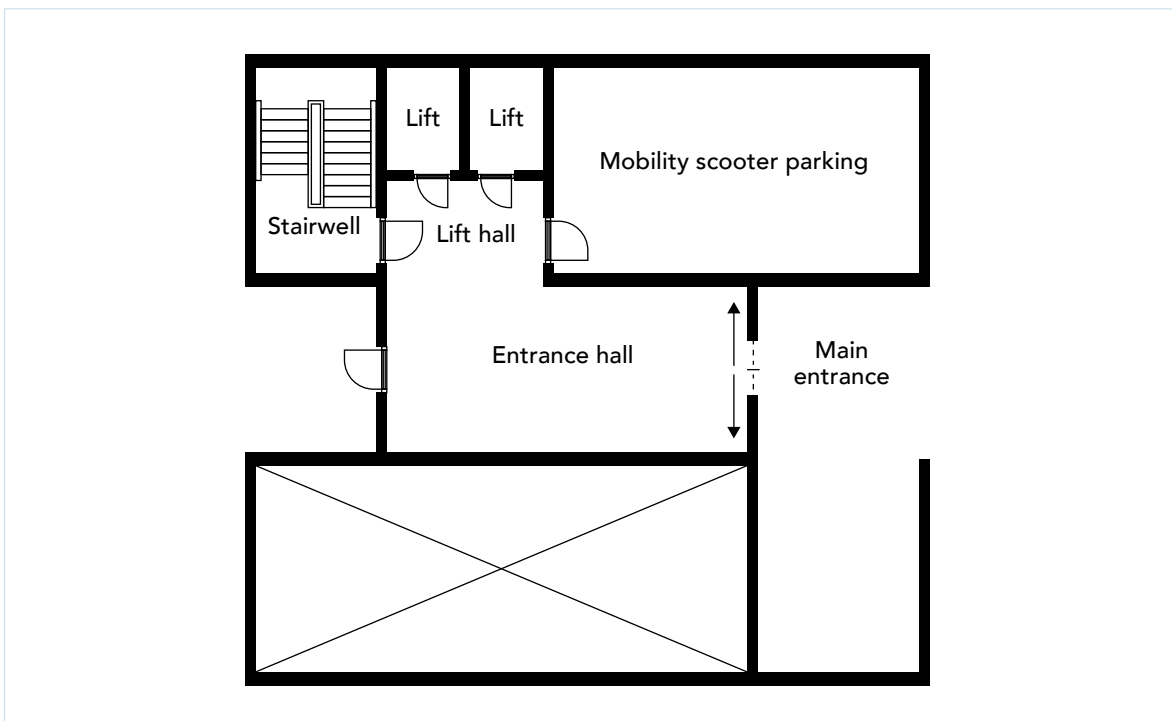
Figure 4: Schematic floor plan of the entrance hall to the block of flats.

The entrance hall was located centrally in the block of flats. The entrance hall featured a main entrance, used regularly by residents and visitors to enter the building. There was a second entrance/exit at the rear. The entrance hall was 8 metres deep and 'L' shaped. The short leg of the 'L' was the lift hall. It should be noted that this was not separated from the rest of the entrance hall. Entrance hall and lift hall together had a floor area of 37 m<sup>2</sup>. Figure 4 below shows a floor plan of the entrance hall.

There were four doors in the lift hall: two metal lift doors with small round windows, one windowless door to the mobility scooter parking and a fourth door fitted with a Lexan panel<sup>11</sup> to the stairwell.

The lift section of the entrance hall featured two entrance doors to the lift (see figure 4) side by side. The left-hand lift served the uneven floors (1-3-5-7-9); the right-hand lift served the even-numbered floors (2-4-6-8). Both lifts stopped on the ground floor. Both lifts were fitted with manually operated landing doors, opening outwards. The landing doors could only be opened if the lift cage was present on the floor in question. If the lift cage was not present, the lift landing door was blocked. In addition, both lift cages were fitted with an automatic sliding door in the cage entrance, also referred to as the cage door. When the lift was (stationary) at a floor or on the ground floor, this sliding door was open. In other words, in this situation, people could walk from inside the lift by pushing the landing door open, and enter the lift by pulling the door open. The lifts were not fitted with an automatic return setting to the ground floor. A parked lift remained parked on the floor where it was left by the last user.

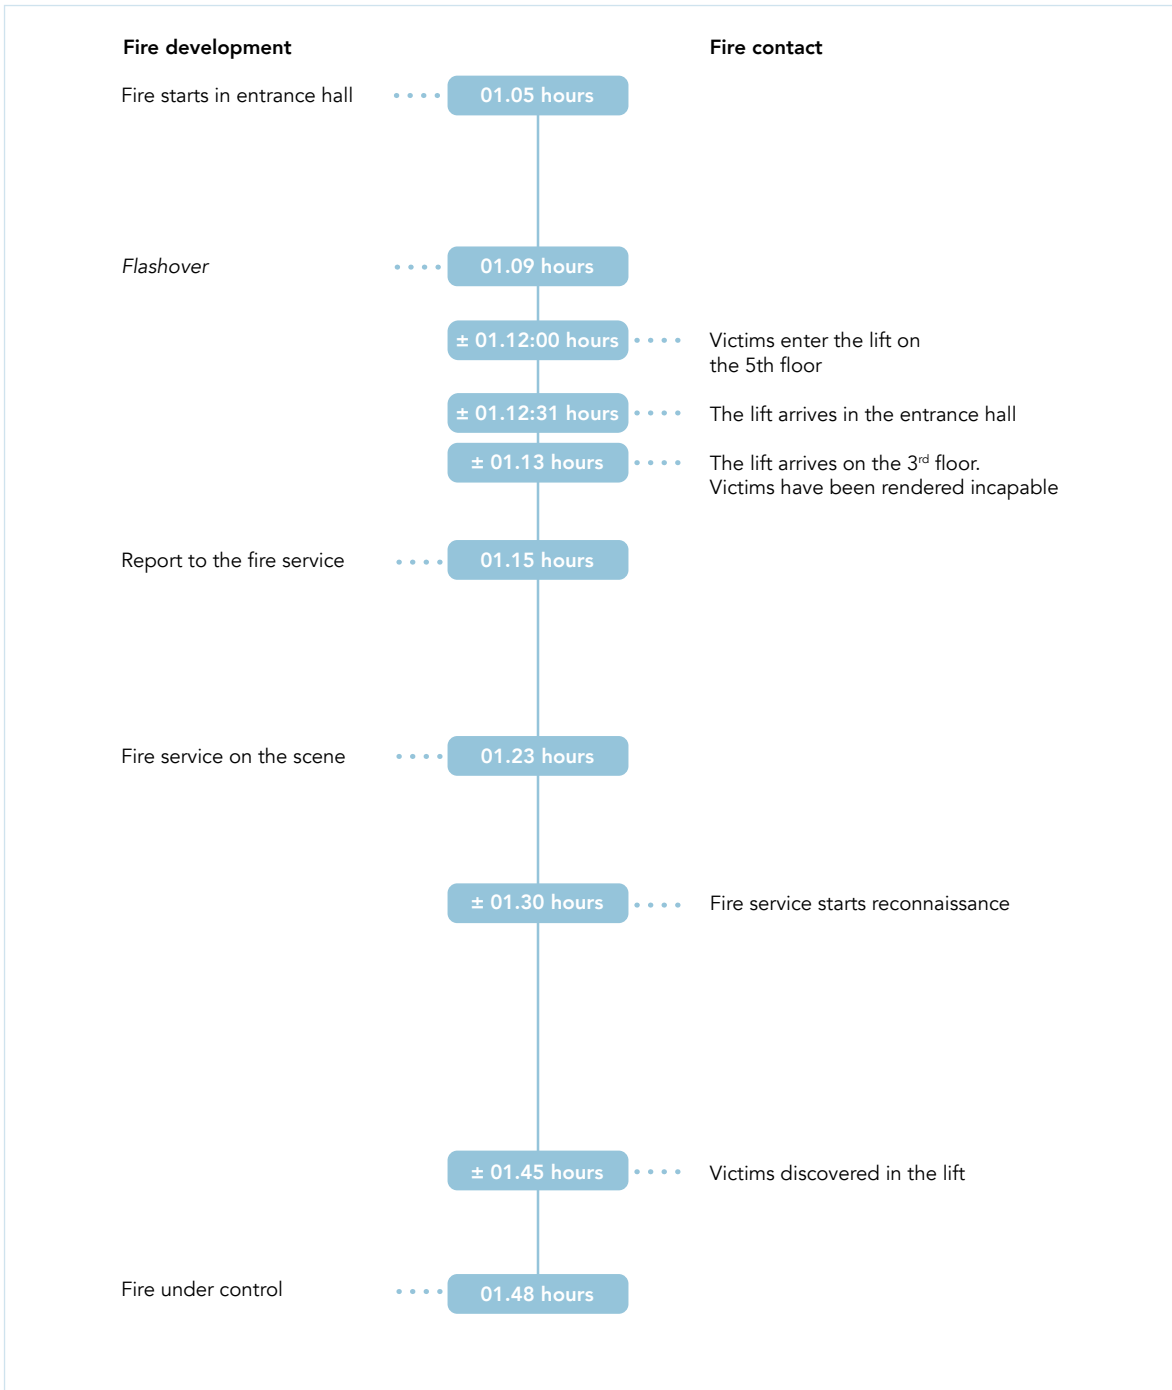
Figure 9: Timeline of fire development and fire contact.

The figure below shows the timeline for the development of the fire together with the timeline for the fire contact, resulting in a complete picture of the timeline for the occurrence.

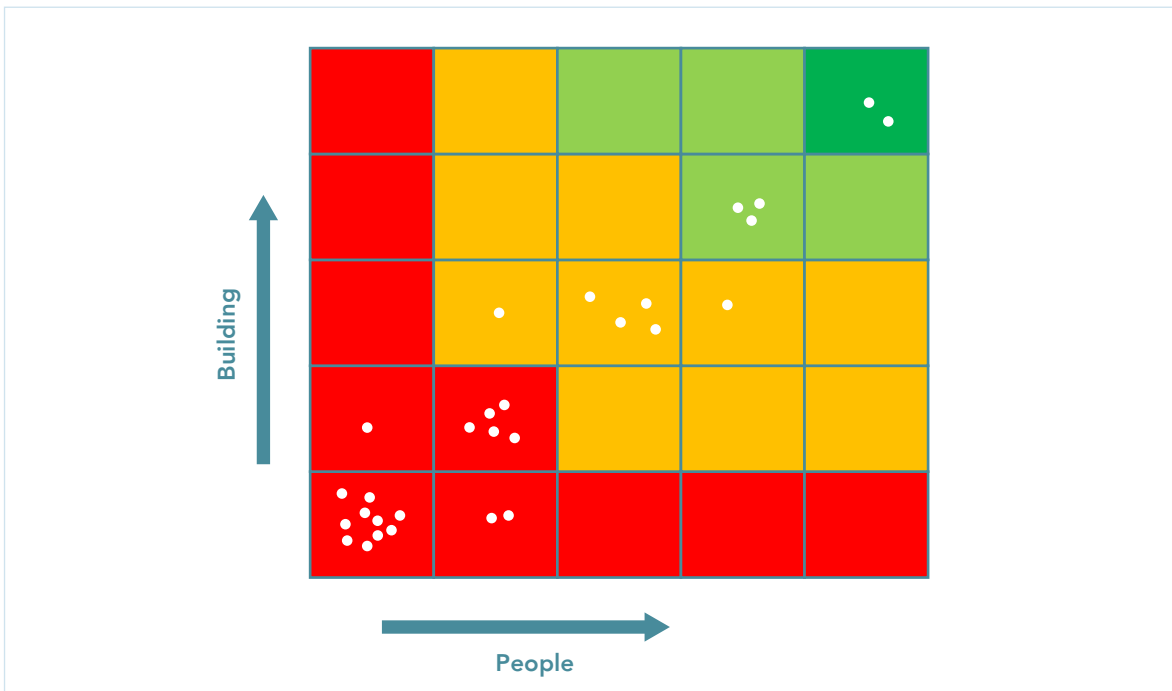
There is also room for improvement in the fire safety awareness of many other housing associations. This is confirmed by an inventory by Regieweb<sup>86</sup>, which examined fire safety awareness at 29 housing associations<sup>87</sup>, see figure 11. Interviews by the Safety Board show that this can be explained by the fact that fire safety must compete with numerous other subjects that also require attention. Such competing subjects referred to include the sustainability challenge and, in respect of safety, the problems of asbestos and lead pipes in homes and residential buildings. The Safety Board notes that problems with fire safety above all emerge in the event of incidents, at which point they briefly receive extra attention. In practice, this attention wanes rapidly, again allowing fire safety awareness to lapse quickly.

Figure 11: Overview of scores for fire safety awareness of the 29 housing associations evaluated by Regieweb. Each point on the figure represents a housing association. The further along the horizontal and the vertical axes, the higher the fire safety awareness level. The horizontal axis shows the human dimension and the vertical axis the building dimension. Building relates to the structural and installation engineering elements and human to both the integration of fire safety in the organisation and the extent to which attention is focused on fire-safe behaviour by tenants/users.

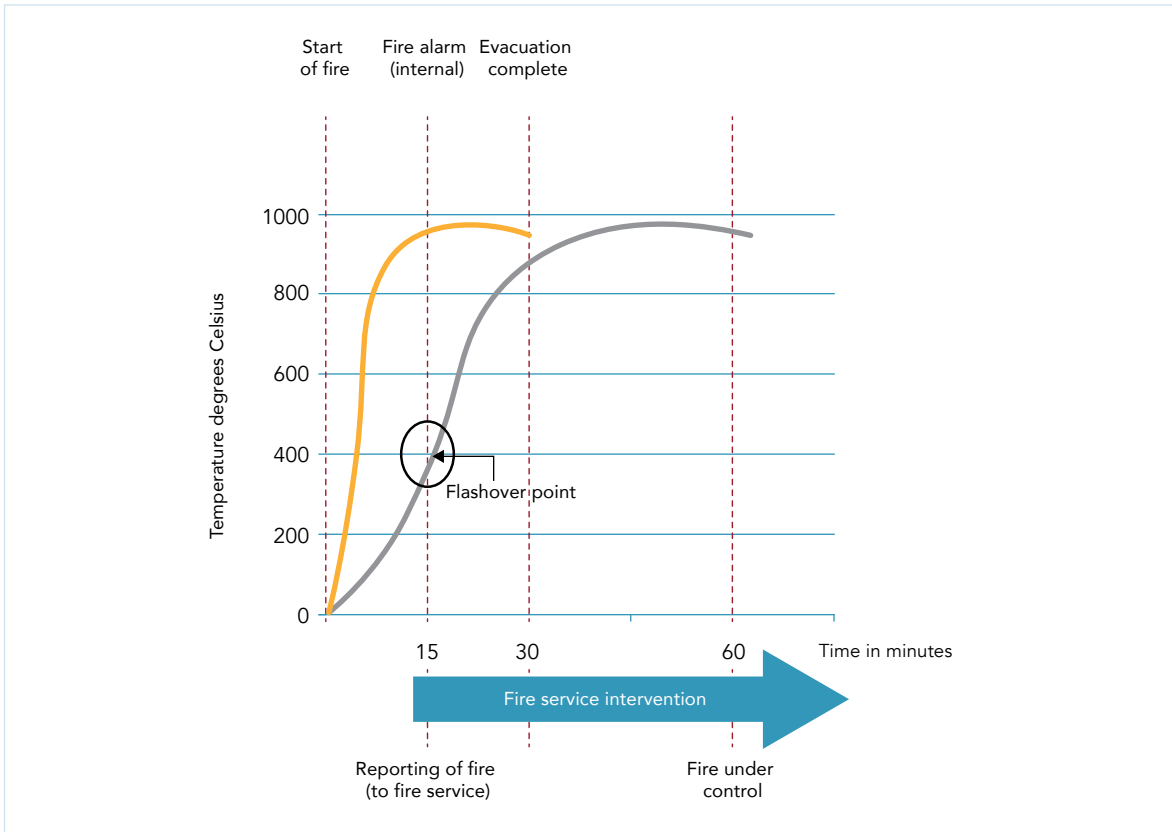
Figure 12 below shows the temperature development in a room as a function of time from the moment of starting of a fire, for both the normative fire and the fire started in a plastic foam-filled item of furniture or a mattress in the case of a fuel-controlled fire (with no shortage of oxygen).

Figure 12: Current normative fire development in grey. (Source: Hagen, R. & Witloks, L. (2017), *The Basis for Fire Safety*) and the faster fire development of a furniture fire in yellow. Both curves are indicative and may develop differently depending on the fire conditions, for example size of the room, level of ventilation and the quantity of other flammable materials.

The burning behaviour of furniture and mattresses filled with plastic foam has serious consequences for residential fires. Whereas years ago, after hearing a smoke alarm, people had approximately ten minutes to escape from their home, a house furnished with plastic foam-filled furniture can be fully ablaze and/or filled with smoke in less than three minutes.<sup>122,123</sup> This is faster than the normative fire development used in legislation and regulations and the assumed underlying principles for fire safety.<sup>124</sup> This means that in the event of a residential fire involving furniture or mattresses filled with plastic foam, the residents have less time to report the fire to the fire service, and escape from their home. In particular less self-reliant individuals run a greater risk, as a consequence. In order to be able to start putting out a fire on time and rescuing victims, the fire service needs to be at the location of the fire sooner than the arrival time currently specified. Given the current number of fire stations and the distribution of fire stations across the country, this is barely if at all achievable.

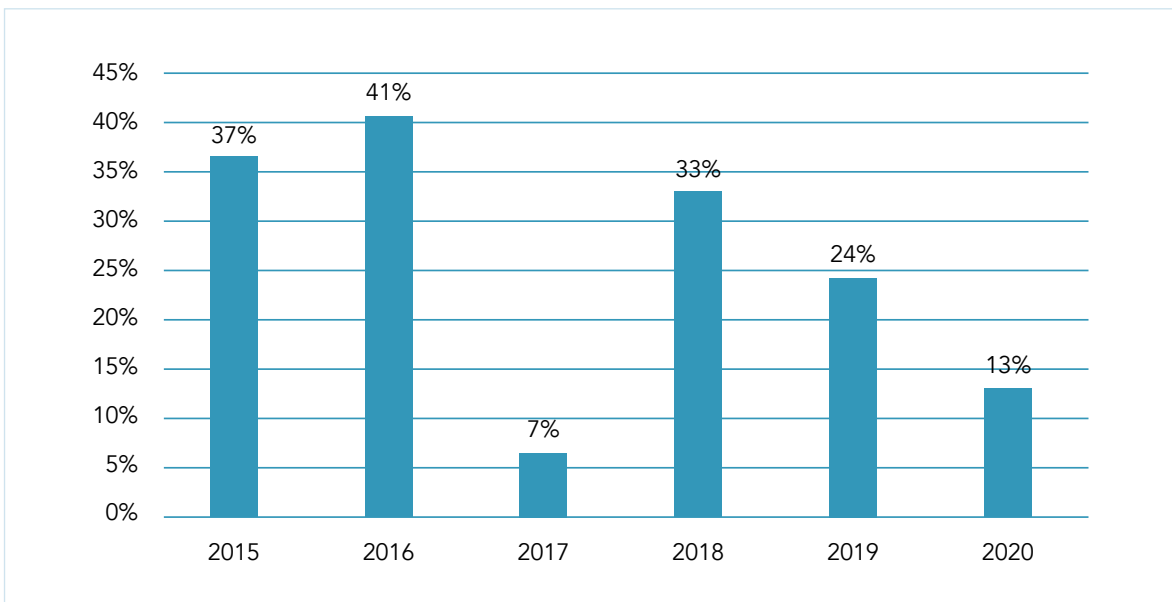
Four of the 31 fatal residential fires in 2020 occurred in a block of deck-access flats. Although the figures for the period 2015 to 2020 vary annually, they do show that a large proportion of the fatal residential fires each year take place in blocks of deck-access flats, see the figure below.

Figure 14: Number of fatal residential fires in a block of deck-access flats (open and closed gallery) as a percentage of the total number of fatal residential fires (Source data: IFV)
