DUTCH
SAFETY BOARD

Fishing vessel sinks due to failure of bilge pumping system

Lessons learned from the occurrence
involving the UK-160 Riemda,
23 December 2020

The Hague, May 2022

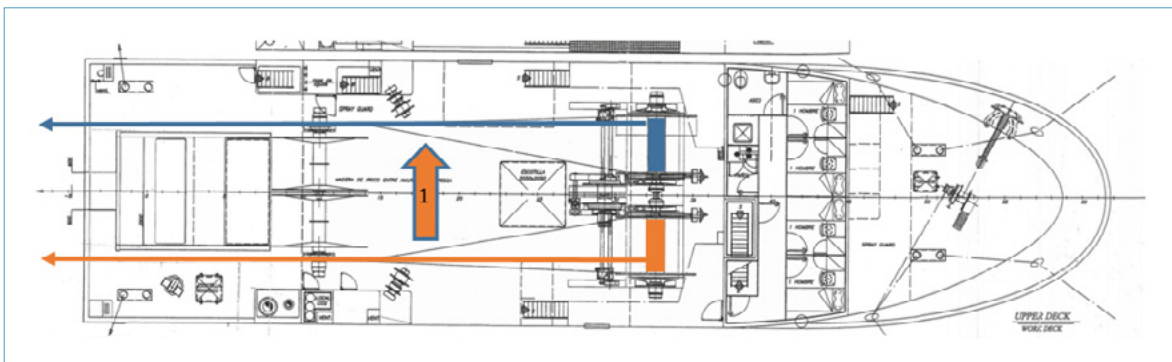
Figure 2: Top view main deck - Afterdeck actions step 1. Original configuration in orange, new configuration in dark blue. (Source: Maaskant Shipyards Stellendam / ILT)

Despite transferring the bunker water, the starboard list in fact increased. It was then decided to first haul in the fishing line over the port side (in blue on figure 2) instead of via the starboard side (orange). This meant that the pulling force of the fishing net would no longer be applied over the starboard side but over the port side. However, this resulted in no change to the angle of list.

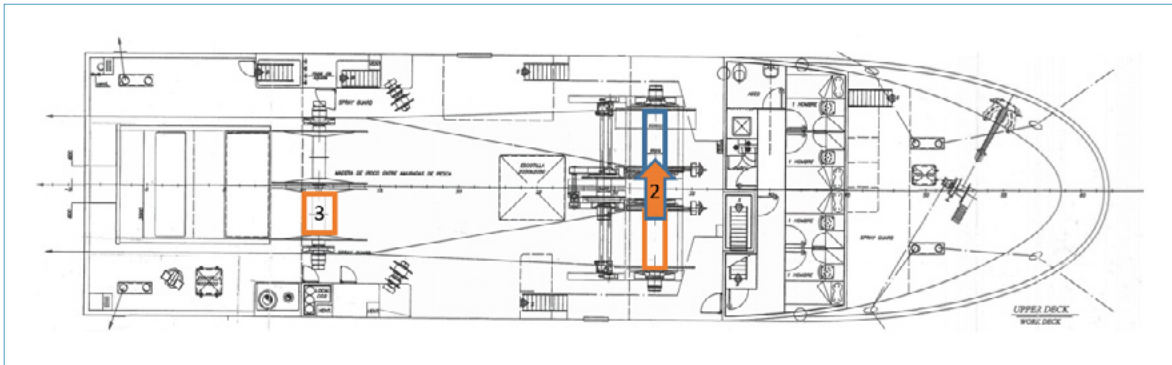
Figure 3: Top view main deck - Afterdeck actions steps 2 & 3. (Source: Maaskant Shipyards Stellendam / ILT)

The crew decided to transfer the steel cables of the spare fishing gear that was wound around the starboard reel to the port side (see step 2 on figure 3). This too led to no improvement in levelling the vessel. By the time the cable had been transferred, the vessel had adopted a starboard list of around 30 degrees. As a final attempt (see step 3 on figure 3) to shift the vessel to port, the crew placed the starboard net overboard.

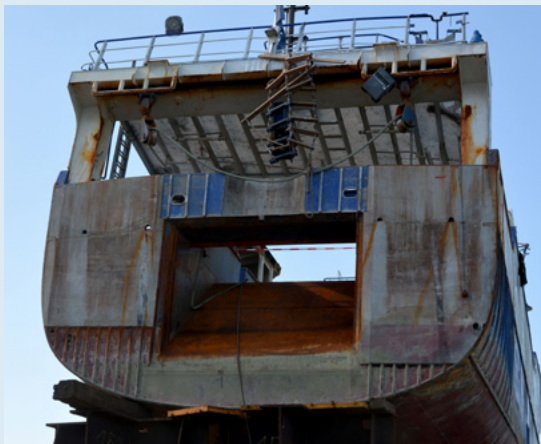
Figure 8: UK-160 with stern opening.

The design of the vessel was based on Spanish methods whereby the vessel was equipped at the stern with a slipway (angled stern opening) as shown on figure 8 and 9, with no sealed stern part. This slipway makes it easier to haul the net in, because the net does not have to be lifted up and over an upright stern wall. The accommodation was divided into an officer's and a deckhands' compartment. The vessel was originally deployed for long fishing periods so that in the initial design, she was equipped with freezer cells and freezer installations, to allow the fish to be stored for longer periods. Under current ownership, some of these freezing facilities were no longer required, and were removed from the vessel, following the reflagging process. The compartmentalization was also adjusted.

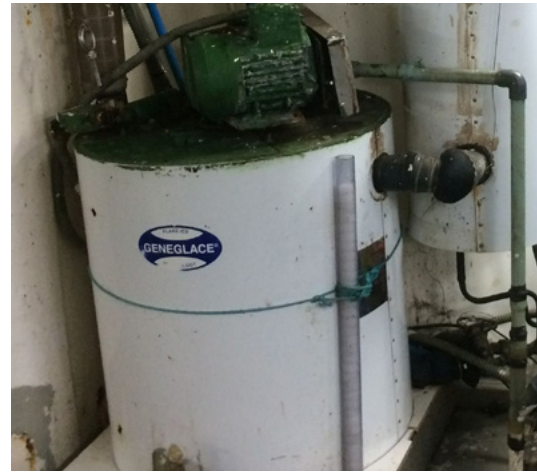
Figure 29: Original freezer installation. (Source: Maaskant Shipyards Stellendam)

The fish hold, located below the fish processing area, had two openings to the area above (see figure 30). Midships was a large hatch through which the fish could be transported into and out of the hold. On the starboard side was a further smaller opening (see figure 28 and 30) at the site where a freezer installation had previously stood. As shown in figure 29, at the time of the last maintenance period, this installation was still on board. The opening was only made in the year before the occurrence, by removing the freezer installation positioned above the hole and then closing the hole with a water-permeable panel. This change to the ships' structure was not known to the Dutch Shipping Inspectorate.

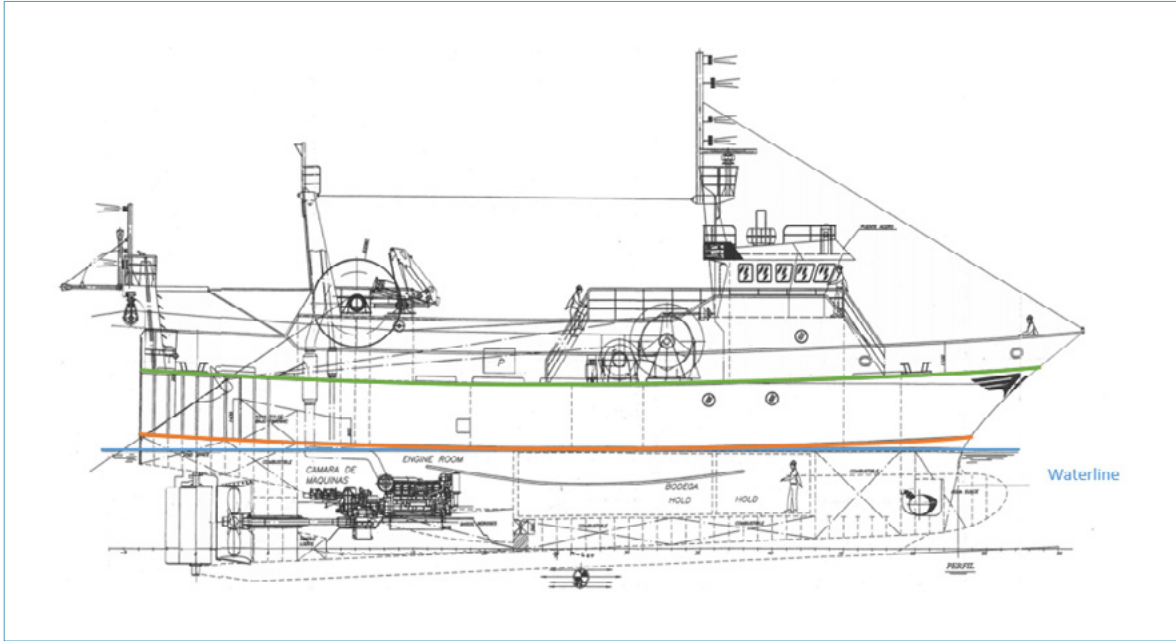
Figure 35: Approved general arrangement plan UK-160. (Source: Maaskant Shipyards Stellendam / ILT)

The reviewing response from I&W showed that when the UK-160 Riemda was flagged into the Dutch shipping register in 2018, a different deck had been taken for the reference of the watertight subdivision and the deck used as a reference for the calculations of the stability book. The UK-160 had English registration, prior to the Dutch flagging. It is important to make the distinction between regulations for watertight division and regulations for classification of stability calculations. The English regulator MCA uses regulations for watertight classification that differ from those used by the Dutch regulator (ILT). There is no such deviation with regard to the classification of the stability calculation. Both the regulations of ILT and of the MCA are based on the Intact Stability Code. Both parties have assumed the same weather and watertight classification.

The approved stability book takes all weather and watertight closable spaces into account, including the spaces above the working deck (highlighted in orange on figure 35). With this ship, the above statement results in a weather tight deck one deck above the working deck (green on figure 35).
