ONDERZOEKSRaad
VOOR VEILIGHEID

Mortierongeval Mali 2016

Heropening onderzoek 2022

Den Haag, augustus 2022

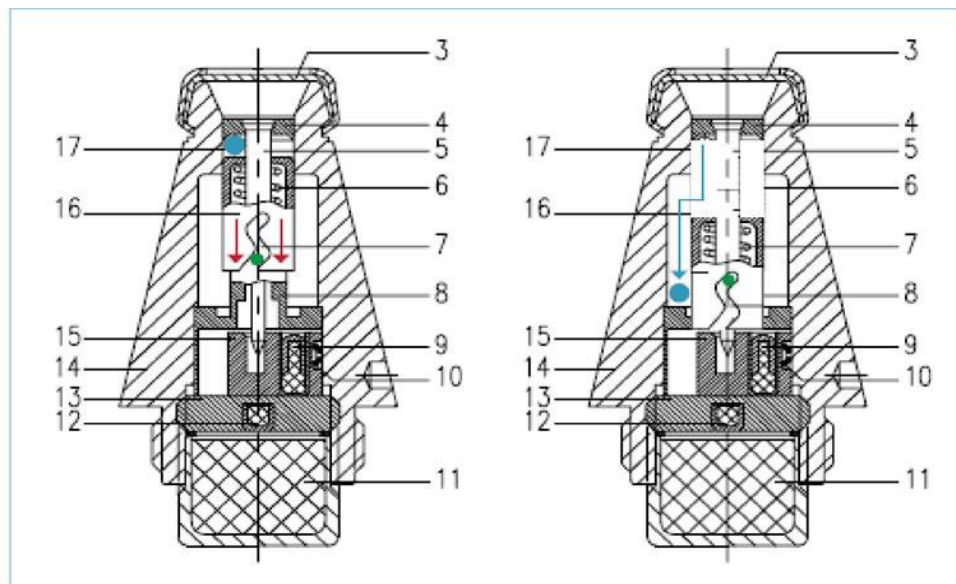
Figure 5: Position of the safety mechanism in the fuze at the moment before the acceleration begins, direction shown with red arrows (left) and at the end of acceleration at leaving the mortar tube (right). Cross pin (not numbered) shown in green. (Source: Ministry of Defence/TNO)

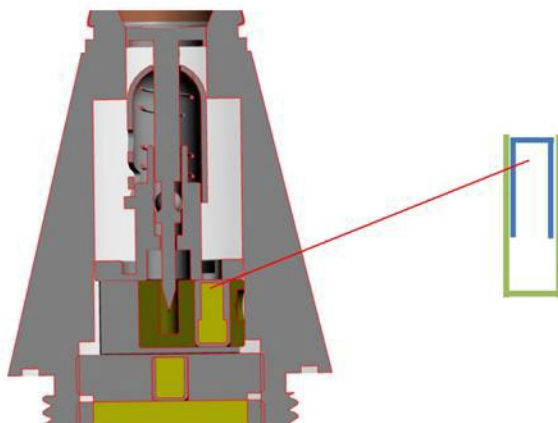
Figure 12: M6-N Fuze. The duplex detonator consists of two metal casings with one slid into the other. The inner casing that contains the energetic materials is made from aluminium. The outer metal casing is made from a copper-nickel metal alloy (Melchior). (Picture: TNO)

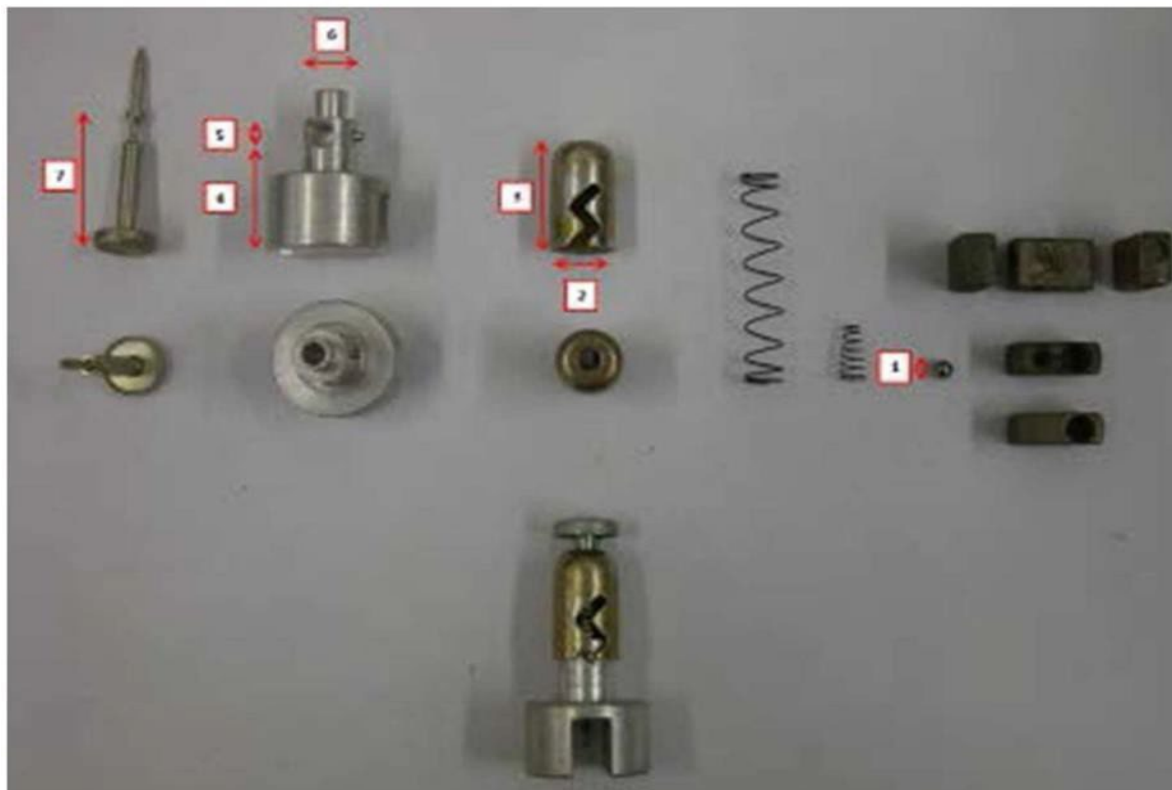
consideration of the fuze design (Figures 4 and 5) makes it apparent that very major dimensional deviations would make it impossible to construct the fuze mechanism. TNO state [7 Section 4]:

Figure 23: Fuse M6-N, Breakdown and dimensions measured by KC W&M. (Picture: KC W&M)

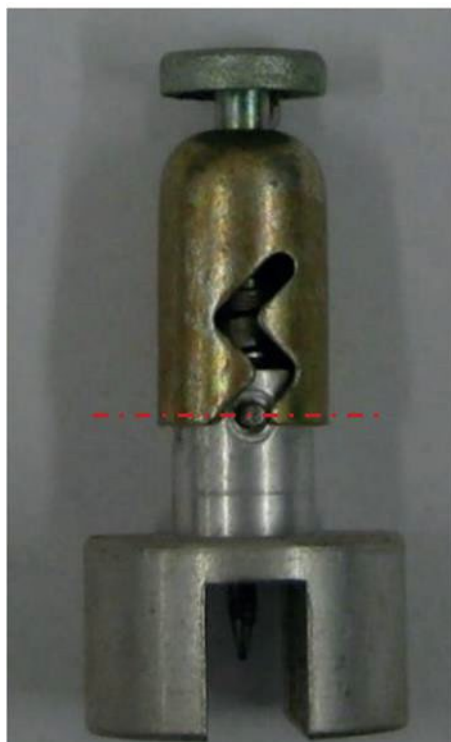
Figure 24: M6-N fuze mechanism composed of correctly positioned zigzag cross-pin at the beginning of the first "knee" of the zigzag slot (Picture: TNO)
