# Loss of control after interrupted winch launch, Gilze-Rijen Air Base

*The Hague, May 2021*

Identification number:	2020047
Classification:	Accident
Date, time of occurrence:	12 July 2020, 12.47 hours <sup>1</sup>
Location of occurrence:	Gilze-Rijen Air Base
Registration:	PH-1150
Aircraft type:	Rolladen-Schneider LS8-18
Aircraft category:	Glider
Type of flight:	Pleasure
Phase of operation:	Winch launch
Damage to aircraft:	Nose destroyed, fuselage and cockpit severely damaged, tail broken
Flight crew:	One
Passengers:	None
Injuries:	Pilot fatally injured
Other damage:	Fence
Light conditions:	Daylight

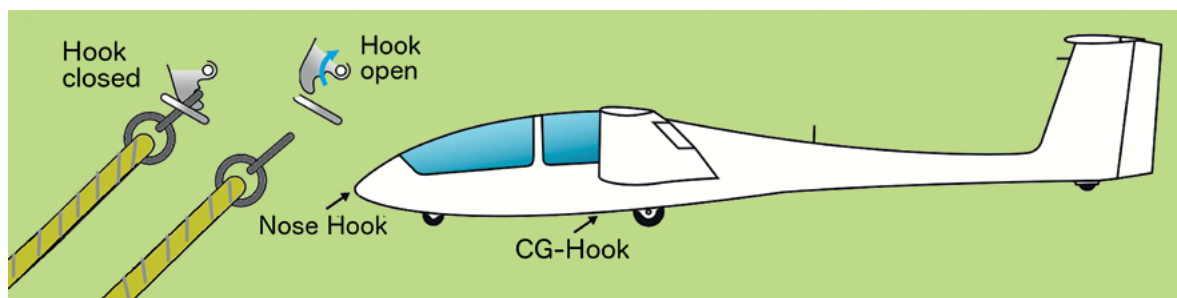
Figure 5: The location of the centre of gravity (CG) release hook. (Source: *Gliding, The basics in 35 lessons*, D. and R. Corporaal)

The winch cable is connected to the glider via the centre of gravity release hook (see Figure 3), which is attached to the bottom of the fuselage near the landing gear (see Figure 5). The pilot can release the cable during the winch launch, by pulling the yellow T-shaped handle in the cockpit. The cable release handle in the LS8 is normally guided a little further into the cockpit, via a molded sleeve<sup>17</sup>, to enable the pilot to access it better during flight (see Figure 4).
