DUTCH  
SAFETY BOARD

# Loss of control after opening of canopy, near Kornhorn

*The Hague, February 2023*

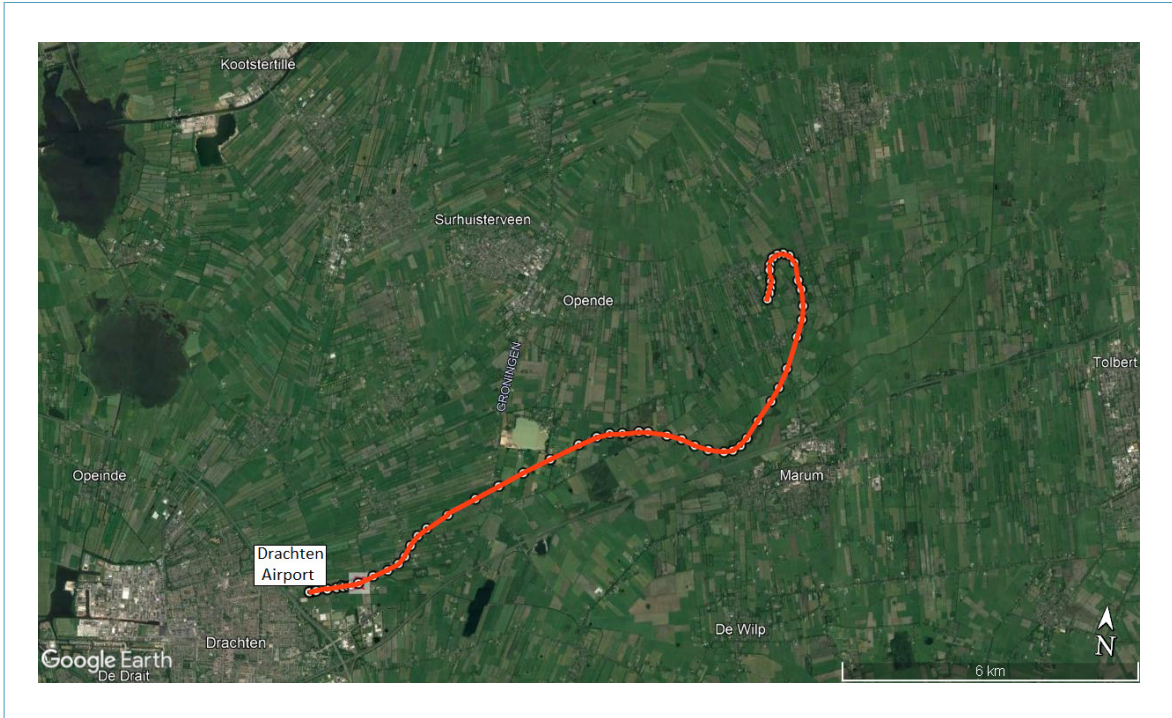
Figure 1: Reconstructed flightpath. (Source: Google and Dutch Safety Board)

The Dutch Safety Board reconstructed the flightpath using two devices: a Garmin navigation device that had been mounted in the cockpit and was found on the crash site and the pilot's iPad, which was later found in a field along the flight track of the aircraft (see Figure 1). Both devices used satellite navigation (GPS) to determine altitude and groundspeed.

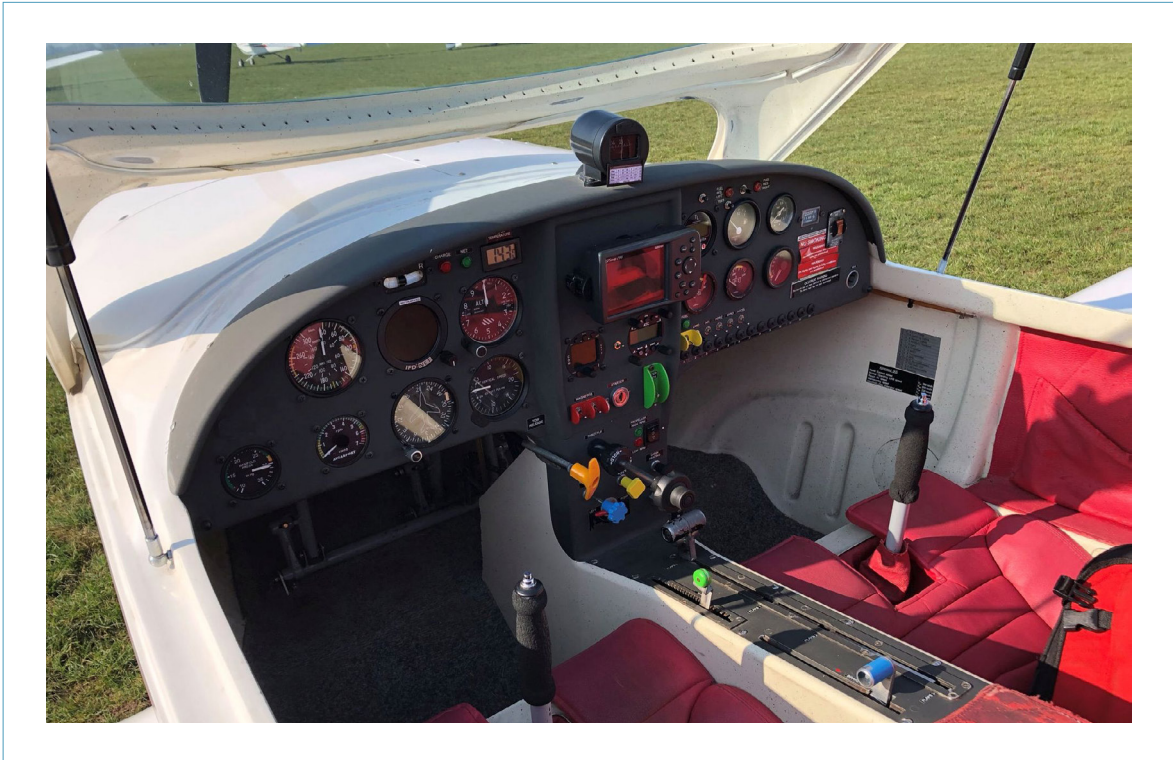
Figure 6: Opened canopy with gas struts. (Source: Dutch Safety Board)

The cockpit canopy of the Aerospool Dynamic WT9 consists of one part. The plexiglas is glued on the composite frame. It hinges on two pins at the front of the fuselage and opens upward and forward, assisted by two gas struts on either side of the canopy (see Figure 6).
