DUTCH  
SAFETY BOARD

# Loss of directional control during water landing, Consolidated PBY-5A Catalina

*The Hague, December 2018*

Identification number:	2017086
Classification:	Serious incident
Date, time <sup>1</sup> of occurrence:	15 August 2017, approximately 14.15 hours
Location of occurrence:	IJsselmeer, near Lelystad, the Netherlands
Aircraft registration:	PH-PBY
Aircraft model:	Consolidated PBY-5A Catalina
Type of aircraft:	Twin engine amphibious
Type of flight:	Memorial flight followed by touch-and-go on water
Phase of operation:	Landing
Damage to aircraft:	Minor
Cockpit crew:	Two
Cabin crew:	One
Passengers:	Fifteen
Injuries:	None
Other damage:	None
Lighting conditions:	Daylight

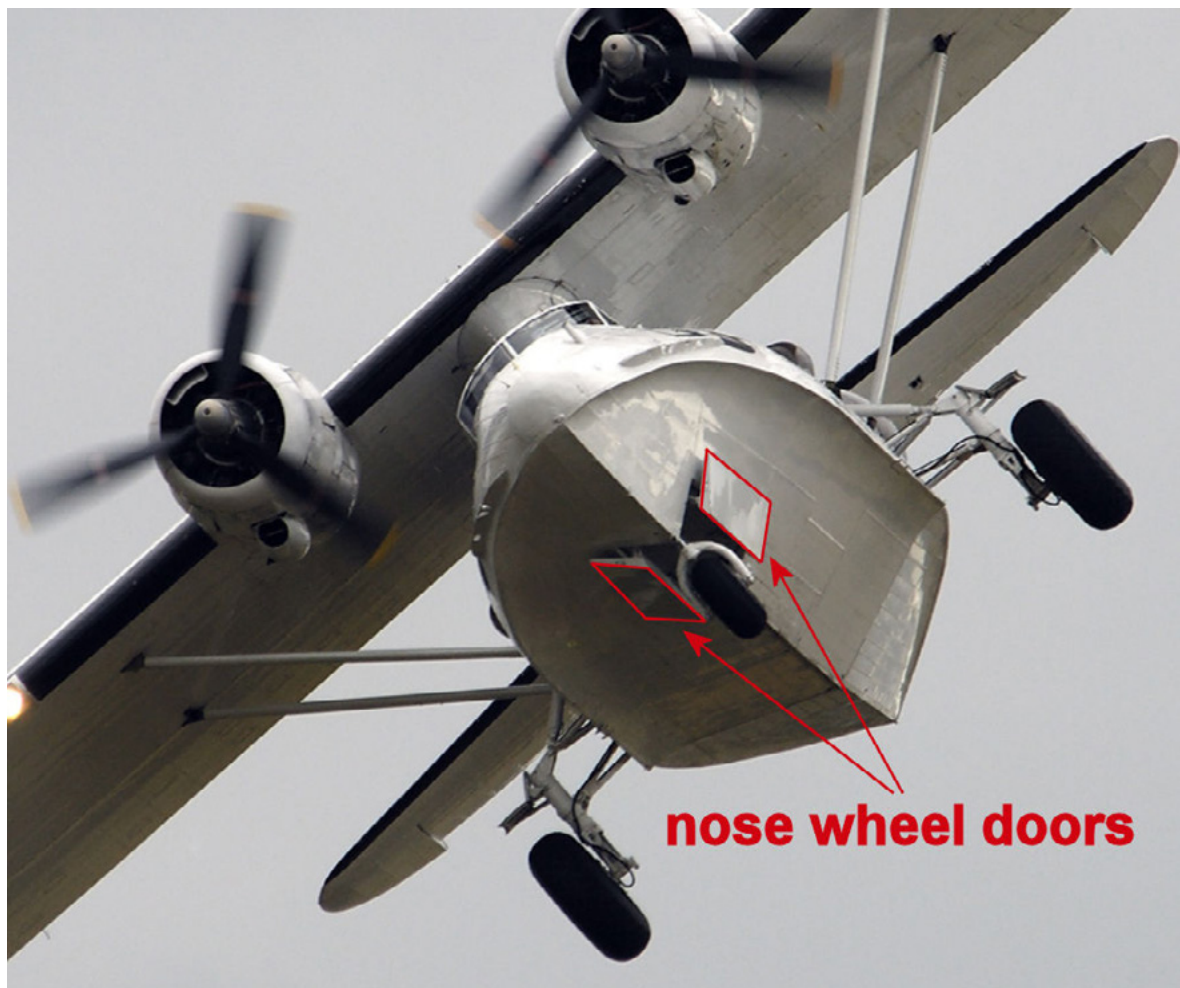
Figure 3: Nose wheel doors open. (Source: Airplane-Pictures.net / Alistair Bridges)

The aircraft is equipped with two nose gear doors, one on either side. When closed, the doors are flush with the fuselage to minimise drag both in flight and on the water. Through a viewer in the cockpit, the flight crew can check that the doors are closed prior to a water landing. This is part of the water landing procedure.

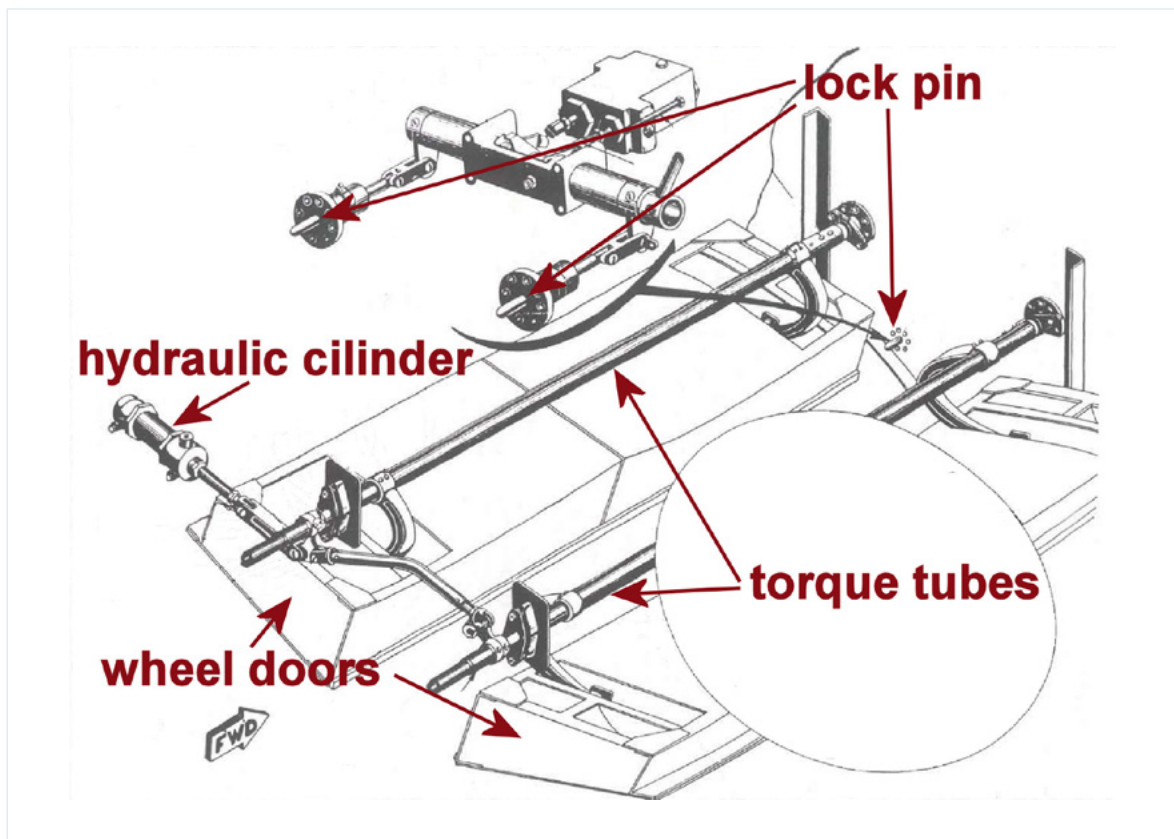
Figure 5: Nose wheel door control mechanism. (Source: Aircraft Maintenance Manual)

When pressure is applied to the hydraulic cylinder the torque tubes start to rotate and open or close the corresponding wheel doors. Before the doors can be opened, a lock pin on each door must be retracted. When the lock pins are not retracted, the doors remain closed and the nose wheel cannot be lowered. During inspection of the nose gear mechanism of PH-PBY, the flight crew's initial findings were confirmed: the left-hand door was missing completely. Besides the missing door it was discovered that the left-hand lock pin was bent in the extended (locked) position (see Figures 6 and 7).

A search for the door was performed but it was not found. As the door was not recovered and could not be investigated, the extent and cause of the deformation of the left-hand door remains unknown. Possible causes, such as the doors not having been shut completely before the water landing or that the nose gear door hit a piece of debris in the water could therefore not be confirmed.

After a more than 360-degree turn on the water, the left-hand wheel door was most likely ripped off. This caused the movement to the left to stop. The flight crew then managed to regain control of the aircraft, increased speed and took off. The bending of the left-hand lock pin most likely occurred when the door broke off.
