DUTCH
SAFETY BOARD

Man missing after falling overboard

Learning points from an accident
in the Baltic

The Hague, November 2019

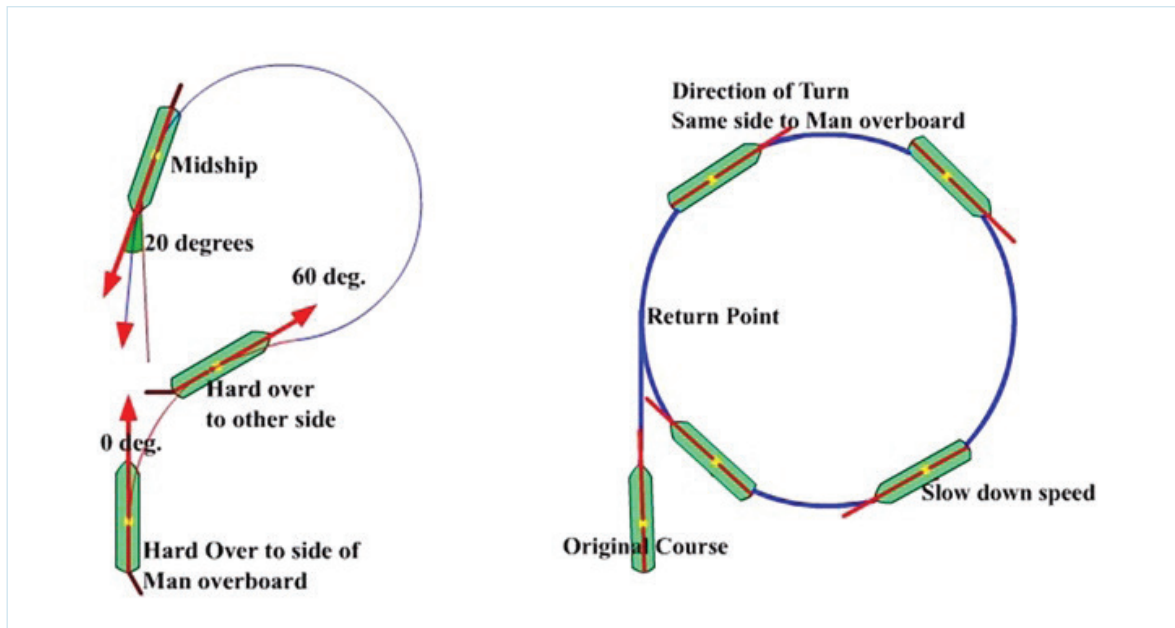
Figure 7: The Williamson turn (L) and the Anderson turn (R), Source: officerofthewatch.co.uk/2016/02/man-overboard-actions, consulted on 31 July 2019.

As soon as a man overboard (MOB) situation occurs, the attention of the crew must be aimed primarily on relocating and rescuing the man overboard. In many cases, the ship is required to carry out a manoeuvre to return to the MOB position. There are a number of different MOB manoeuvres. The most commonly employed manoeuvres are the Williamson turn and the single MOB turn (also known as the Anderson turn). The choice of manoeuvre depends on the situation, whereby above all weather conditions and visibility are important.⁴

⁶ The Williamson turn is often employed in bad weather conditions or in the hours of darkness because it brings the vessel precisely back onto the victim on the opposite course. The Williamson turn does take more time.
