DUTCH  
SAFETY BOARD

# Damage to left wing spar

*The Hague, August 2018*

Identification number:	2016072
Classification:	Accident
Date, time of occurrence:	15 July 2016, 14.20 hours
Location of occurrence:	Larserveld
Registration:	PH-1006
Aircraft type:	SZD-51-1 "Junior"
Aircraft category:	Glider
Type of flight:	Local
Phase of operation:	En route
Damage to aircraft:	Substantial to left wing spar
Flight crew:	One
Passengers:	None
Injuries:	None
Other damage:	None
Light conditions:	Daylight

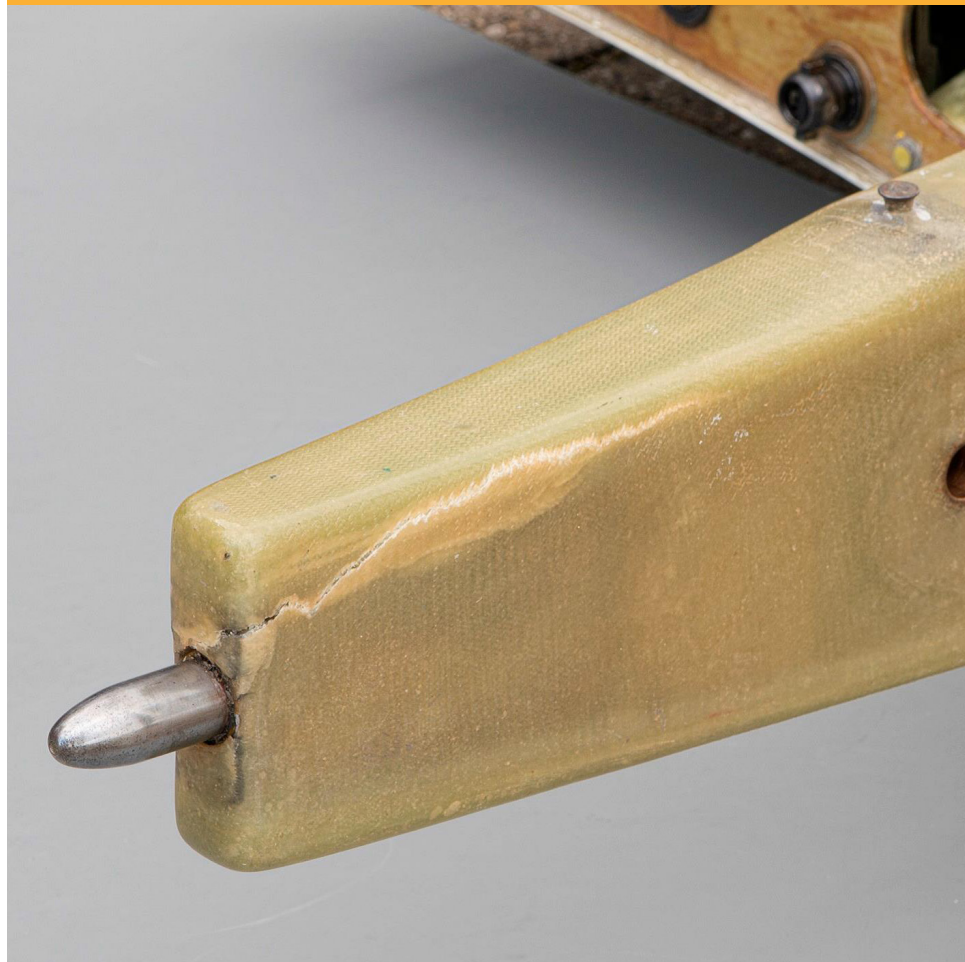
A post flight inspection revealed cracking in the left wing, at the end of the glass-fibre reinforced plastic (GFRP) spar. Investigation revealed that the crack already existed before the occurrence took place. The aluminium insert in the wing spar had detached from the GFRP material, causing some freedom of movement, which resulted in high local stresses in the spar. It is likely that the spar eventually failed by a high load at the end of the loop. The cause of the detachment of the aluminium insert could not be established with certainty.

The glider sustained substantial damage as a result of the occurrence. A crack was present at the top of the end of the spar of the left wing.

Figure 1: Failed spar of the left wing observed from the leading edge side. (Photo: NLR)
