DUTCH
SAFETY BOARD

Quarterly Aviation Report

Januari - March 2020

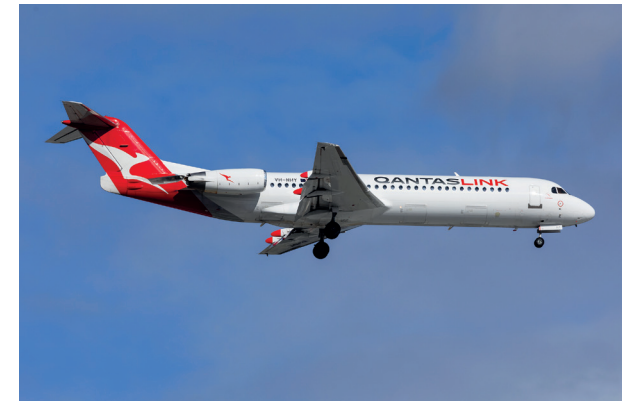
Runway excursion, Fokker F28 Mk 0100, Newman Airport (Australia), 9 January 2020

Following its flight from Perth, the Fokker 100 landed at Newman Airport in Western Australia. The aircraft came to a standstill approximately 100 metres beyond the end of the runway. There were no injuries; the aircraft suffered no damage.

Archive photograph Fokker 100. (Source: W. Kaiser)
