DUTCH
SAFETY BOARD

Quarterly Aviation Report

January - March 2021

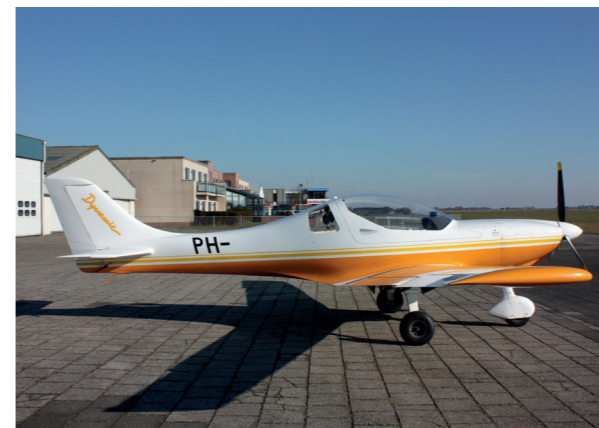
Crashed, Aerospool s.r.o. Dynamic WT9, Kornhorn, 13 February 2021

The aeroplane had departed from Drachten airfield and crashed during a local flight. The pilot was fatally injured.

Archive photo of the aircraft concerned. (Source: Texel International Airport)

Classification: Accident
Reference: 2021003
