DUTCH
SAFETY BOARD

Quarterly Aviation Report

January - March 2022

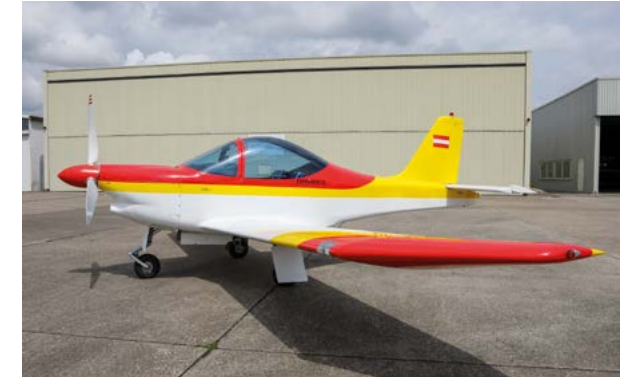
During the approach to Runway 01, the Dutch pilot and owner of the self-built aircraft experienced turbulence. The aircraft made a hard landing. The pilot and passenger were unharmed. The aircraft suffered damage.

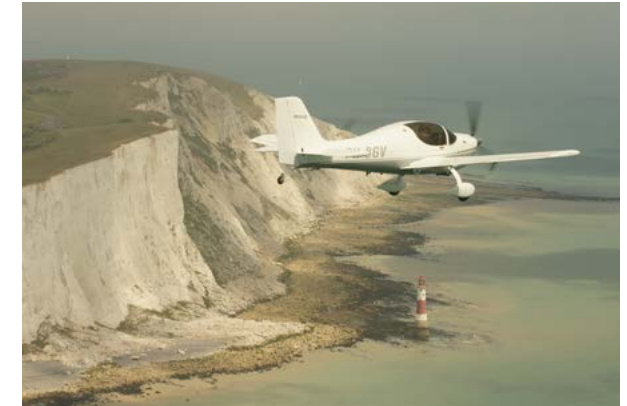
The investigation revealed that the tailplane trim was not set in the take-off position, but in the full aircraft nose-down position. The cause of the full aircraft nose-down trim position could not be determined with certainty, but a technical anomaly in the trim indicator (shifted needle position over the scale) or a human factor (procedure slip or a reading error) are the most likely explanations.

During the ground roll, the incorrect trim position caused an abnormal nose-down effect. An uncommon backward stick position with a significant stick force would have been required to counteract this nose-down tendency. When applying such force, it is difficult to set the correct pitch attitude. Due to the unnatural control feel and given the risk of a ground strike of the propeller, the pilot presumably pulled the stick abruptly backwards, unintentionally initiating an early over-rotation followed by a steep climb at low airspeed. The gusty wind may have contributed to an early lift-off and the degree of rotation. Furthermore, the design of the aircraft is prone to become airborne at low speeds. As maximum take-off power at low airspeed possibly required up to full right rudder, this increased the susceptibility to slip and wing drop.

When the aircraft got airborne, the situation became critical because of the low height and low speed in combination with the still-occurring unnatural control feel, substantially required rudder input and chance of rapidly varying windspeed. This made it difficult to set the correct pitch attitude and maintain a coordinated flight (no slip). Even if the pilot would have instantly assessed the situation correctly, margins to safely remedy this critical situation were small.

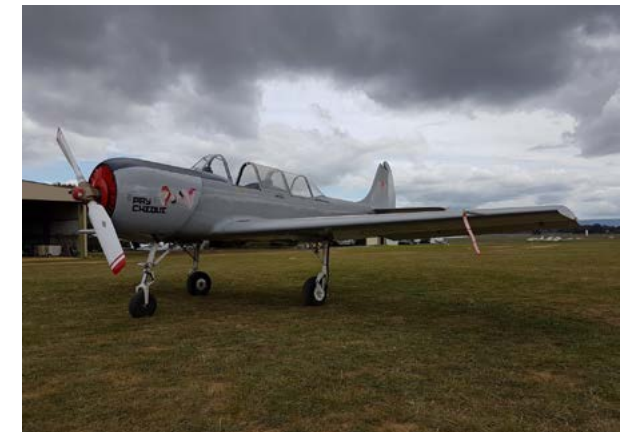
The Yak-52, with two occupants including the Dutch captain, was performing aerobatic manoeuvres at an altitude of 500 feet AGL. The aircraft collided with water at high speed, resulting in the death of both occupants. The aircraft was destroyed. In the absence of registered details or witnesses of the accident, however, it could not be determined with absolute certainty that the pilot was performing an aerobatic manoeuvre immediately prior to the impact, but this was considered a possibility.

During the accident flight and previous flights, the pilot had performed aerobatic manoeuvres at low altitude, without having completed the required training and while not in possession of the correct certificate of competence. This may have impaired the pilot's assessment of the risks of low altitude aerobatics.

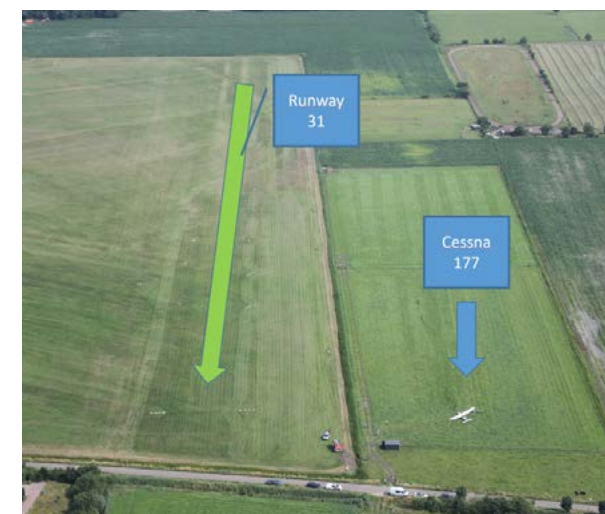
The accident location in relation to Runway 31. (Source: Dutch aviation police)
