DUTCH
SAFETY BOARD

Quarterly Aviation Report

July - September 2021

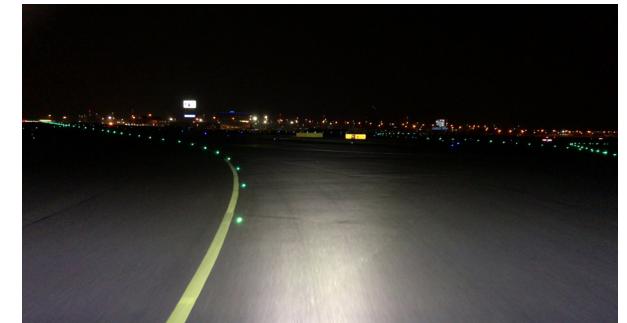
The serious incident was caused because the crew of the aircraft that had to give priority did not notice the other aircraft in time. The factors below played a role:

Left turn where the Airbus 320-200 came from right. (Source: Amsterdam Airport Schiphol)

Preventing collisions and dangerous situations on the ground is a shared responsibility. Both flight crews and air traffic control play an important role in this, certainly in cases where a possible conflict is foreseen. In addition, it is preferable to repeat stop instructions and continue to stay in touch with the crews, until they have a clear picture of the situation and the possibility of making mistakes is reduced.

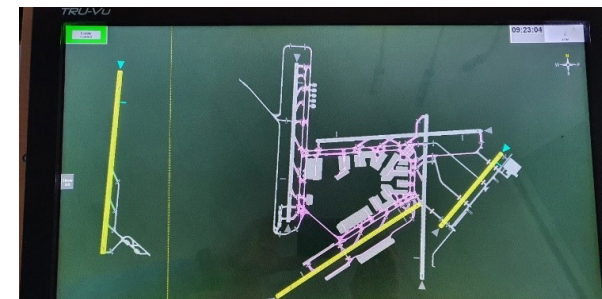
Over the past few years, AAS and LVNL have introduced a number of systems that contribute to preventing the use of unavailable runways. In 2017, the Airfield Lighting Control and Monitoring System (ALCMS) was commissioned by the airport. Via an interactive screen, this system provides an overview of the status of the runways at Amsterdam Airport Schiphol; see the photograph below.

The Airfield Lighting Control and Monitoring System (ALCMS) control panel at Amsterdam Airport Schiphol. The runways illuminated in yellow are available to air traffic control. The runways in grey are unavailable.

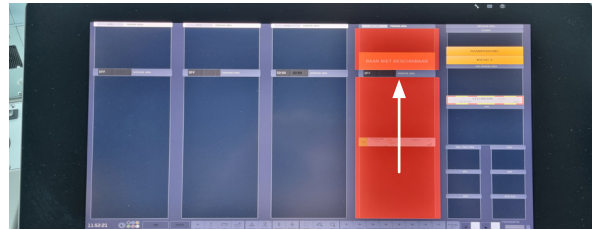
Part of a workstation at Schiphol control tower: the EFS of LVNL. In the above example, runway 18L/36R is unavailable. The red rectangular block (marked with an arrow) contains the tekst 'runway unavailable'. (Source: LVNL)

By connecting these two systems, it is no longer possible to allocate a flight to an unavailable runway. If an attempt is made to do so, the runway section lights up red and the flight data do not appear on the screen. The system also generates the warning 'Runway unavailable'.

In response to the occurrence on 18 January 2020, ahead of the planned date, the ALCMS was linked to the EFS commissioned by LVNL, on 17 March 2020.

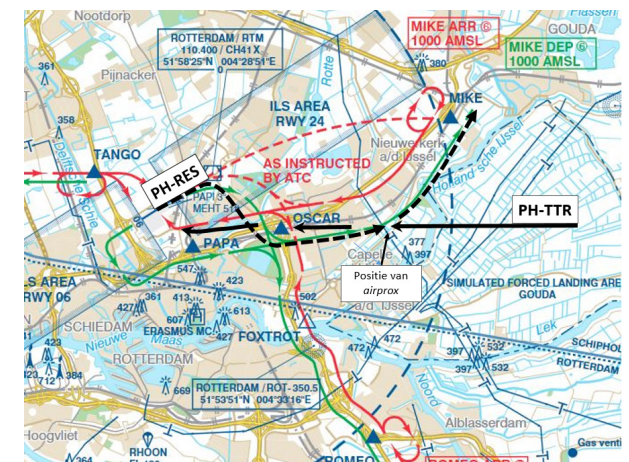
Position of the airprox between PH-TTR (black) and PH-RES (black dotted). (Source: LVNL, modified by the Dutch Safety Board)

The air traffic controller had issued the necessary initial clearances to the air ambulance helicopter and the aircraft. These clearances led to a situation where both aircraft found themselves approaching each other in opposite directions. The controller did not issue any further traffic information about the possible conflict to the aircraft. The air traffic controller indicated that the cause of this omission was the high traffic volume in the CTR and the resultant increased workload.

To the east of point Oscar, the helicopter pilot had deliberately opted to fly at 800 feet AMSL, based on his experience in recent days that the area was busy with other VFR traffic flying at 1,000 feet AMSL. This meant he was flying 200 feet below the altitude of the Mike departure. Furthermore, the crew of the helicopter observed no other traffic that could represent a conflict, on the traffic advisory system. However, PH-RES was not indicated on the helicopter's traffic advisory system. The aircraft transponder was not transmitting any information, because it had been switched to the wrong setting. In addition, just before the airprox, the crew of the helicopter was distracted by an electronic noise on the intercom system. As a result, their attention was mainly focused inside the helicopter.

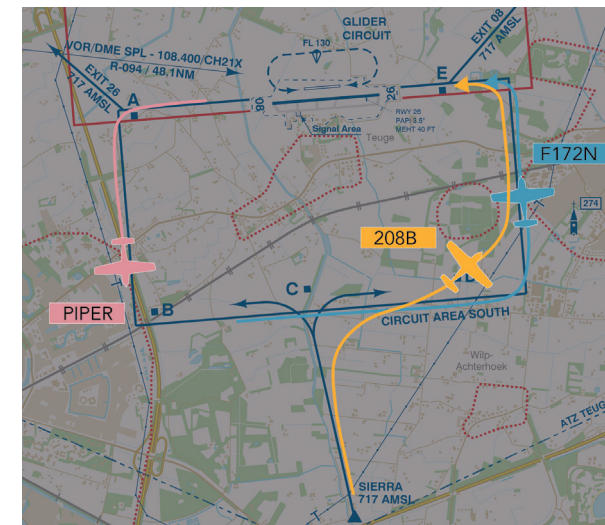
Situation overview based on statements from the pilots. (Chart: visual approach chart International Airport Teuge, source: AIP, LVNL)

The weather conditions played no role in the occurrence of this incident. The sky was clear and visibility was more than 10 kilometers. The incident could have occurred because the pilot of the 208B had not seen the other aircraft. Due to the higher speed of the 208B the aircraft caught up with the 172N.

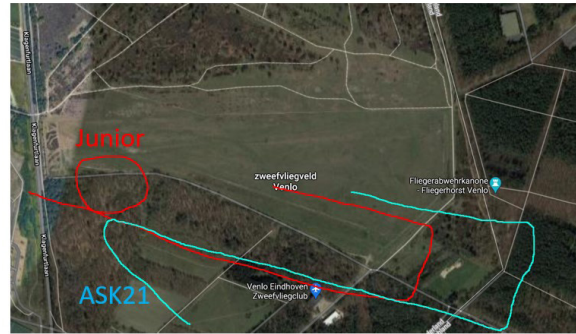
The pilot of the Junior stated that he had only seen the ASK 21 at the last moment, because the aircraft was approaching him head on. Previously, no movement of the ASK 21 had been visible to him, until the aircraft made a right-hand turn to join the circuit. In addition, from the point of view of the Junior, the visible surface of the ASK 21 was minimal. The instructor and trainee in the ASK 21 subsequently declared that they had not seen the Junior close to the circuit starting point. The minimal contrast between the white gliders and the pale blue/white sky (in the background) probably also represented a factor in the late observation or non-observation of the aircraft.

Flight paths completed by both gliders. (Source: Gliding club)

In neither aircraft had the FLARM issued a warning. The cause of this was that the FLARM in the ASK 21 was defective. The occupants of the ASK 21 had not heard the radio call that was intended for them because the transmitter of the radio in the Junior was not working correctly. In other words, both gliders demonstrated defects. The defects were already known before the start of the flight. In particular a fully functioning FLARM is able to notify pilots of an approaching collision hazard on time, thereby leaving sufficient time to evaluate the situation and if necessary to undertake an evasive manoeuvre. A FLARM should be seen as the last line of defence and may never take the place of a 'see and avoid' concept.

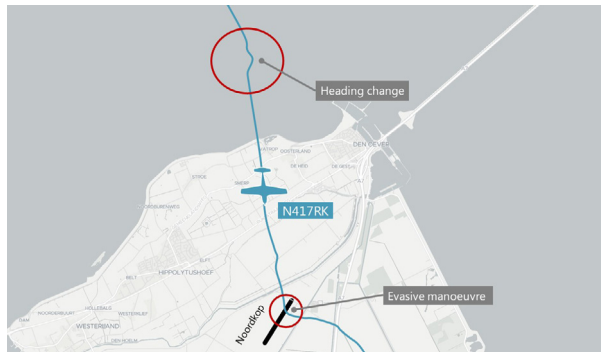
The radar data show that N417RK was flying above the Wadden Sea at an altitude of approximately 1,750 feet. Before reaching the coast, the pilot altered the heading of the aeroplane slightly to the south, and upon reaching the coast of Noord-Holland, the aeroplane descended to approximately 1,400 feet. The aeroplane then flew over the northern perimeter of the glider airfield, and made the evasive manoeuvre above the glider airfield. At the moment of the evasive manoeuvre, N417RK was flying at an altitude of approximately 1,400 feet. According to the FLARM data, at that moment, PH-1569 was flying west of N417RK, at an altitude of approximately 1,690 feet (QNH). The horizontal separation between the two aircraft was approx. 180 metres and the vertical separation approx. 290 feet (88 metres). The figure below shows the radar data for the relevant section of the route of N417RK.

Route followed by N417RK. (Source of data: Air Traffic Control the Netherlands)

The Noordkop glider airfield was made operational in 2018, after having moved from another location. The pilot of the N417RK was aware of the presence of the glider airfield because he regularly flew to and from Texel Airport. The investigation failed to explain why the pilot opted to change his heading in such a way that it meant he would fly over the glider airfield. There is sufficient space between the glider airfield and the transmitter mast on the coast or to the east of the transmitter mast to pass the glider airfield at a safe distance. The change of heading and the descent increased the risk of a hazardous situation.
