DUTCH
SAFETY BOARD

Quarterly Aviation Report

July - September 2022

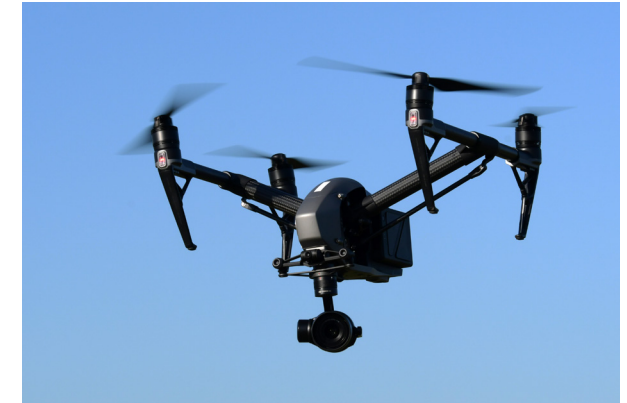
Fly-away after loss of connection, DJI Matrice 210 V2, Amsterdam, 26 July 2022

The operator had the drone take off from a bridge for the flight controls check. Shortly after, the drone stopped responding to instructions. This resulted in a fly-away. The drone hit a tree and was damaged.

Archive photo DJI Matrice 210 V2.
