DUTCH
SAFETY BOARD

Quarterly Aviation Report

October - December 2018

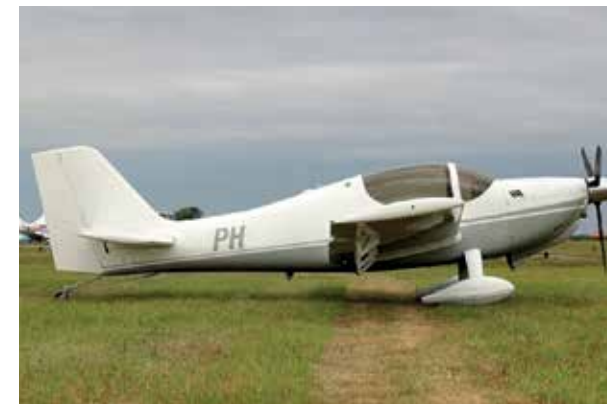
Archive photograph of the Europa AL Europa. (Source: H. Wadman)

The pilot – the only person on board – intended to take off from grass runway 13 at Hilversum airfield. Shortly after leaving the ground, the aircraft crashed. The pilot was killed.

Classification: Accident
Reference: 2018125

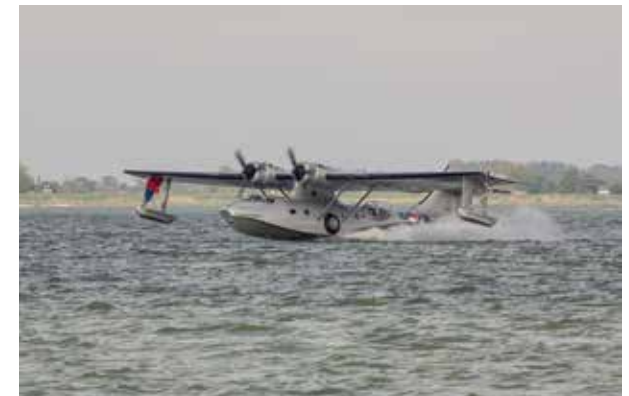
Archive photograph PH-PBY. (Source: J. Redeker)

After passing 500 feet during the climb, both pilots noticed via an inspection hatch that the left-hand nose wheel door was missing. When selecting lowered landing gear for the landing at Lelystad Airport, the right-hand nose wheel door remained closed and the nose wheel stayed inside the bay. Even using the emergency system it was not possible to extend the nose wheel. The crew was aware that a landing with nose wheel withdrawn had become unavoidable, and duly informed Lelystad Airport. The landing was well executed by keeping the nose up from the runway for as long as possible.

The damage resulting from the water landing was limited to the nose gear construction and its doors. As a result of the nose wheel up landing at the airport, the underside of the nose section of the aircraft was damaged. The eighteen persons on board suffered no injury.

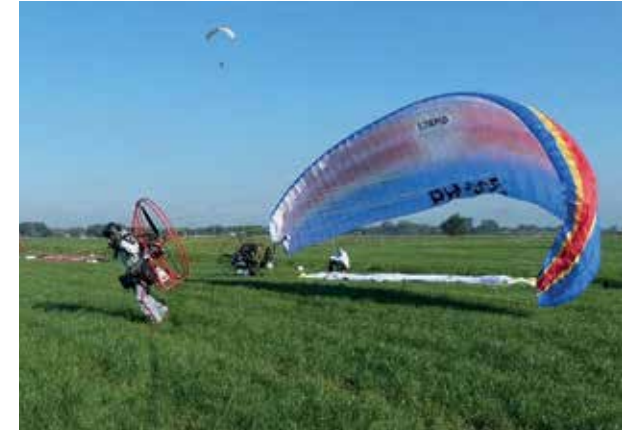
A paramotor. (Source: F. Moorman)

During the take-off run for the paramotor the pilot sat down too early, and the propeller cage came into contact with the ground. The pilot's hand came into contact with the rotating propeller, causing permanent injury to the hand. The paramotor mesh was also damaged.
