DUTCH
SAFETY BOARD

Quarterly Aviation Report

October - December 2021

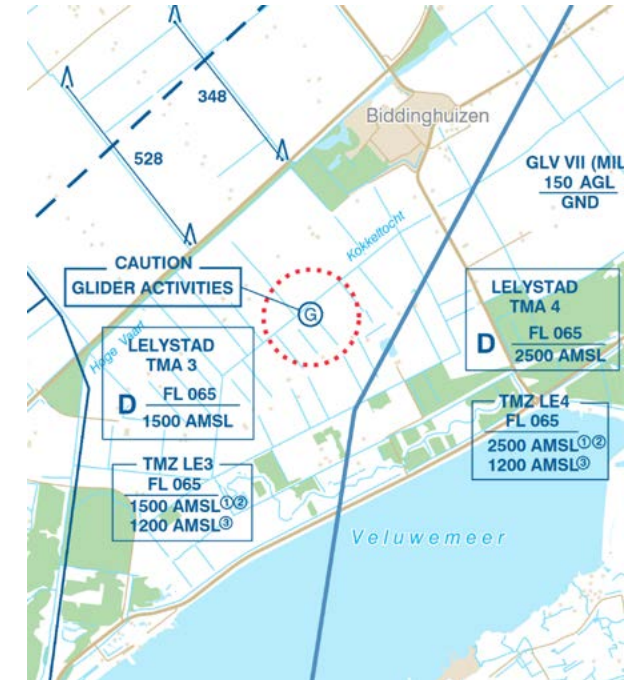
Location glider airfield Biddinghuizen. (Source: AIP)

The pilot on board the two-seater glider made an evasive manoeuvre near glider site Biddinghuizen to avoid a collision with a single-engine aircraft. At the same time, the pilot of the single-engine aircraft also made an evasive manoeuvre. Both aircraft continued their flight without further reported irregularities.

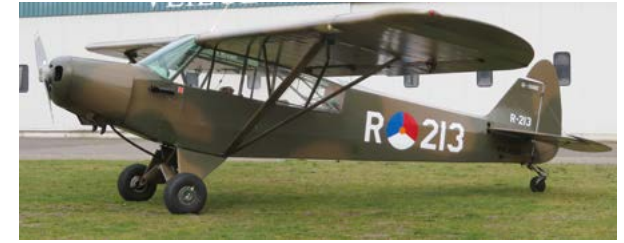
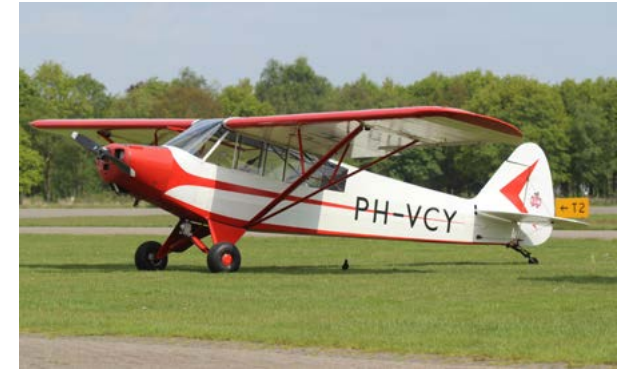
The mid-air collision had severely damaged PH-VCY, causing the aircraft to become uncontrollable and to crash. The pilot and passenger of PH-VCY were fatally injured. PH-RED was substantially damaged; however, the pilot was able to make an emergency landing in a field nearby. The pilot of PH-RED suffered minor injuries, the passenger remained unharmed.

The investigation revealed that during the rejoin of the new formation manoeuvre, the wingman (PH-VCY) closed in from behind at the right side with a higher airspeed, before colliding with leader (PH-RED). It was determined that technical factors did not contribute to the cause of the accident. Both pilots had a valid pilot licence, display authorization and medical certificate.

The formation team practiced a new formation manoeuvre that had the inherent risk for the pilots of not being able to adequately keep each other in sight during the rejoin phase of the manoeuvre. Even though the hazard of losing sight was recognized by the two pilots who were proficient in formation flying, the mitigating measure consisting of a fixed altitude separation of 100 feet was not effective to ensure the safety of the formation during the rejoin. Even with an applied altitude separation as a measure to avoid a mid-air collision, the new formation manoeuvre was by its design unsafe to perform.

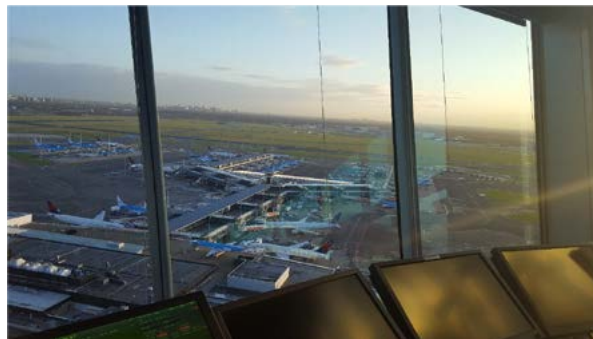
Ground controller's view toward D-pier. (Source: ISMS Schiphol)

Just after the moment he had cleared the B737 at D48, the ground controller saw the A320 that was parked opposite to the B737, starting a push back. He was convinced that the A320, which then started moving backwards, was a different aircraft than the A320 he had just cleared and was towed under the control of Apron Control. However, this was the aircraft that he had just cleared for pushback. His attempt to relay the stop message to the A320 via Apron Control was futile.

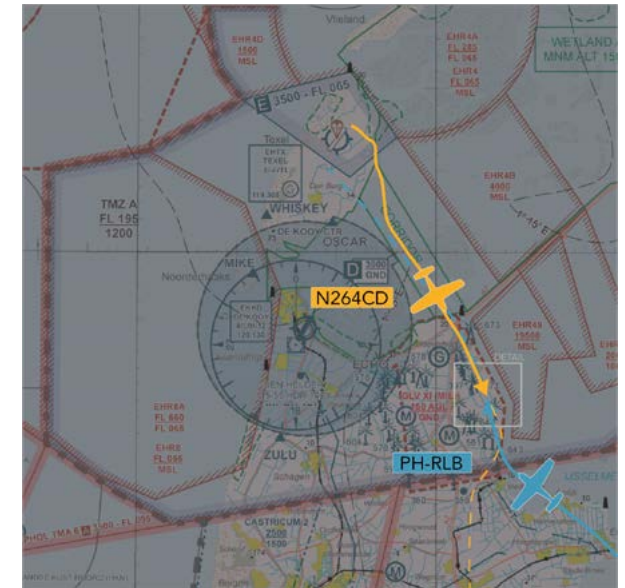
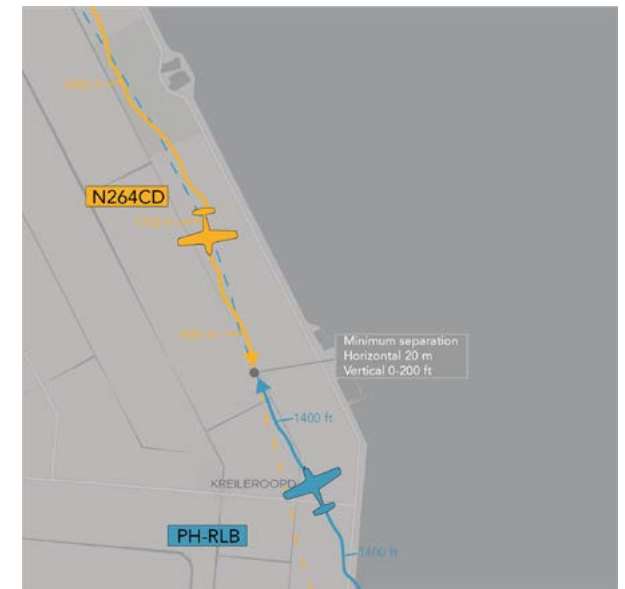
According to the weather report of the Royal Netherlands Meteorological Institute (KNMI), the weather was mostly dry with a small chance of isolated light rain showers. The visibility around the time of the occurrence was good (more than 10 km, in light rain showers 5-8 km). There were scattered to broken clouds at 3,000-4,000 feet, with cloud tops at 5,000 feet. The azimuth of the sun was around 152 degrees and 28 degrees above the horizon, which meant that from the perspective of the Cirrus the sun was behind the Saab. The glare of the sun may therefore have contributed to the pilot of the Cirrus not seeing the other aircraft.

Above: Flight tracks and airspace lay-out. (Source: Aeronautical chart ICAO 1:500,000, LVNL)

Below: Airprox. (Source data: LVNL)
