DUTCH
SAFETY BOARD

Quarterly Aviation Report

October - December 2022

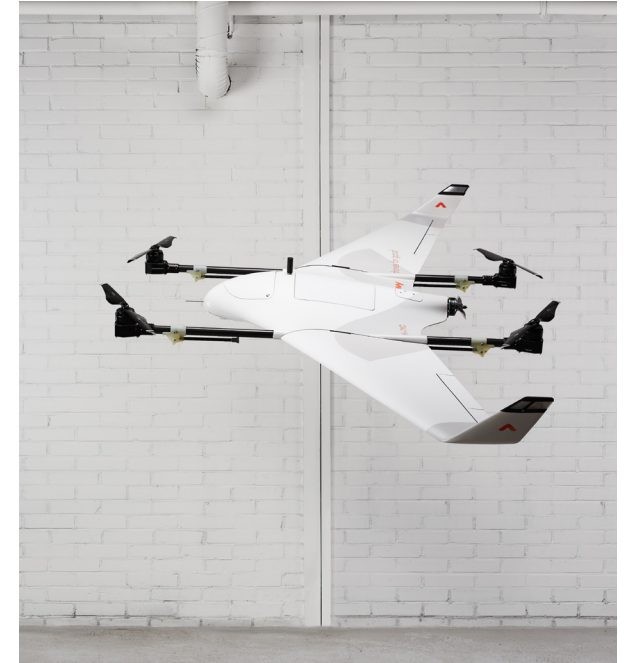
The Dutch-manufactured Unmanned Aircraft (UA) was hovering at between 50 to 65 metres AGL during a demonstration flight, when a rhythmic, lower than normal sound was heard emanating from the Unmanned Aircraft System. It then dipped and spiralled downwards during which control could not be re-established. The UA hit the ground and was severely damaged. A fatigue failure of a blade attachment bolt caused one of the lift propeller blades to detach in flight.

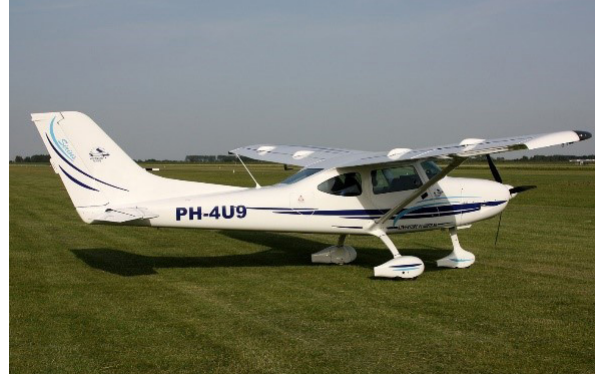
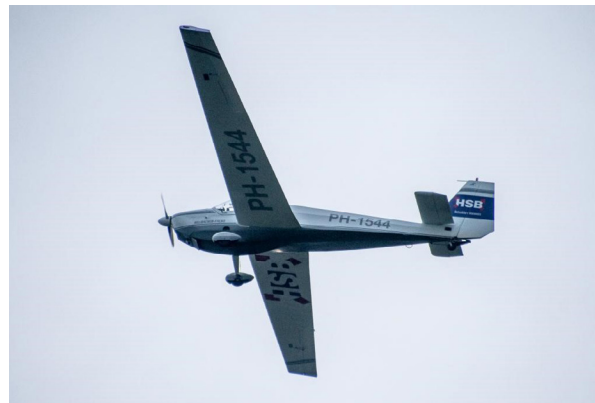
The Scheibe had taken off from Runway 27 of glider airfield Lemelerveld (Salland) for a local flight.²¹ The pilot was seated in the left-hand seat, with a passenger on his right. The pilot of the Scheibe declared that following takeoff, he had flown straight ahead in a westerly direction and was climbing to an altitude of more than 1,500 feet. The aircraft would thus end up in Class E airspace.

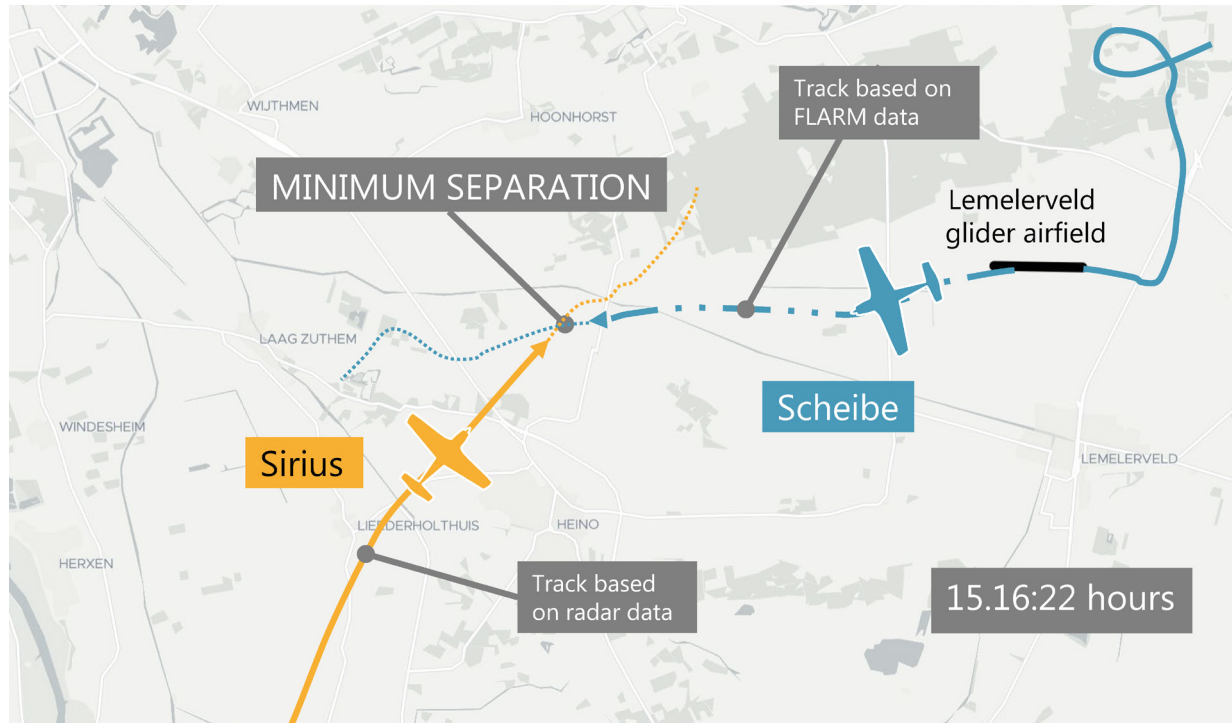
The airprox which took place at an altitude of approximately 1,200 feet. (Source data: LVNL, source map: OpenStreetMap)

Radar information shows that the Scheibe was last detected at an altitude of approximately 500 feet during its approach for landing during its previous flight.²⁵ Around one minute after the two aircraft had passed each other, the Scheibe for the first time reappeared on the radar at an altitude of 1,380 feet. The pilot of the Scheibe was unable to provide an explanation for this.

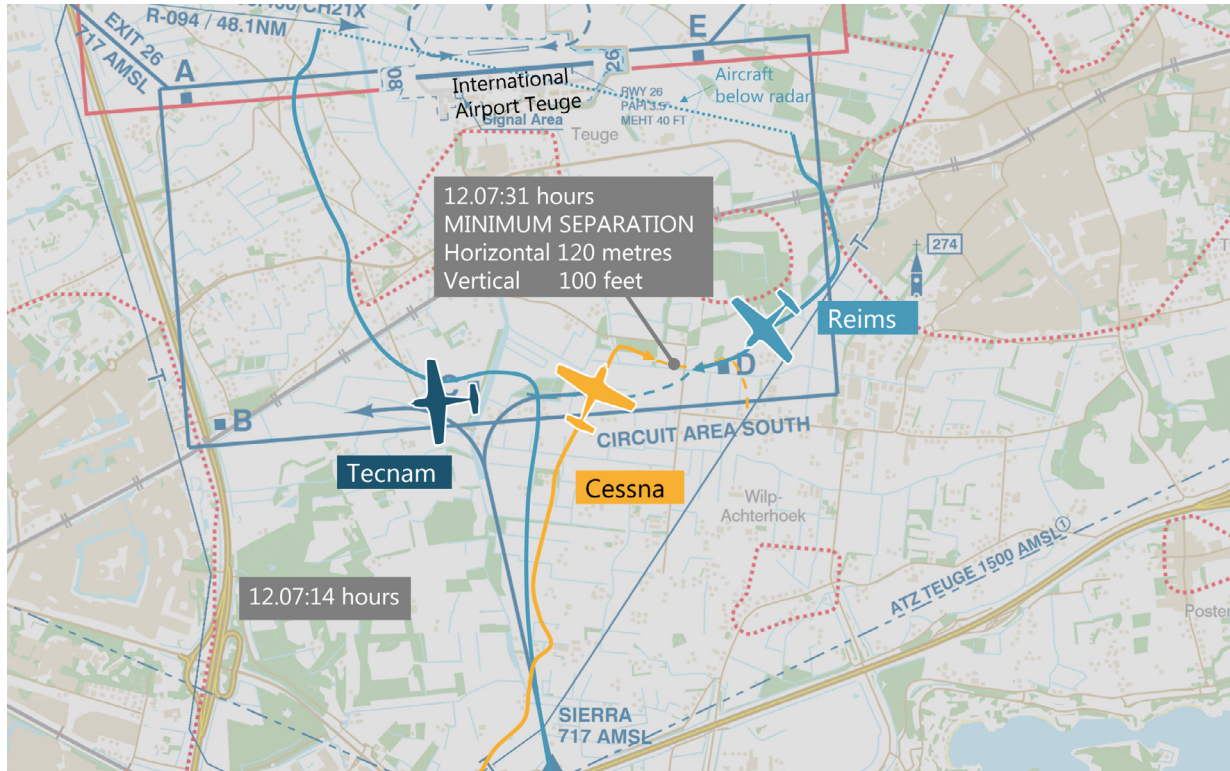
It is not mandatory at Teuge Airport, as for most uncontrolled aerodromes, to make downwind calls. The occupants of both aircraft only saw the other aircraft when they were flying towards each other on the downwind leg. The pilot of the Cessna stated that he was under the impression that there was only one aircraft flying in the circuit. The Cessna's right-hand turn resulted in the aircraft flying in the opposite direction on downwind. Such a manoeuvre may only be performed outside the circuit area.

Circuit area International Airport Teuge. (Source: AIP and radar data, LVNL)

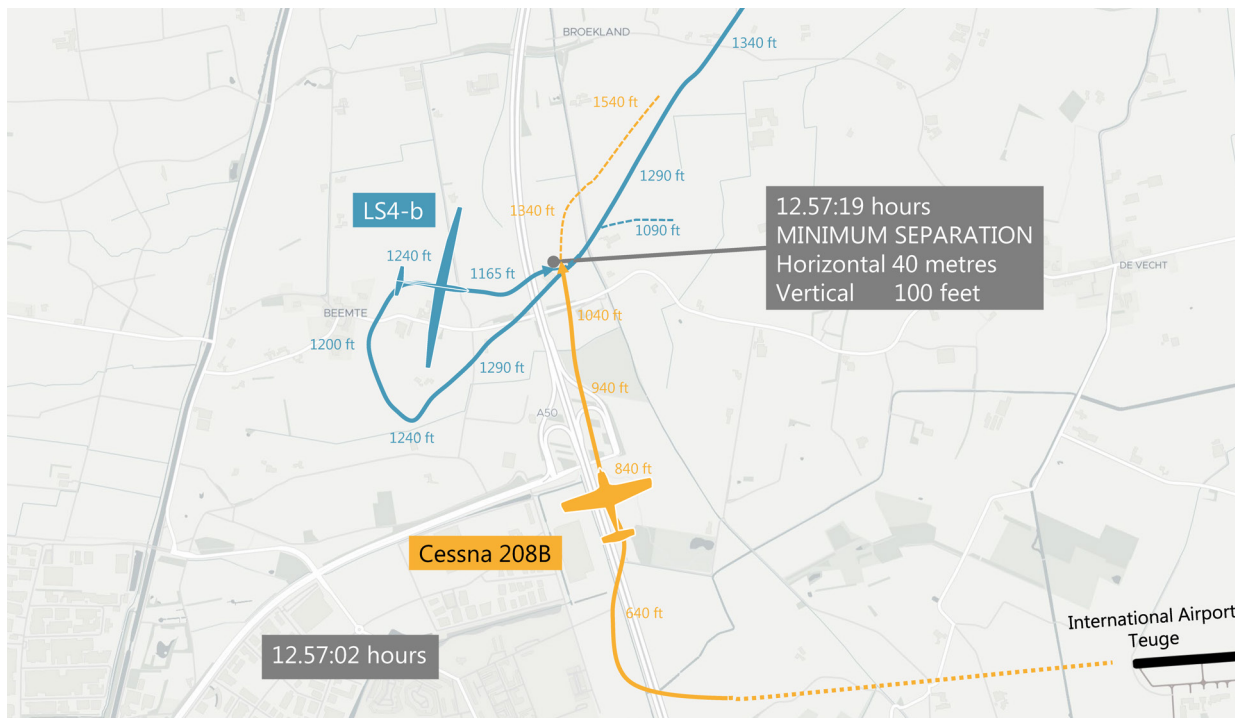
The aircraft from the parachute centre were equipped with the FLARM system, but because PH-SPT had only recently entered the service of the parachute centre, this aircraft was not yet equipped with FLARM.

Radar track of the LS4-b and the Cessna 208B. (Source data: LVNL, source map: OpenStreetMap)
