Accident with Apache during night flight training
near Rossum, 12 December 2007

The Hague, January 2009 (M2007DE1212-08)

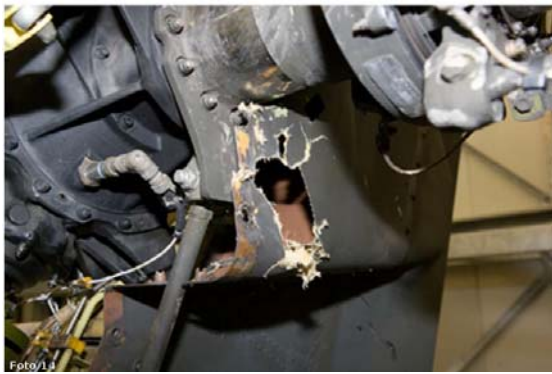
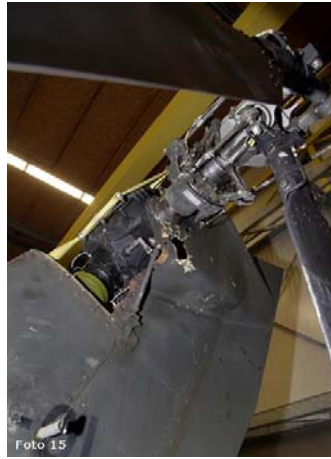
The tail rotor head (head and swashplate⁹⁹) did not show any damage, however there was some damage to the tail rotor blades. Damage to the tail rotor blades is discussed separately in this report (see photos 14 and 15).

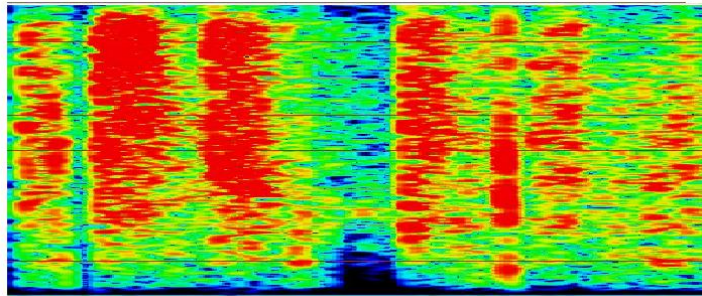
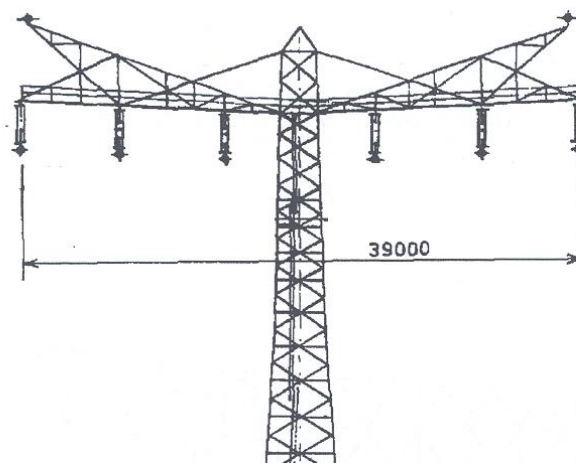
Unravelling the available audio data within a specific frequency range makes it possible to see the impact noise at a specific point in time, followed by a noise that recurs at regular intervals until the end of the flight.

Calculations on the basis of the speed of the Apache and the distances between the wires show that this was the point at which the Apache actually collided with the six power lines (See the adjoining illustration).

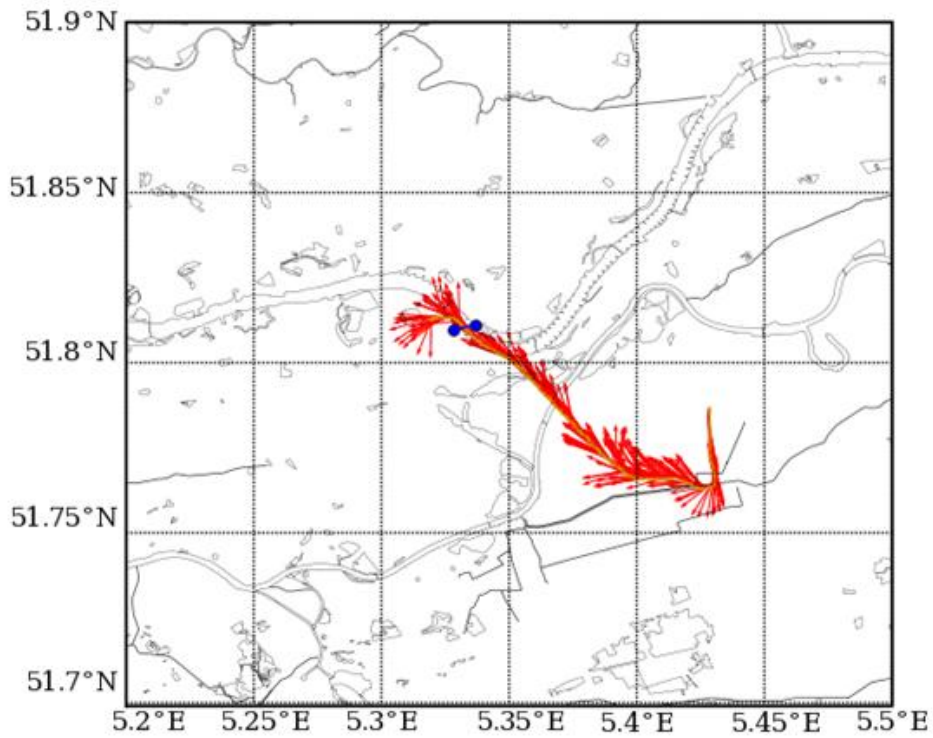
Direction of view of the back seater shown at GPS positions as recorded by the MDR.

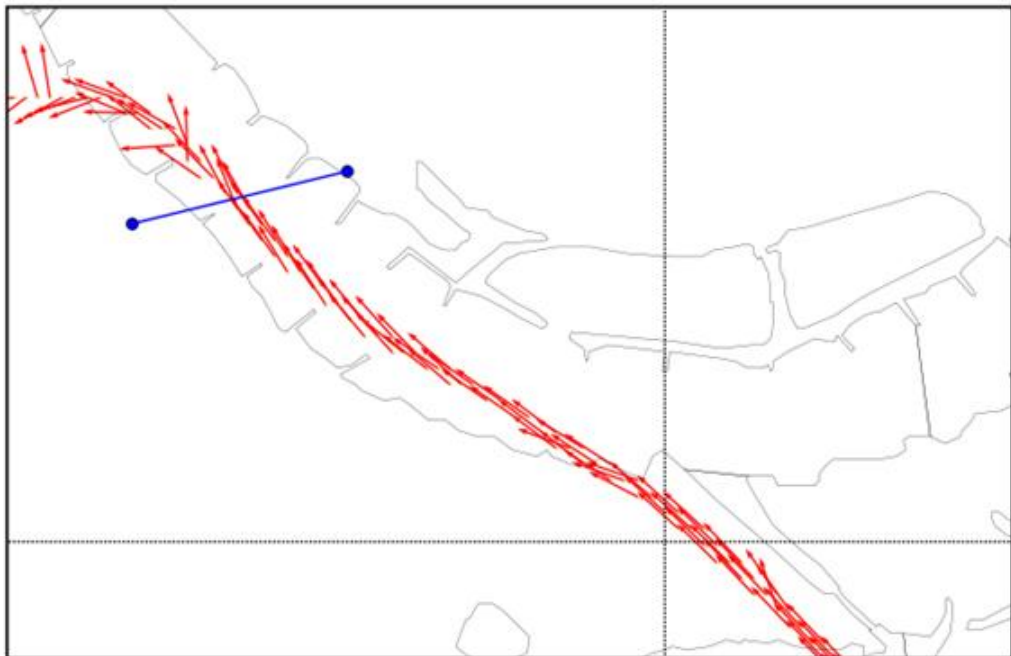
Direction of view of the back seater (red) immediately before, during and after the collision with the high-voltage cables. The interval of the direction of view shown is 0.16 seconds.

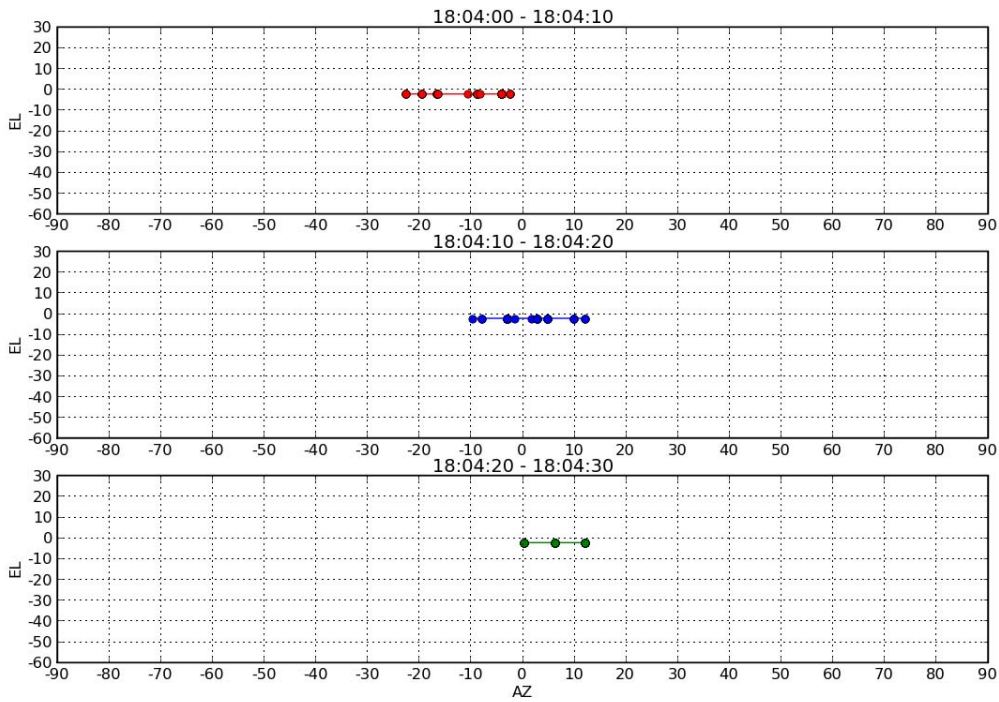
Direction of view of the back seater (altitude [el] and azimuth [az]) for a period of 30 seconds prior to the power line collision.

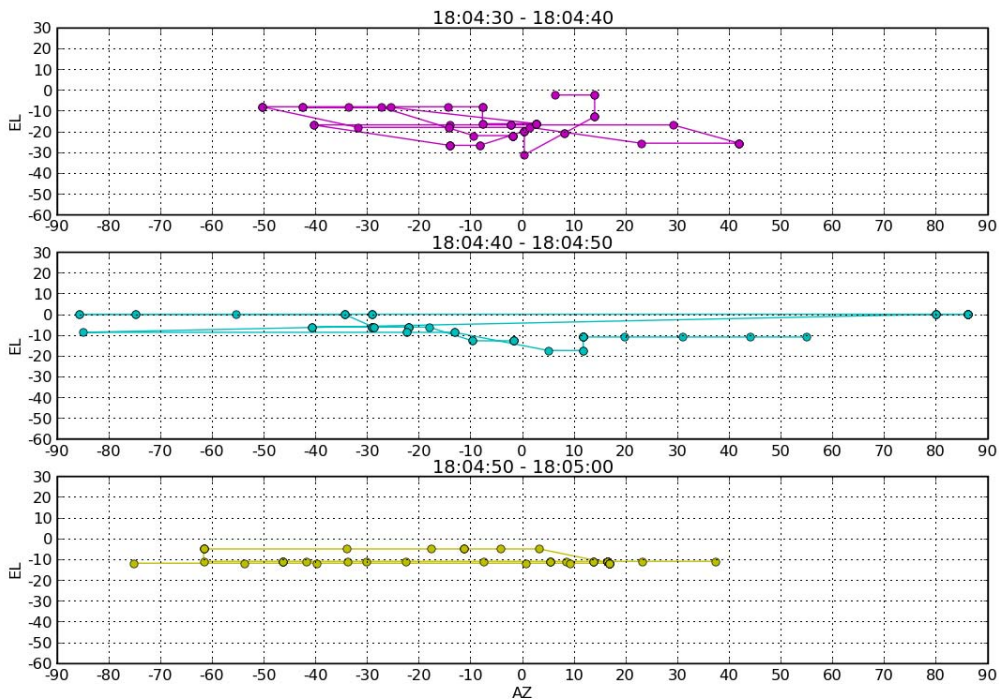
Direction of view of the back seater (altitude [el] and azimuth [az]) at the time of the power line collision (18.04.30) and up to 30 seconds after the collision.

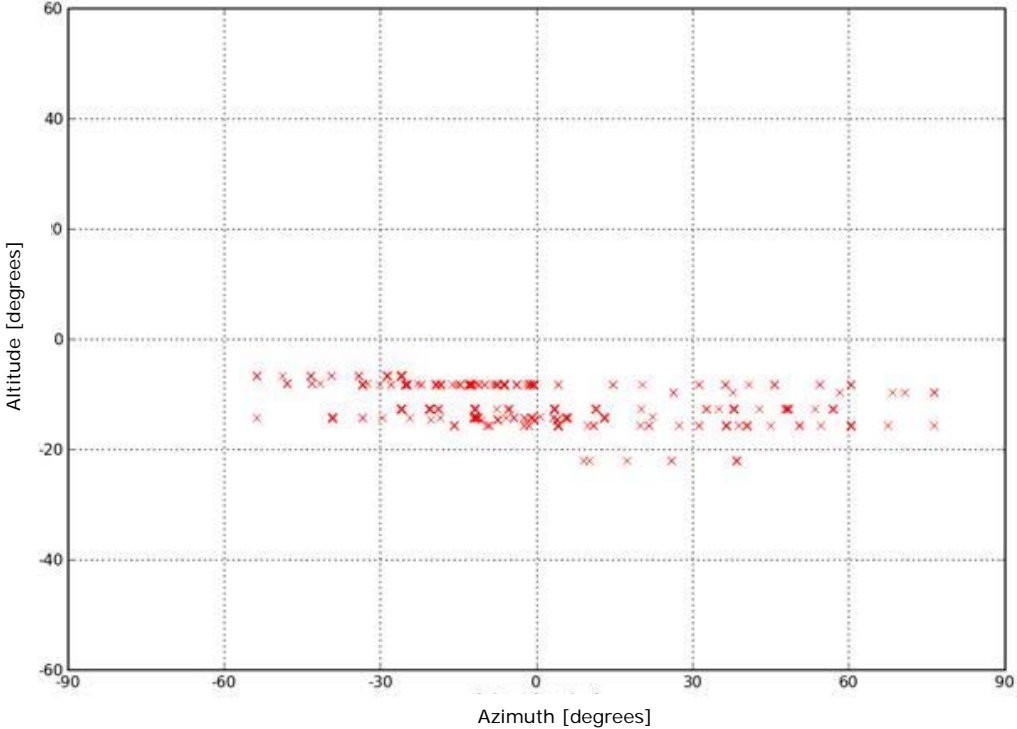
The scan pattern of the back seater at around 25 minutes prior to the power line collision does not differ, however, from the scan patterns in the three other flights investigated (see section 5.2.6).

Position of the back seater's head 25 minutes before the power line collision [2 MINUTES]
